ZLR Public Hearing on February 12th, 2019

The information contained herein pertains to what will be presented by me contradicting the information provided by MacWilliams Co. appraisers who stated that there has been no evidence to show decreased property values as a result of mining and blasting at the Oak Park quarry. This quarry is seeking a new CUP 2018-02449.

Statement at 2/12/19 Zoning and Land Regulation Committee meeting on CUP 2018-02449

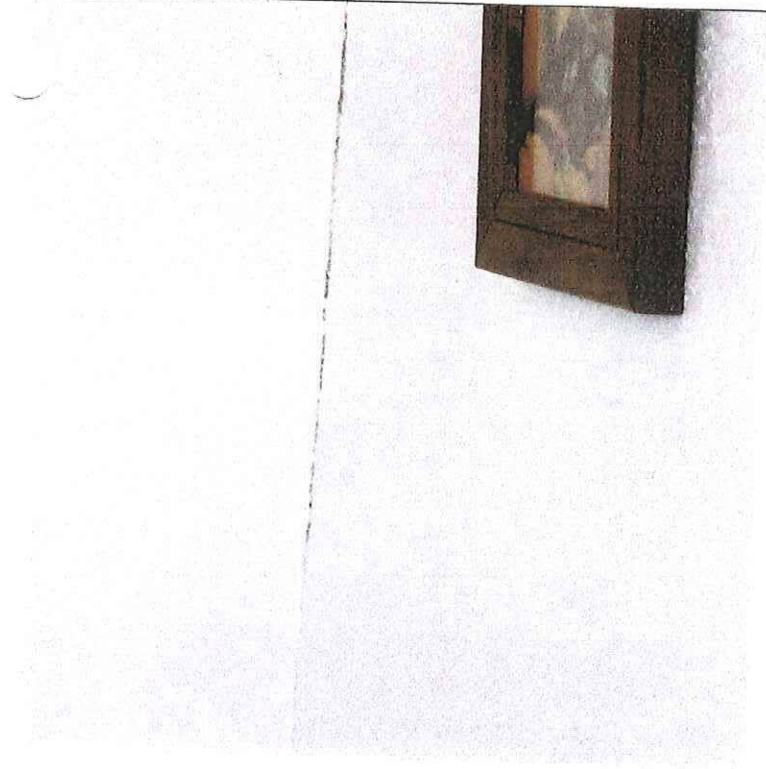
PHOTOS OF CRACKS TAKEN ON
MARCH 4, 2016

We built our home at 1285 Olstad Road in the summer and fall of 2009 with occupancy on 12/18/2009. We had purchased the then vacant land in June, 2008. At that time, there was no activity at the Oak Park quarry or during the time that we were building. In fact, the last CUP with Amon & Son ended April, 2007. The new and present CUP was not approved until March, 2009. New operations did not begin under present ownership until November, 2010. Between 12/09 and the summer of 2015 (6 years), we noted no cracks in our thin coat plaster anywhere in our home. Frequent and intense blasting occurred in the summers of 2014 and 2015 at the quarry. We first noted cracks in 2015, all on the east side of our home which is about 600 feet from the quarry. We started taking pictures of these cracks March 1, 2016.

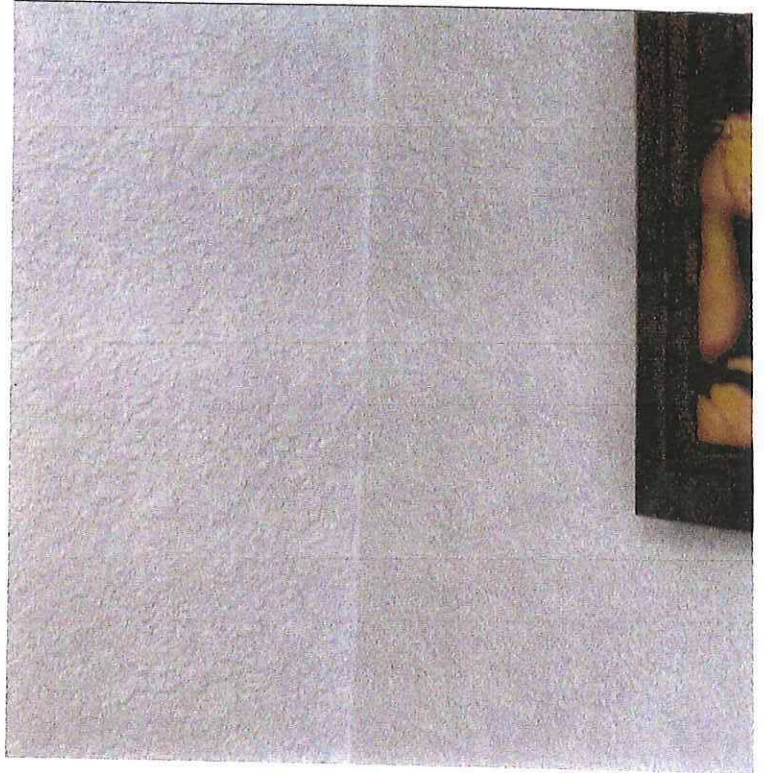
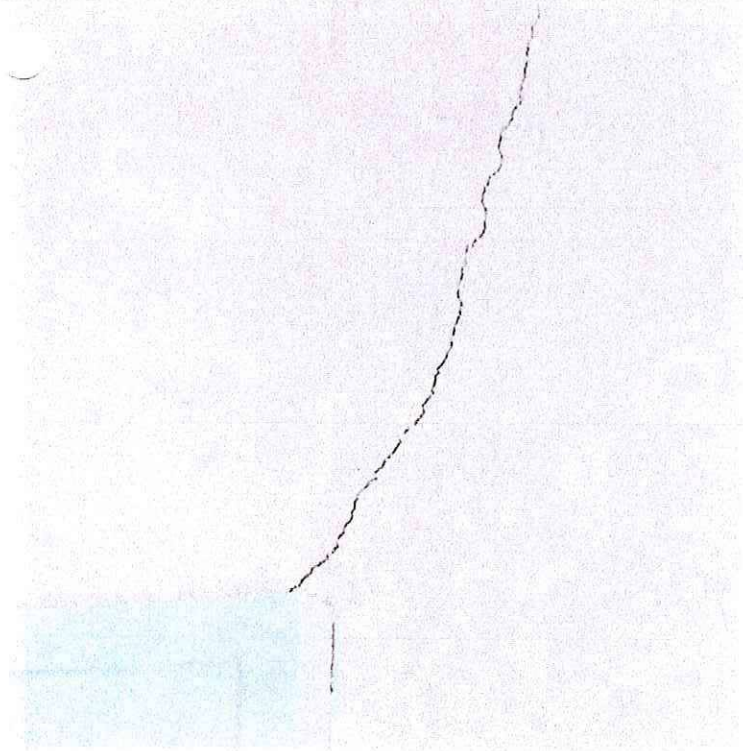
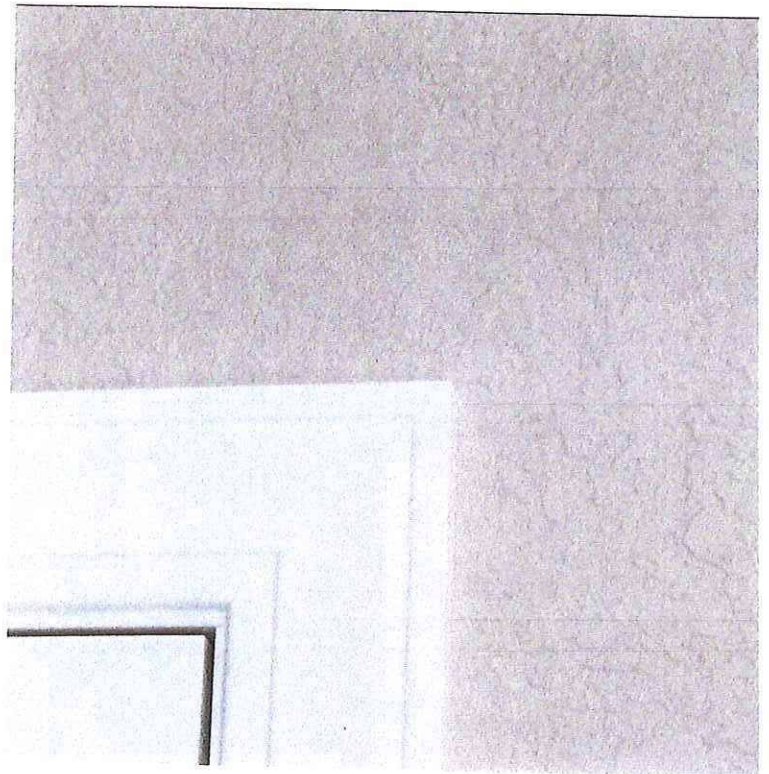
PHOTOS TAKEN OF REPAIRS ON
DECEMBER 13, 2018

When we learned that the quarry was not going to apply for a blasting permit in 2016, we began to repair and repaint the rooms with these cracks the winter of 2016. (Some repairs still remain). We took new pictures of these repairs 12/13/2018. The repairs are in good condition and there are no new cracks anywhere in our home. We believe that the cracks were the result of blasting and that no new damage has occurred because there has been no blasting in the last 3 years.

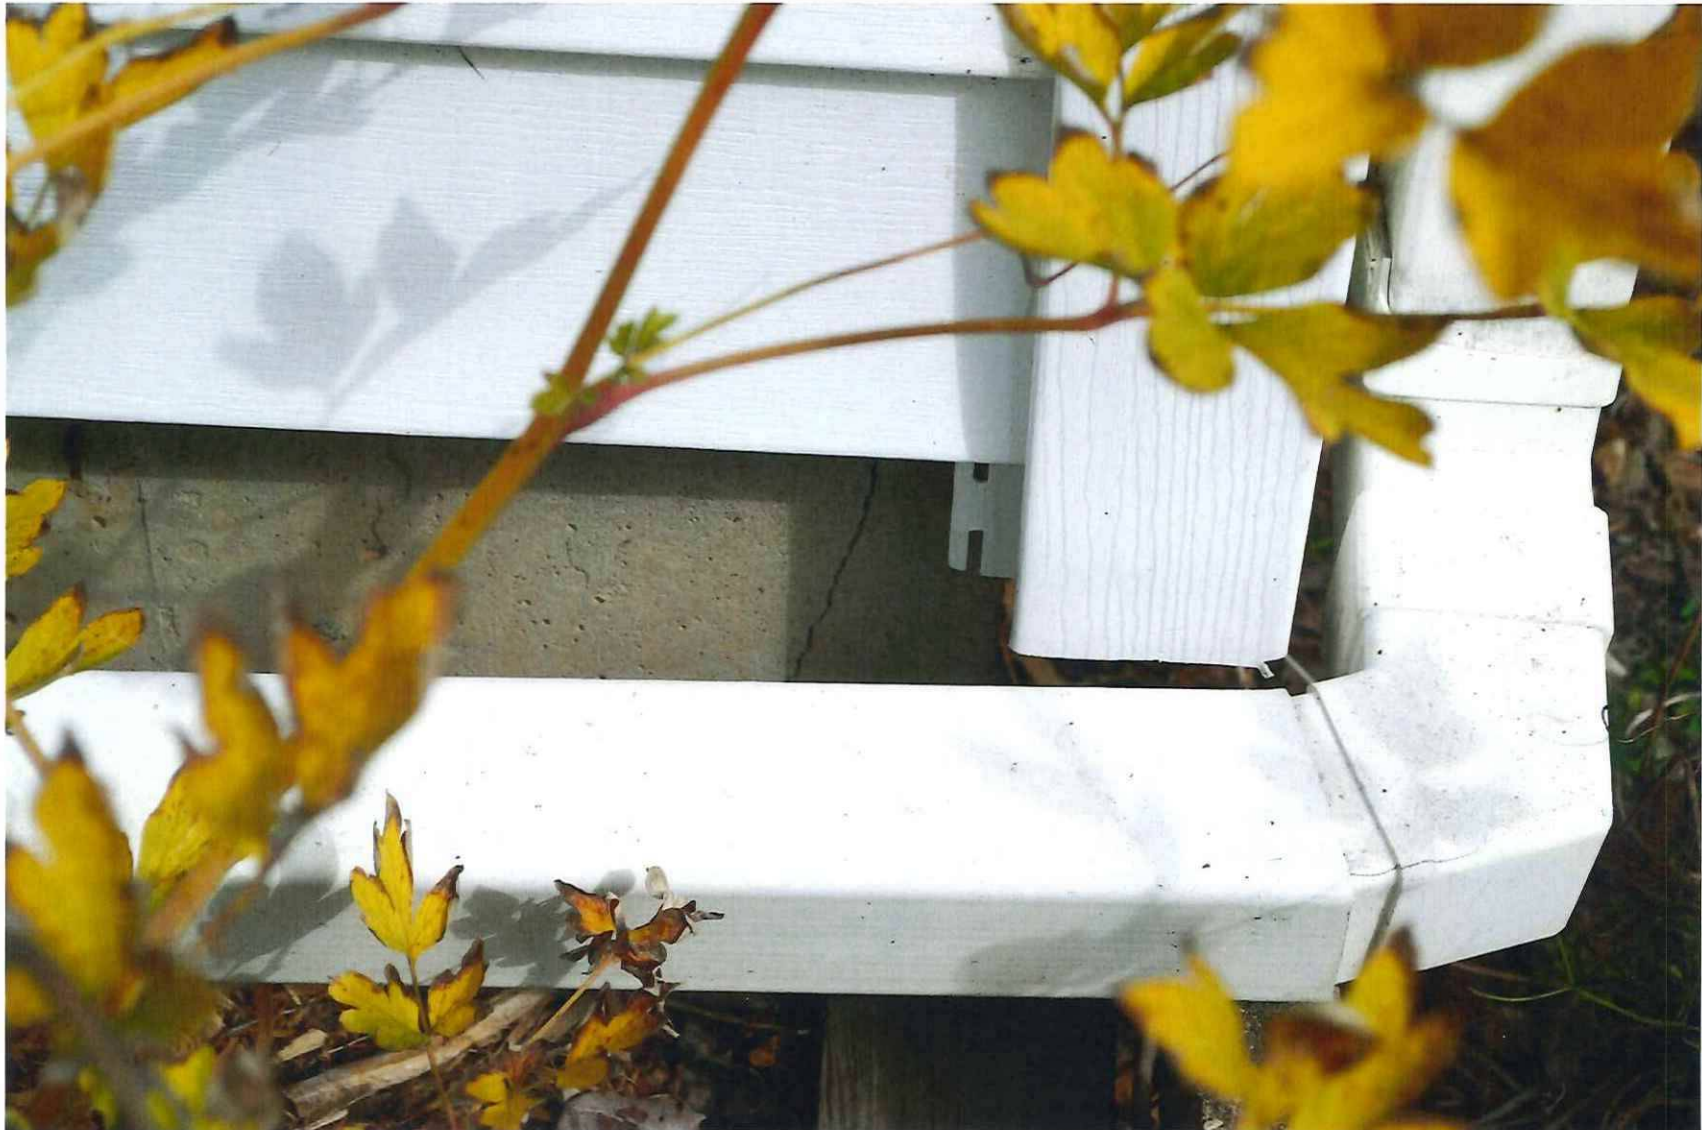
**Ms. Karen Harbort
1225 Liberty Road**

**Photo #1 – Cracks in the foundation of the
garage along the south wall**

Photo from Pre-blast Survey in 2014

The garage foundation was not cracked before Halverson took over the quarry.

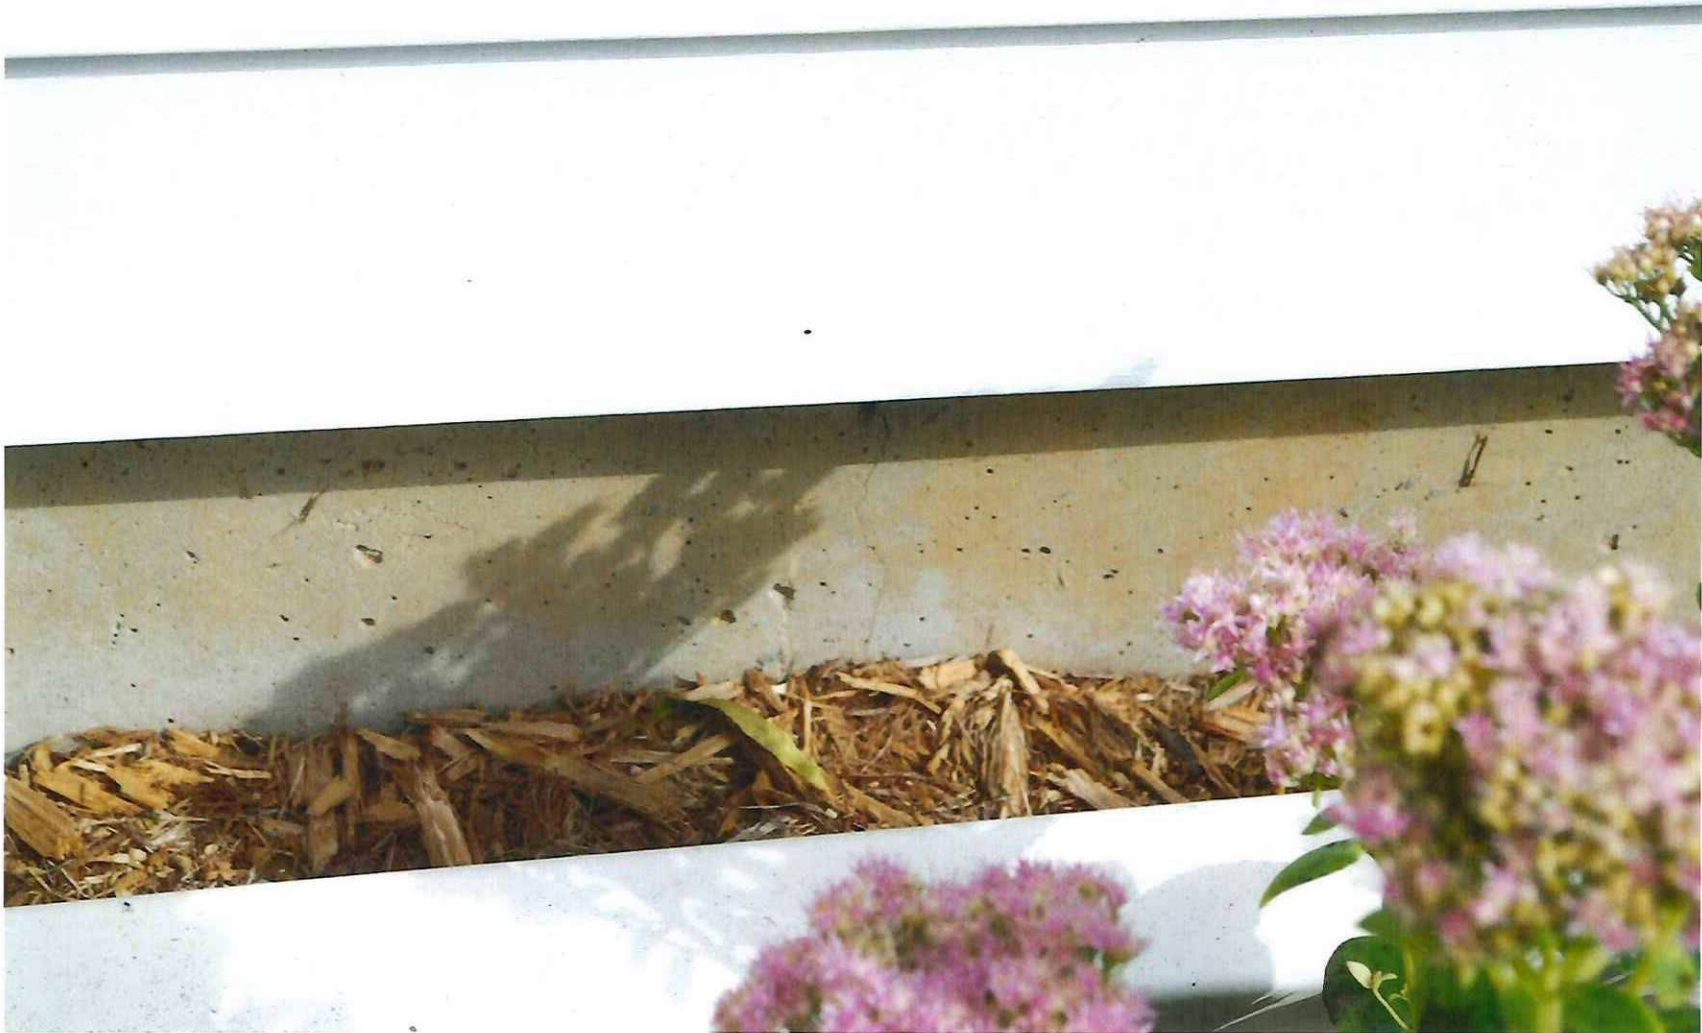
**Ms. Karen Harbort
1225 Liberty Road**

**Photo #2 – Cracks in the foundation of the
garage along the south wall**

Photo from Pre-blast Survey in 2014

The garage foundation was not cracked before Halverson took over the quarry.

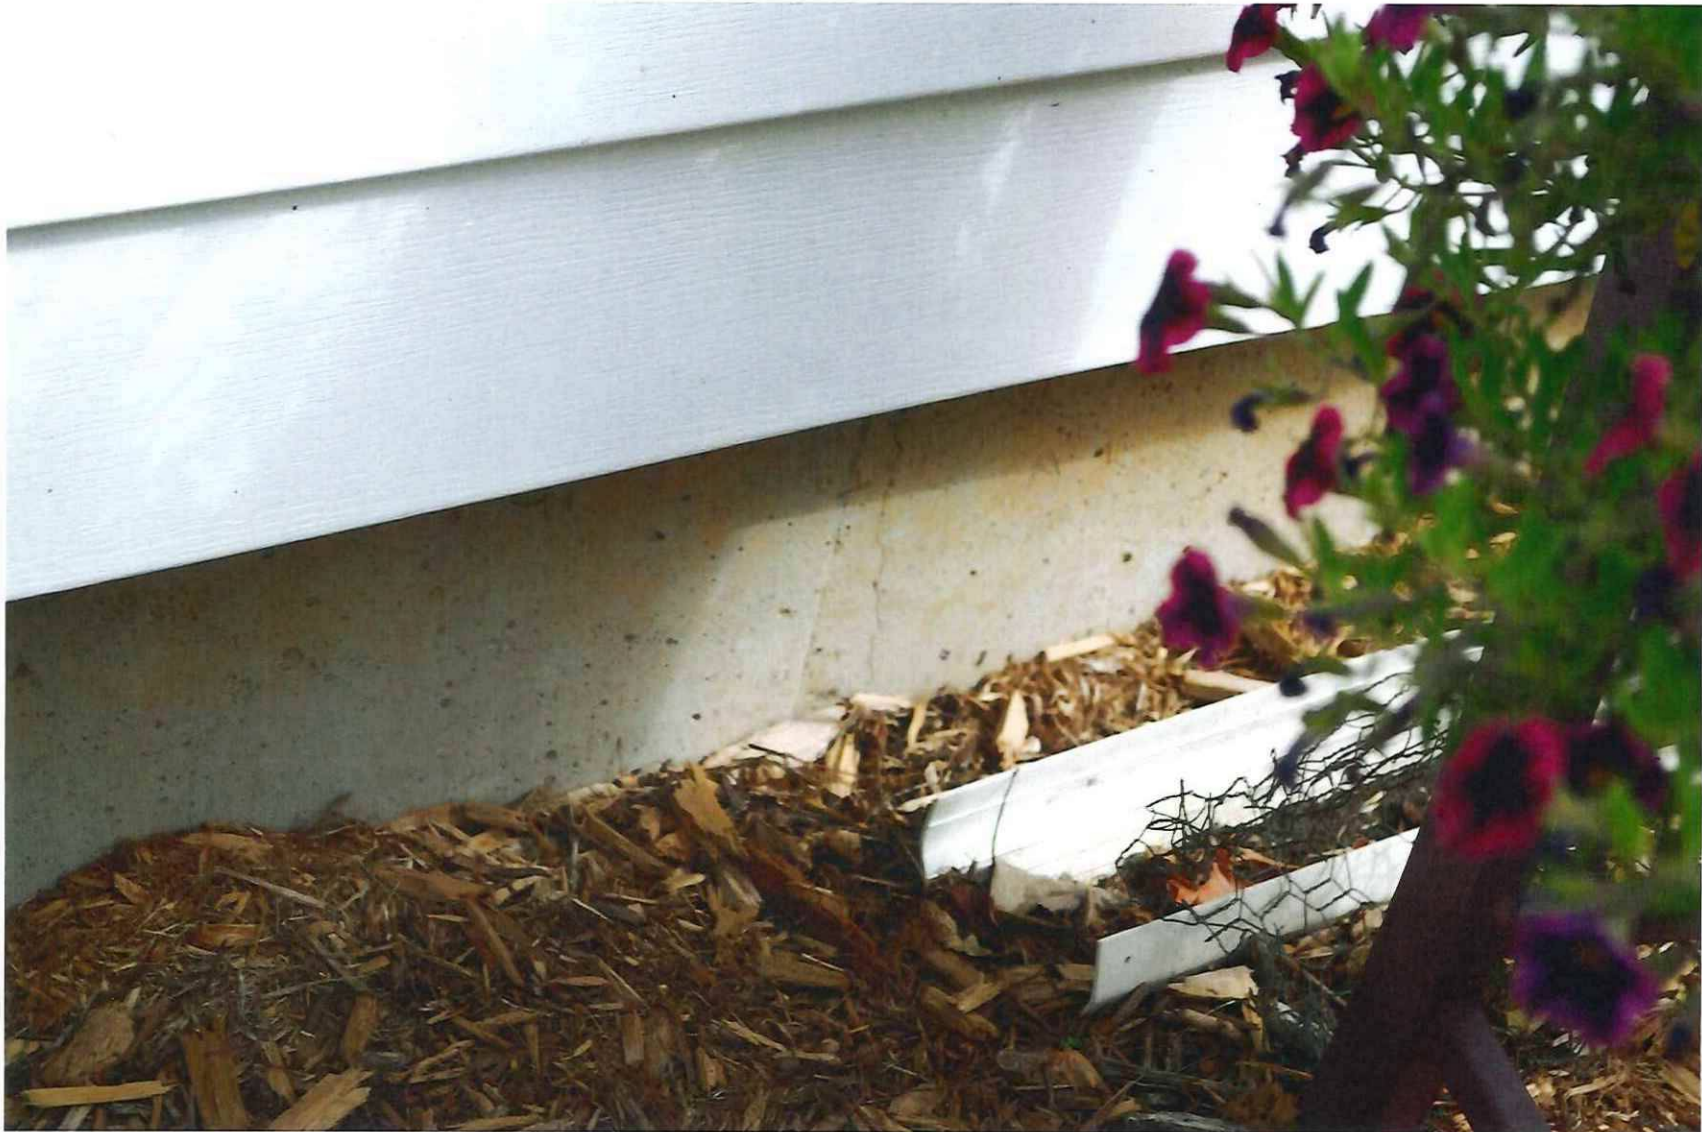
**Ms. Karen Harbort
1225 Liberty Road**

**Photo #3 – Cracks in the foundation of the
garage along the south wall**

Photo from Pre-blast Survey in 2014

The garage foundation was not cracked before Halverson took over the quarry.

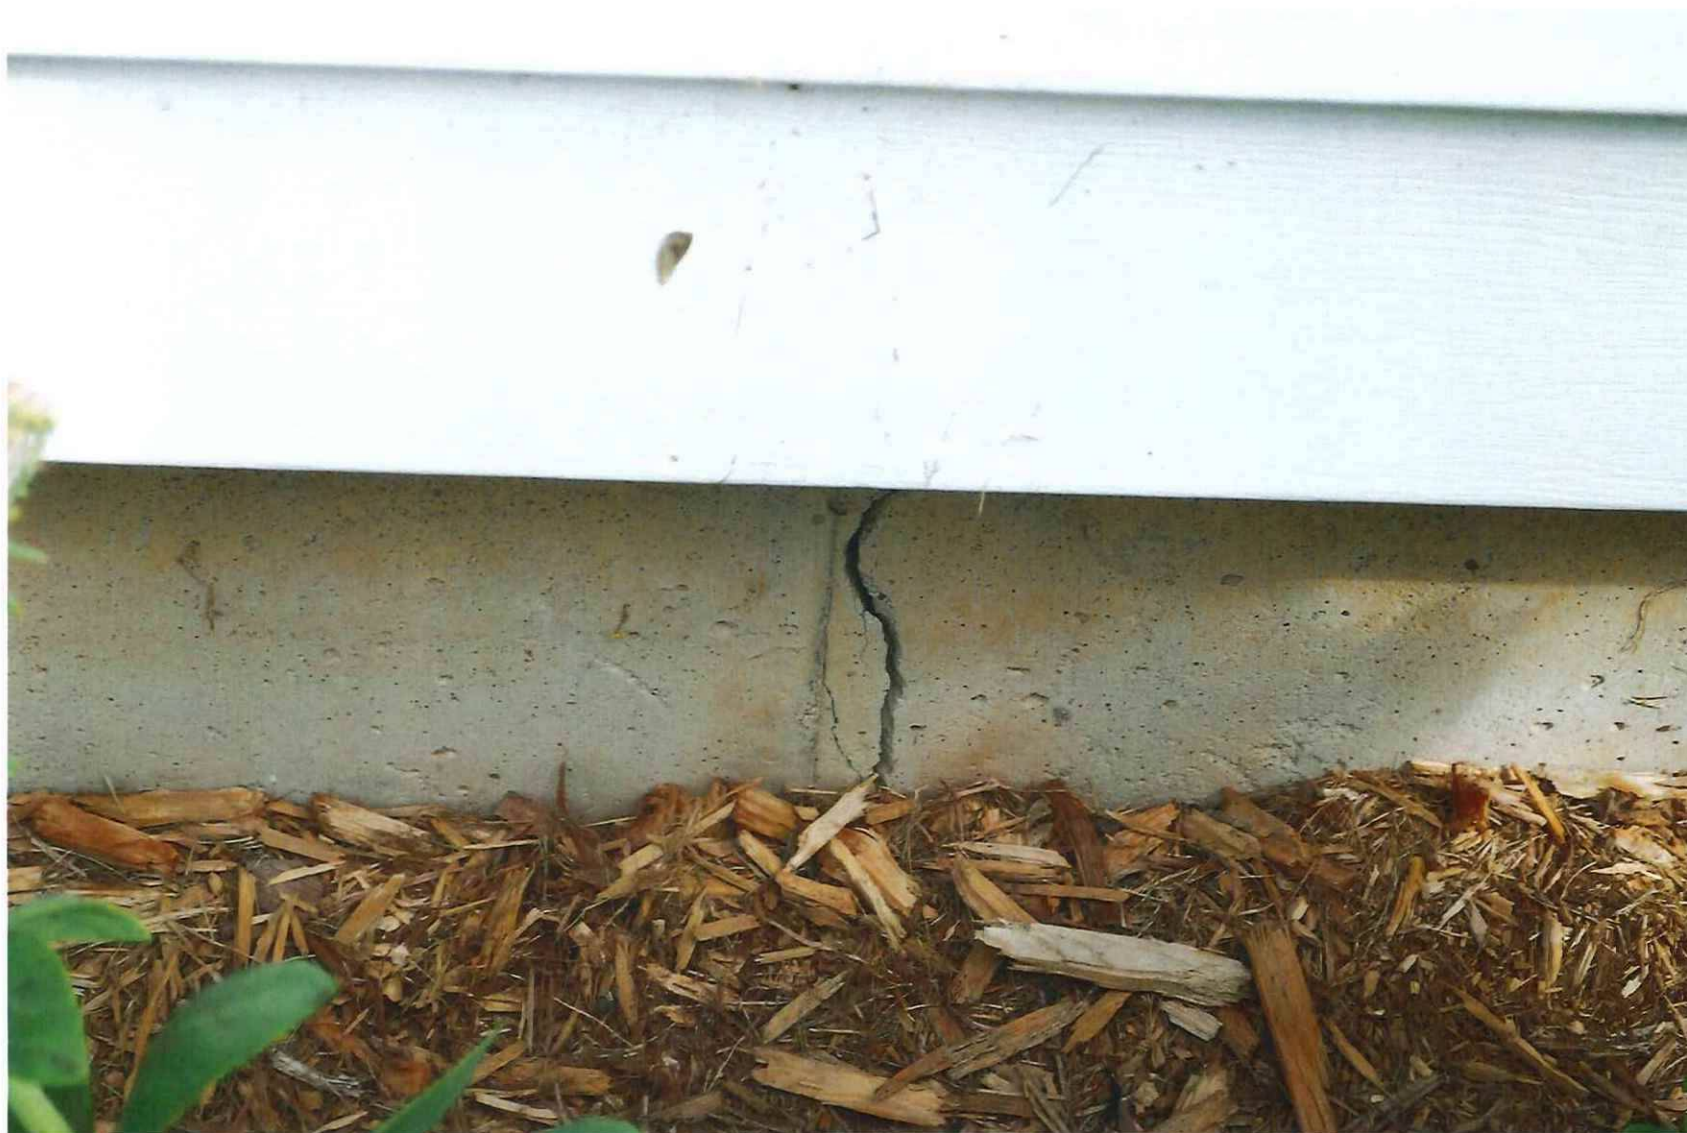
**Ms. Karen Harbort
1225 Liberty Road**

**Photo #4 – Cracks in the foundation of the
garage along the south wall**

Photo from Pre-blast Survey in 2014

The garage foundation was not cracked before Halverson took over the quarry.
