EXISTING FACILITIES EVALUATION REPORT

Dane County Clerk's Office Election Center Facility

DRAFT October 10, 2023

Commission No. 233108

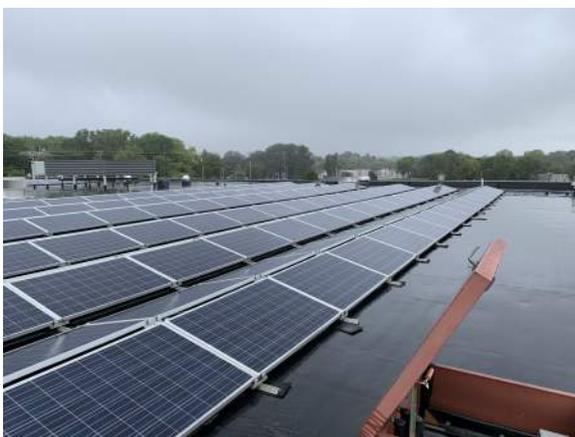
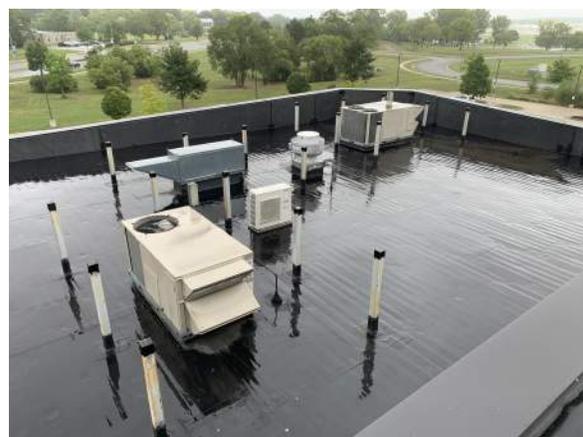
The roofing system is a black, ethylene propylene diene terpolymer (EPDM), single-ply membrane. The membrane appears to be a fully adhered system. The structure of the upper (larger) roof area is sloped to provide positive drainage to roof drains located along the east and west sides of the building. The roof system at the upper (larger) roof area is assumed to date from the building's original construction and appears to be in excellent condition. It was raining at the time of Wold's site visit and there was no visible evidence of standing or ponding water on the roof.

The lower (smaller) roof area over the office portion of the facility (at the north side of the building) is also covered with a black EPDM, single-ply membrane roof system, and is also assumed to be a fully adhered system. Some standing water was observed around the roof drain, however, upon removal of the roof drain strainer the water began evacuating quickly. Debris was removed from the strainer before it was put back into place. The lower roof area was observed to exhibit a few "soft spots" where the insulation beneath the roof membrane gave way when stepped upon, however, there was no evidence of failure in the membrane or evidence of leaks in the occupied area below.

A significant area of the upper (larger) roof area was covered by photovoltaic solar panels. The solar panels appear to be self-supported on a rail system that sits upon rubber pads. There are minimal roof penetrations associated with the solar panels.

Based on the age of the building, the existing roof system would be within the limits of a typical 20- or 30-year warranty period. Given the condition of the roof, it is our recommendation that the existing roof has at least 10 years of useful life remaining.

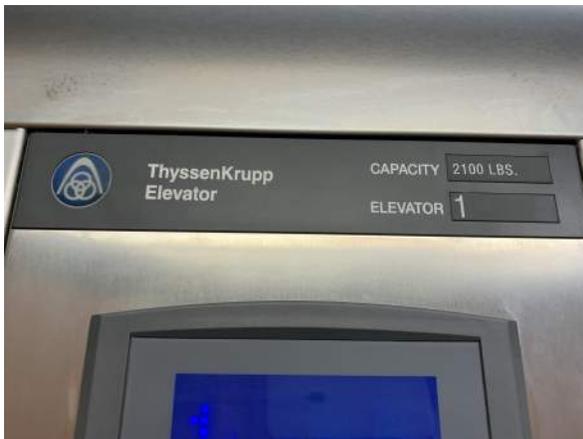
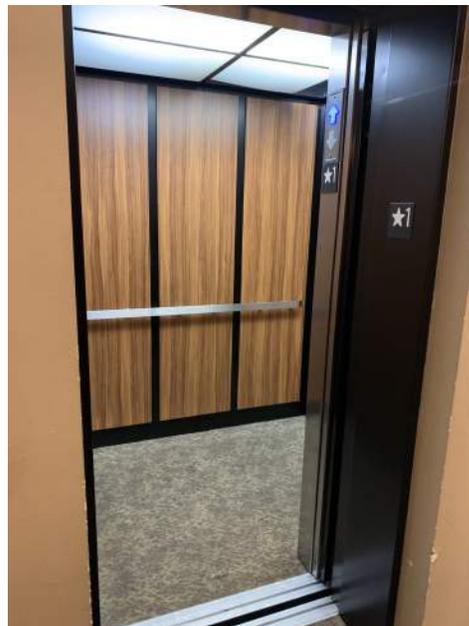
The existing 2-stop elevator serves the main and upper levels and is believed to date from the building's original construction in 2011. The elevator was manufactured by ThyssenKrupp and has a capacity of 2100 pounds.

The elevator is operational. The interior of the cab is in good physical condition and the elevator controls appear to be in good, functioning condition.

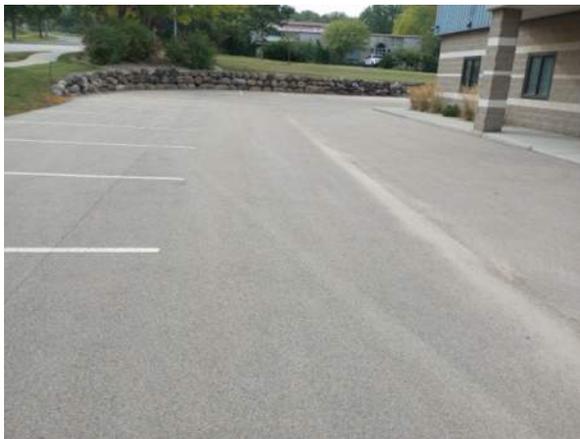
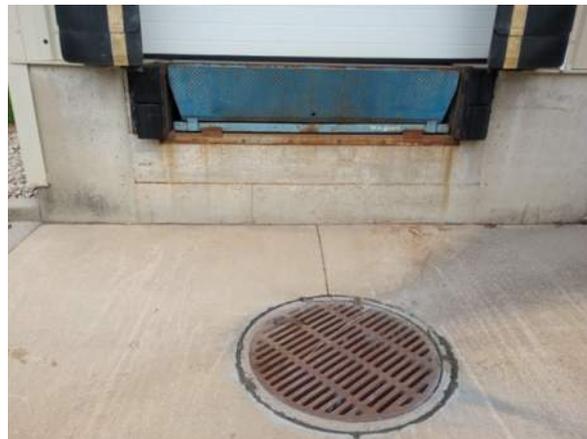
The walkways within the property boundaries are generally in new to excellent condition. No work is required to repair or replace walkways or pads within the property limits.

The asphalt parking lot and access drives are in excellent condition. Recent repaving of the asphalt is evident. No work is required to repair or replace asphalt lot or access drives within the property limits.

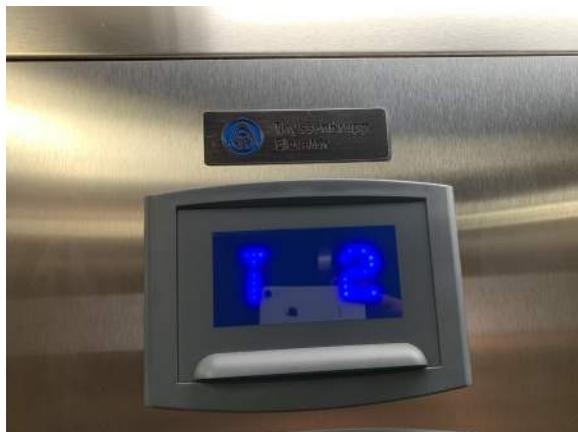
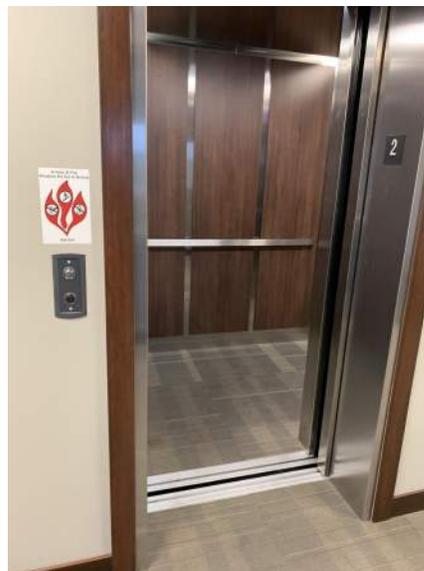
The existing 2-stop elevator serves the main and upper levels. The elevator was manufactured by ThyssenKrupp and has a capacity of 2100 pounds.

The elevator is operational. The interior of the cab is in excellent physical condition and the elevator controls appear to be in good, functioning condition. It appears that the elevator has likely undergone either replacement or modernization in the last few years.
