DANE COUNTY PLANNING & DEVELOPMENT

RE: CUP 2582 Mineral extraction summary – Flooding concerns

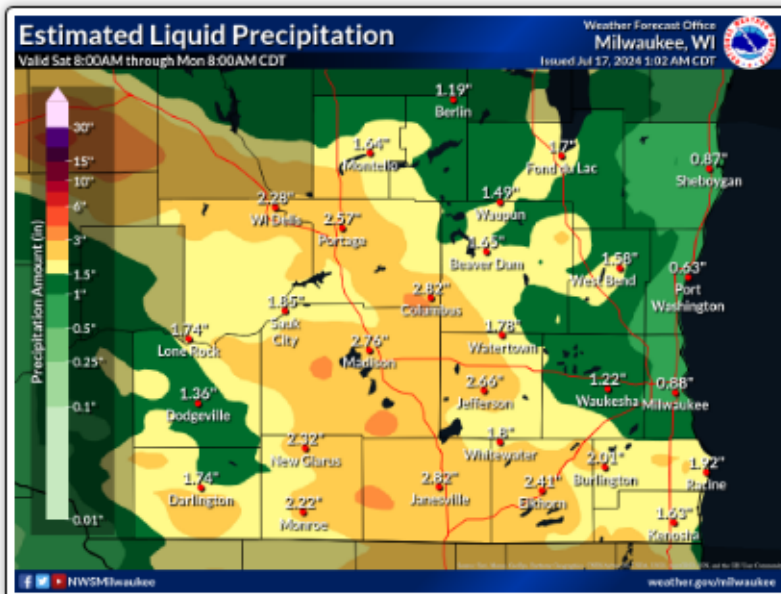
Observed rainfall between 7:00 AM July 13 and 7:00 AM July 16.

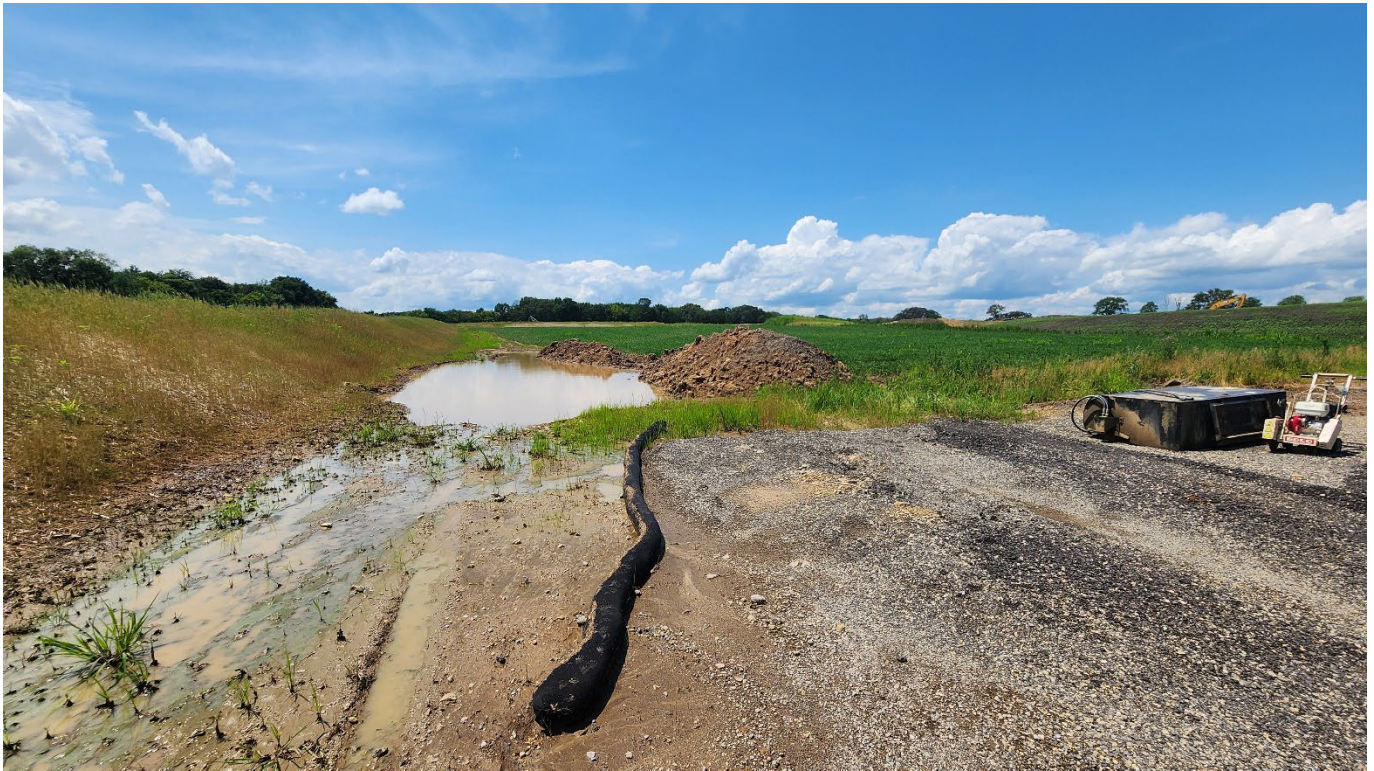
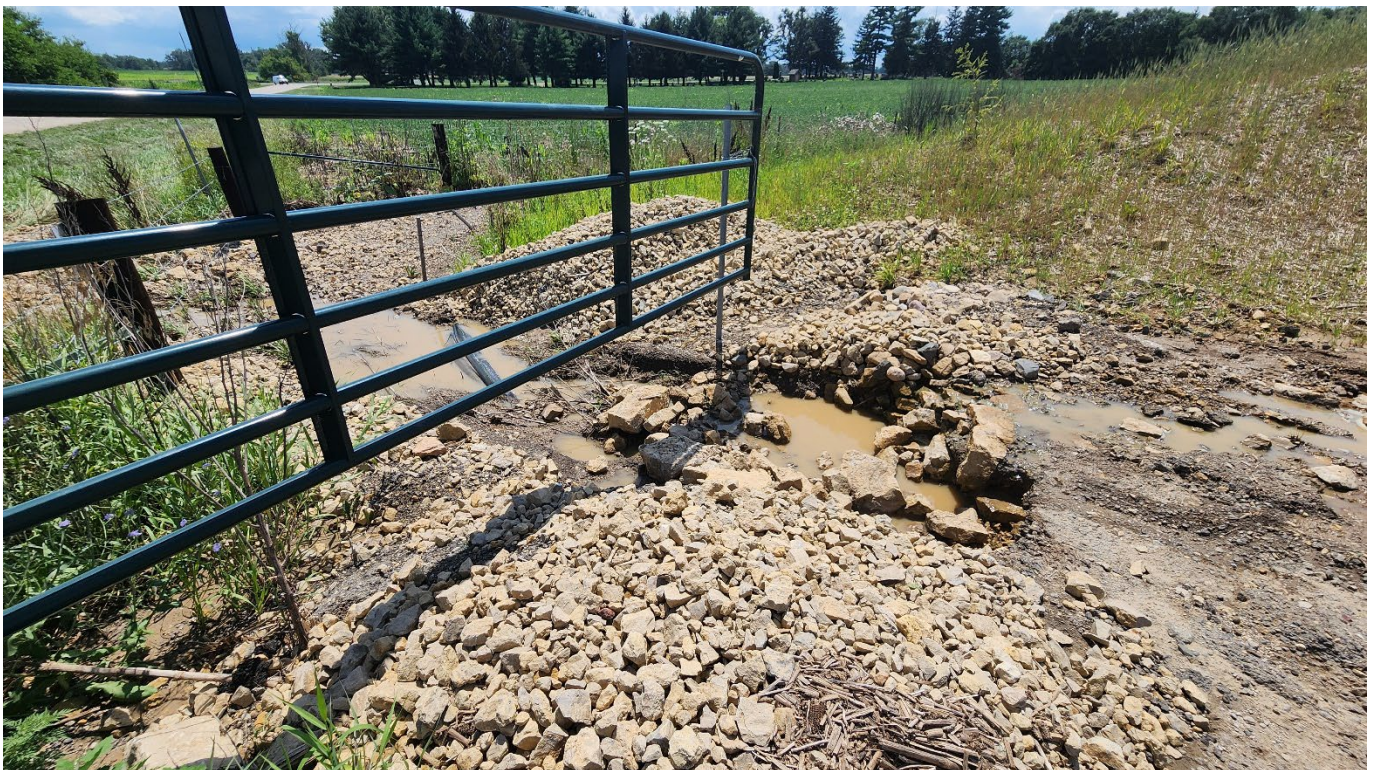
I walked throughout the quarry site and observed a washed out area of rock near the new driveway entrance and breaker stone in the ditch adjacent to the concrete culvert. I also noticed a small dug out pond straight west of the driveway and against the southerly berm to retain surface water from the soybean field. This newly created pond was overflowing and a water was running towards the driveway and to the ditch. No water was being pumped out.

I indicated to the quarry operator, Kevin Hahn that no stormwater is to leave the site other than occasional discharging which is tied to DNR Permit WI-A046515-06. Dewatering is allowed from time to time and may be pumped off-site to the nearby road ditch.

I understand the reasoning for the small dugout pond is to alleviate flooding of the agricultural field within the CUP boundary. However, with the recent storm events and the current saturation levels within the area, the operator will need to reach out to the Dane County Land & Water Resources department to find a solution and design and engineer a suitable detention pond within the site so nothing leaves the site naturally. This will be critical as a large storage building is being proposed in this same area.

This detention pond is not part of the approved operations plans prepared by Mendota Consulting. In addition, the ditch will need to be cleaned out in order to prevent stormwater further backing up.

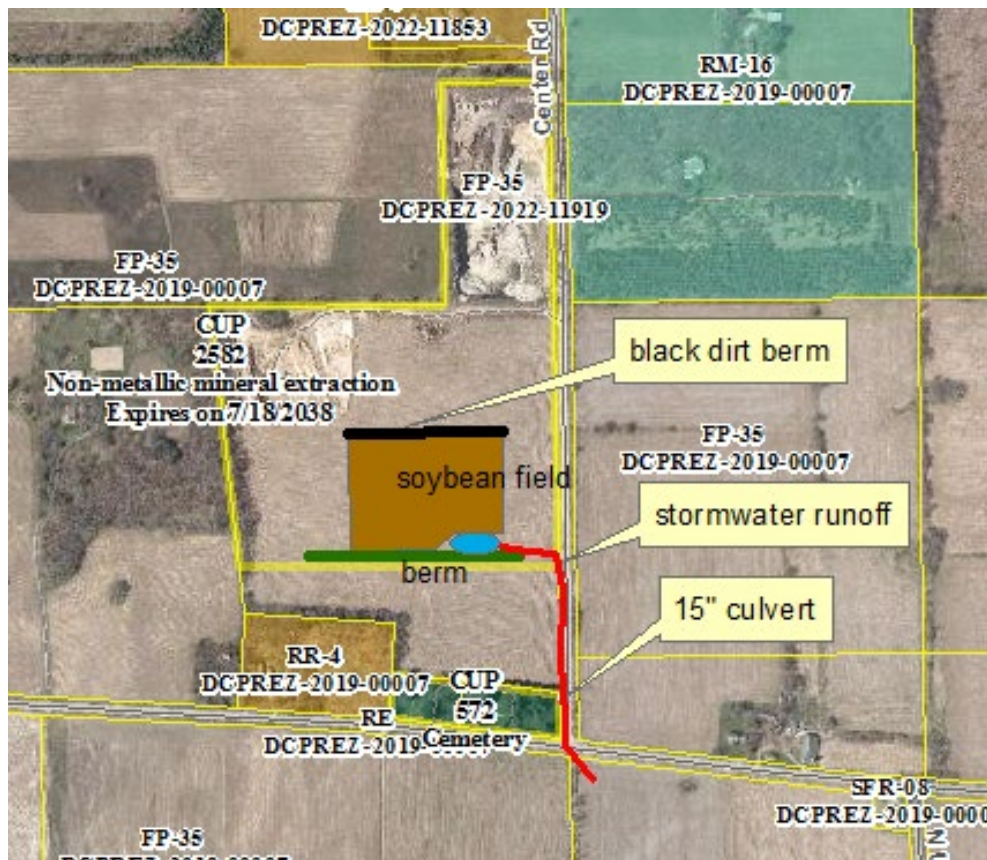
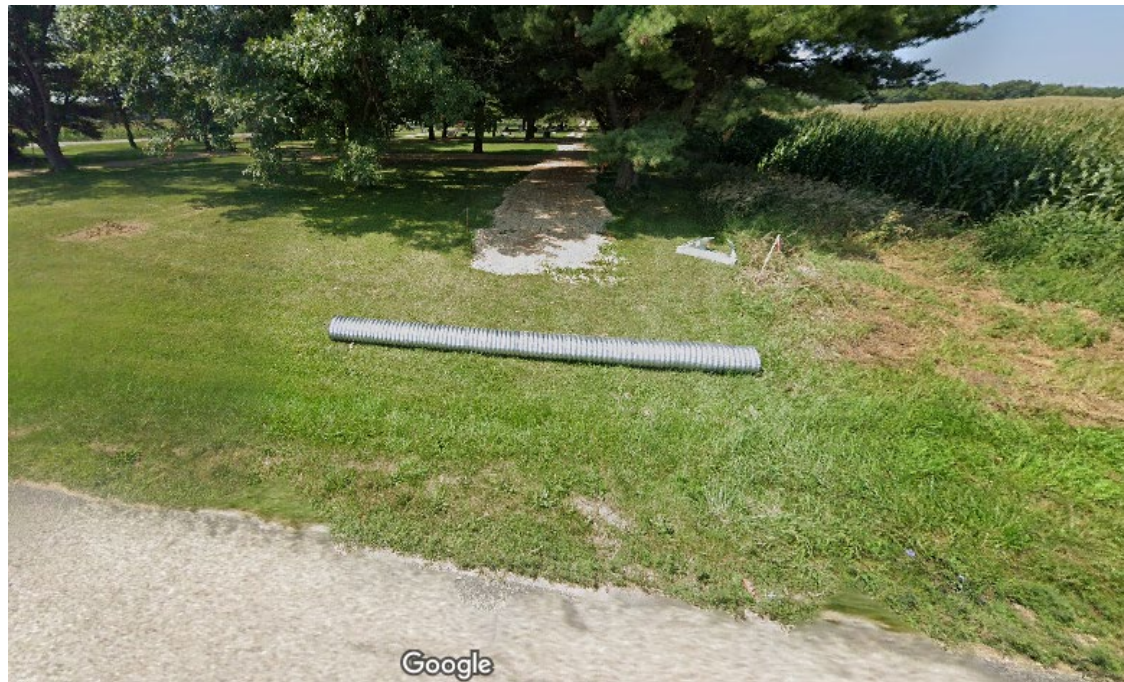
Street view August 2023 – new culvert for cemetery

- Surface water running southerly from the adjacent agricultural field (CSM lot) to the north.
- Internally standing water within the cemetery in low areas near the narrow access roads. Water can't leave and either evaporates or naturally drains.
- The newly placed culvert along Center Rd. in my opinion is undersized. It has been somewhat flattened on the south end and slightly damaged on the north side. Perhaps an 18" minimum or even greater diameter pipe should be installed.

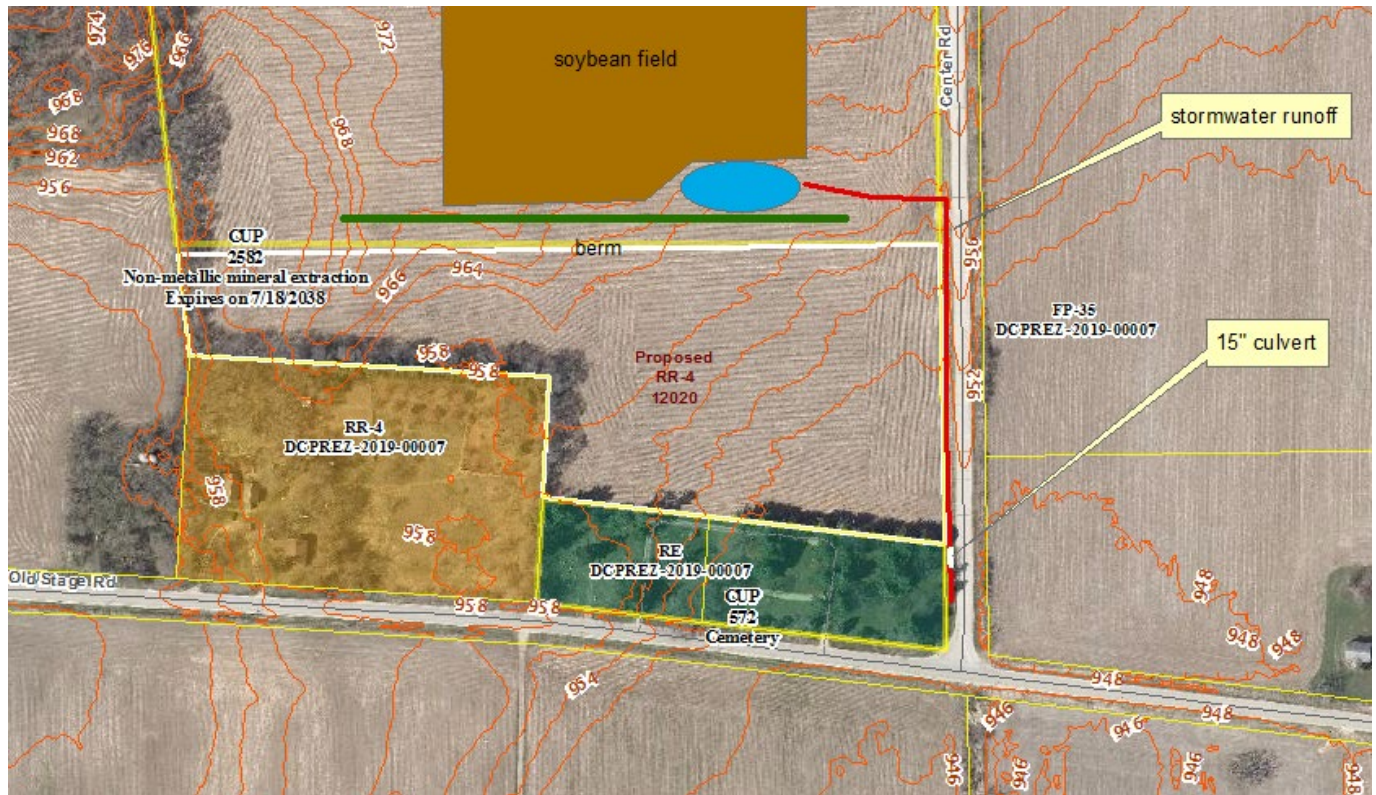
Contours

My findings suggest that flooding within the cemetery is for a few different reasons.
