DANE COUNTY PLANNING & DEVELOPMENT

TO: Town of Rutland
FROM: Dan Everson, Assistant Zoning Adm.
DATE: July 17, 2024
RE: CUP 2582 Mineral extraction summary – Flooding concerns

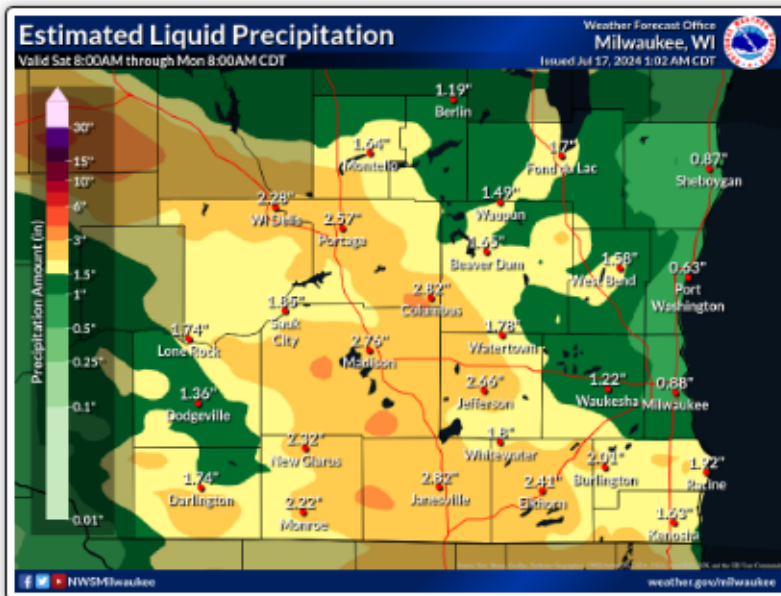
First off, there was a large storm event on the evening of July 15, 2024 and this entire area experienced more than normal flooding. I noticed standing water throughout the easterly portion of the cemetery as well as a flooded field south of the intersection of Center Rd. and Old Stage Rd. NWS is reporting over 3" in three days in this area.

Observed rainfall between 7:00 AM July 13 and 7:00 AM July 16.

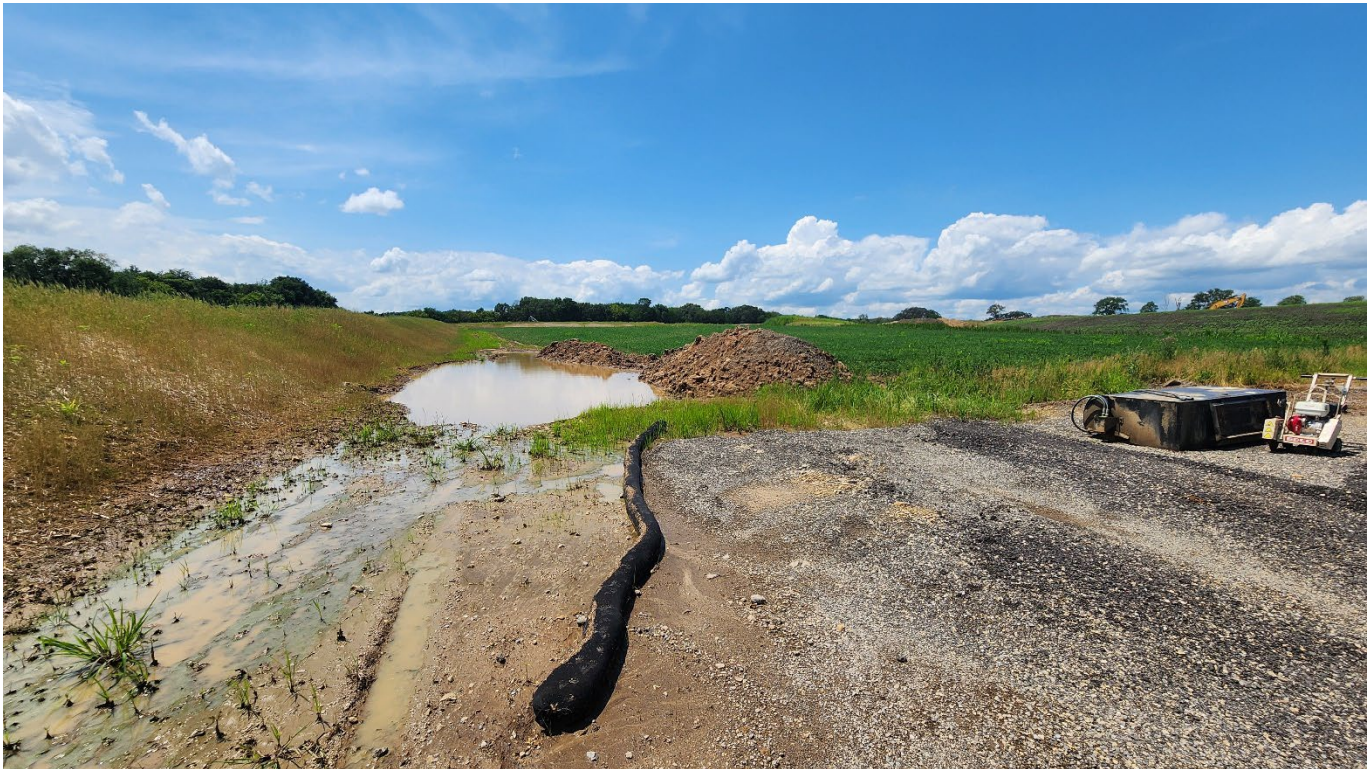
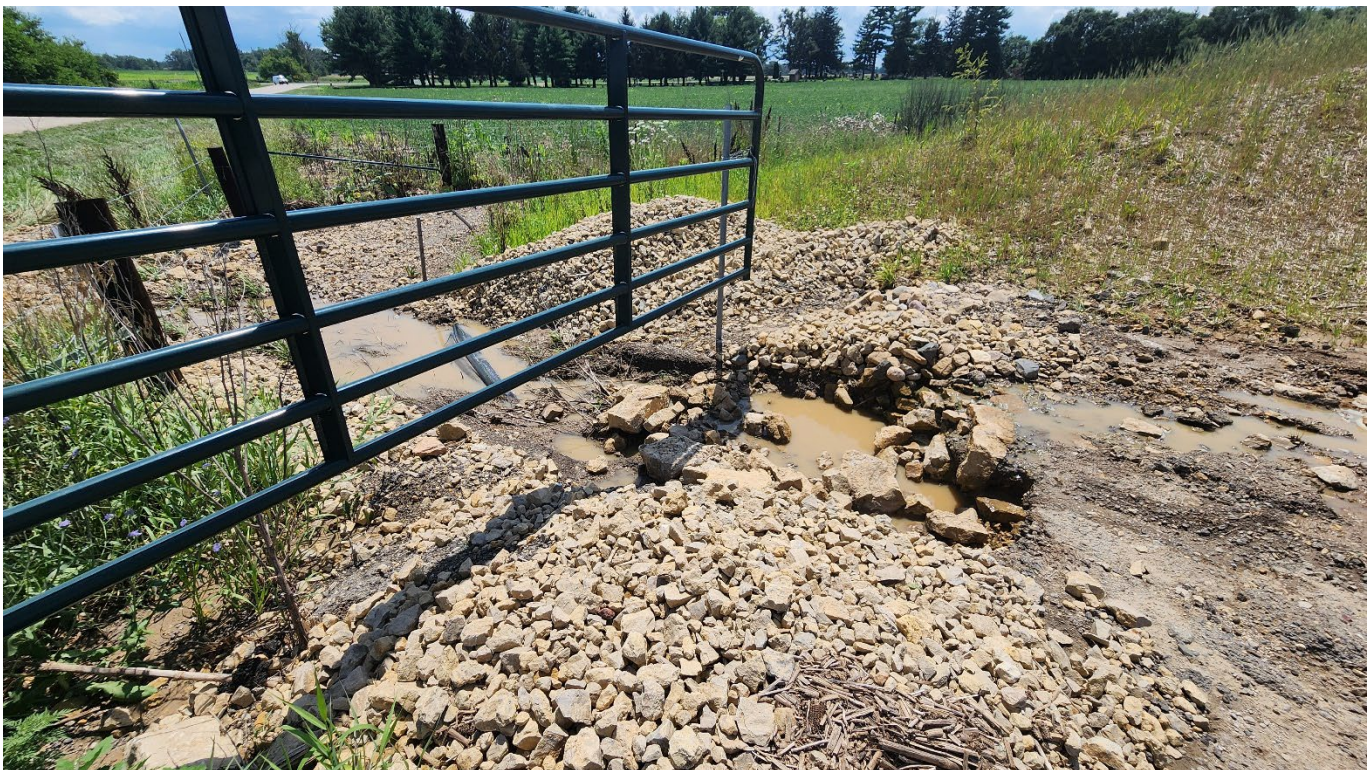
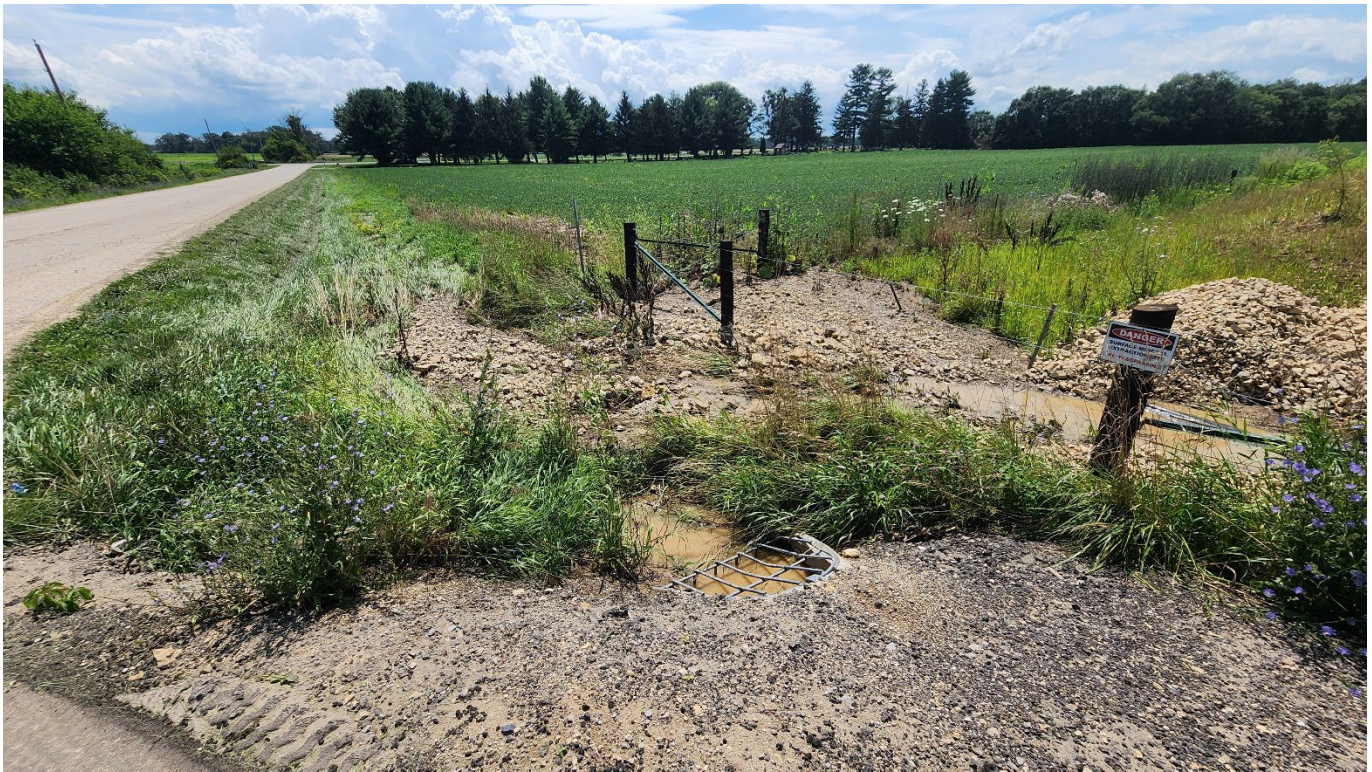
I walked throughout the quarry site and observed a washed out area of rock near the new driveway entrance and breaker stone in the ditch adjacent to the concrete culvert. I also noticed a small dug out pond straight west of the driveway and against the southerly berm to retain surface water from the soybean field. This newly created pond was overflowing and a water was running towards the driveway and to the ditch. No water was being pumped out.

I indicated to the quarry operator, Kevin Hahn that no stormwater is to leave the site other than occasional discharging which is tied to DNR Permit WI-A046515-06. Dewatering is allowed from time to time and may be pumped off-site to the nearby road ditch.

I understand the reasoning for the small dugout pond is to alleviate flooding of the agricultural field within the CUP boundary. However, with the recent storm events and the current saturation levels within the area, the operator will need to reach out to the Dane County Land & Water Resources department to find a solution and design and engineer a suitable detention pond within the site so nothing leaves the site naturally. This will be critical as a large storage building is being proposed in this same area.

This detention pond is not part of the approved operations plans prepared by Mendota Consulting. In addition, the ditch will need to be cleaned out in order to prevent stormwater further backing up.

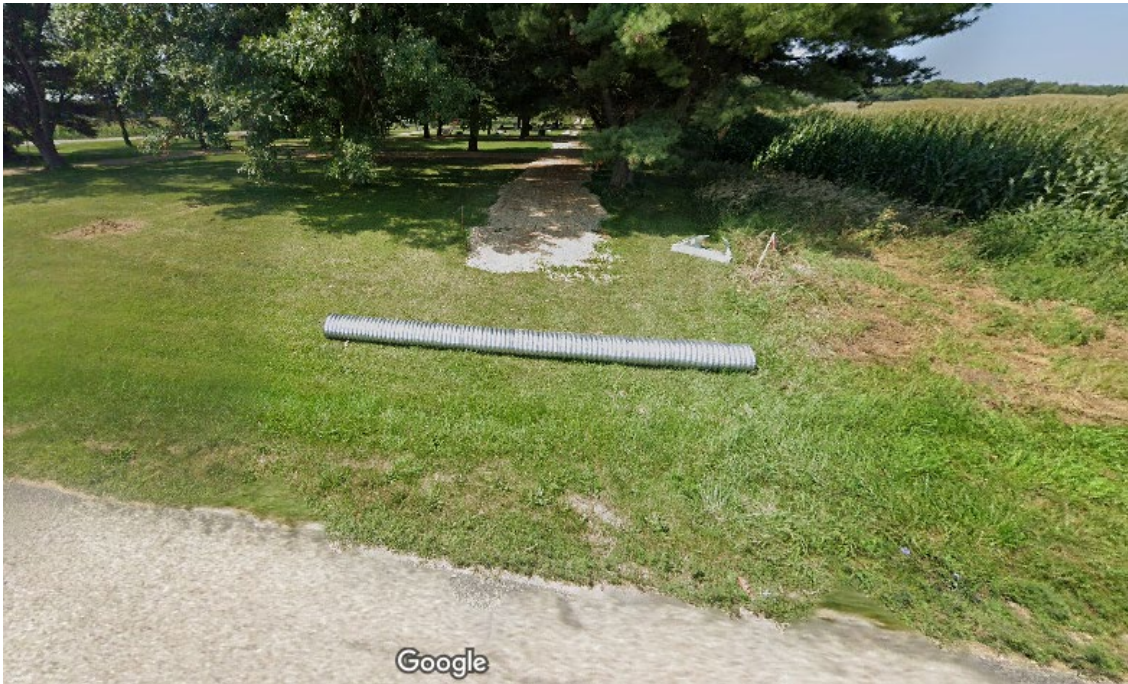
Street view August 2023 – new culvert for cemetery

- Surface water running southerly from the adjacent agricultural field (CSM lot) to the north.
- Internally standing water within the cemetery in low areas near the narrow access roads. Water can't leave and either evaporates or naturally drains.
- The newly placed culvert along Center Rd. in my opinion is undersized. It has been somewhat flattened on the south end and slightly damaged on the north side. Perhaps an 18" minimum or even greater diameter pipe should be installed.
