Wetland Delineation Report

6011 State Highway 51

Town of Burke, Dane County Wisconsin

August 19th, 2021

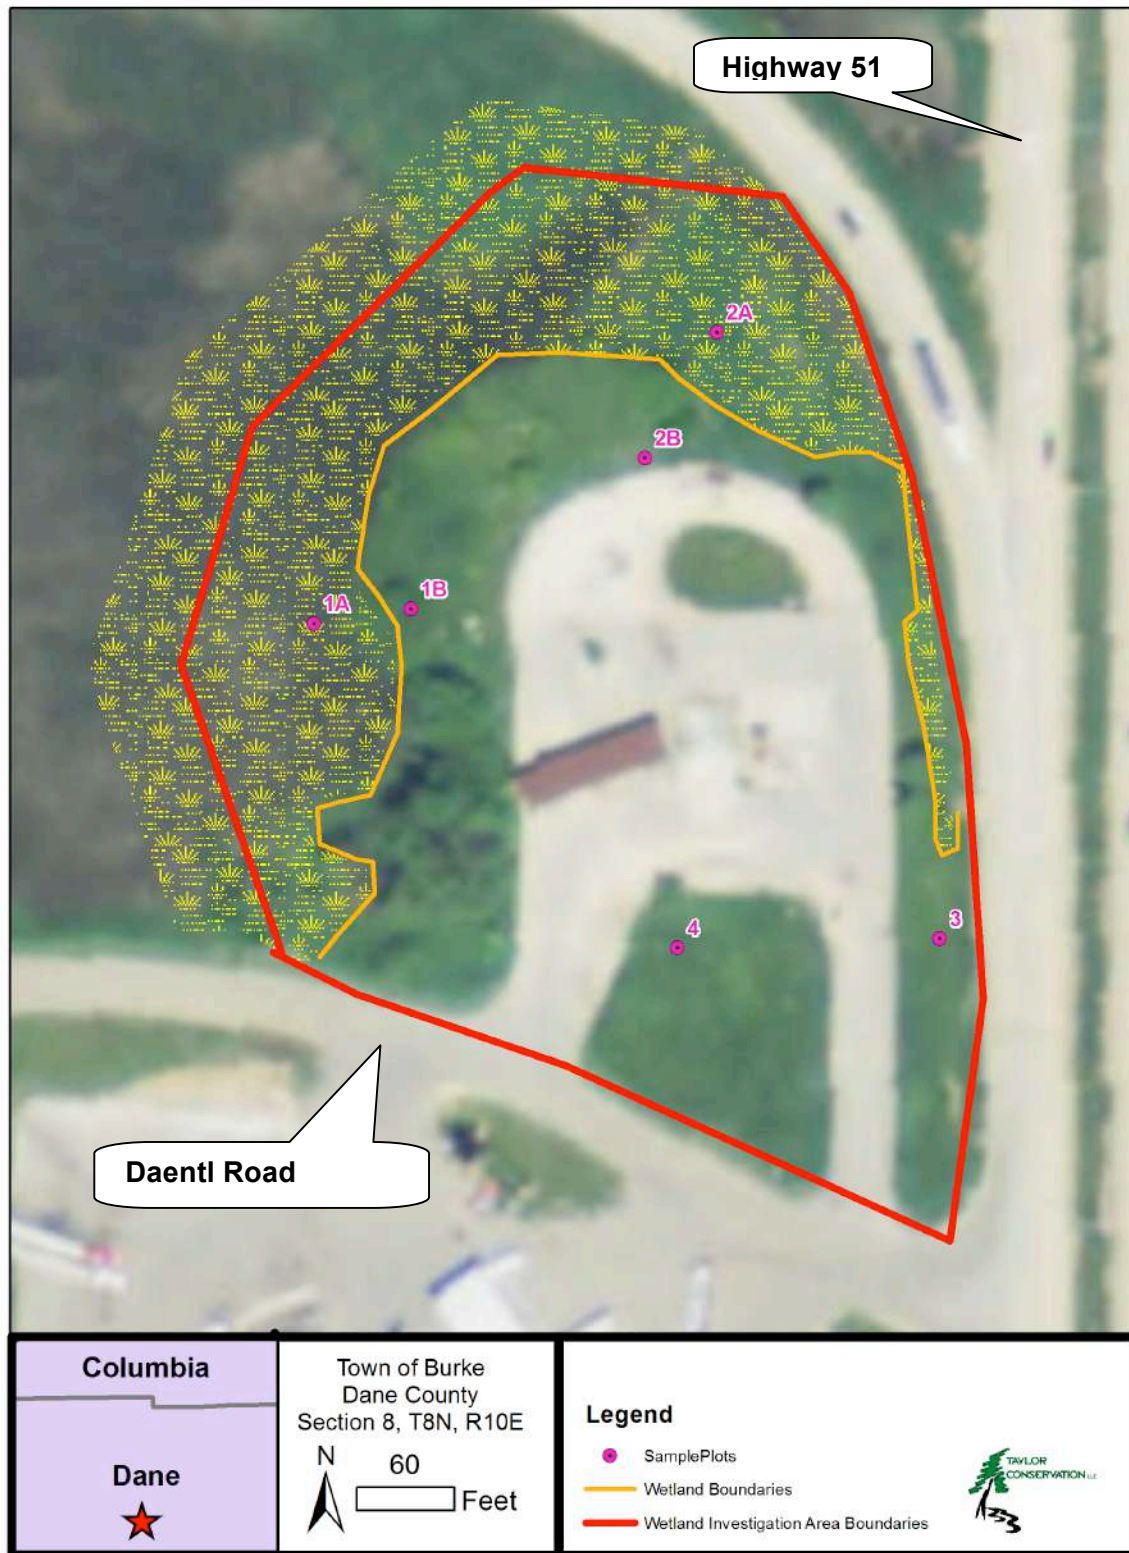
Figure 2: Investigation Area, Wetlands & Sample Plots.

The lowlands at the base of the embankments surrounding the developed area were found to be wetlands (Figure 2). A segment of road ditch on the east side of the investigation area that drained into the lowland was also wetland.

The wetlands consisted of cattail marsh and open meadows (Figure 2). They occupy an extensive wetland complex that stretches 2 miles west to the Yahara River. Two sample plots (1A & 2A) were located inside of the wetlands.

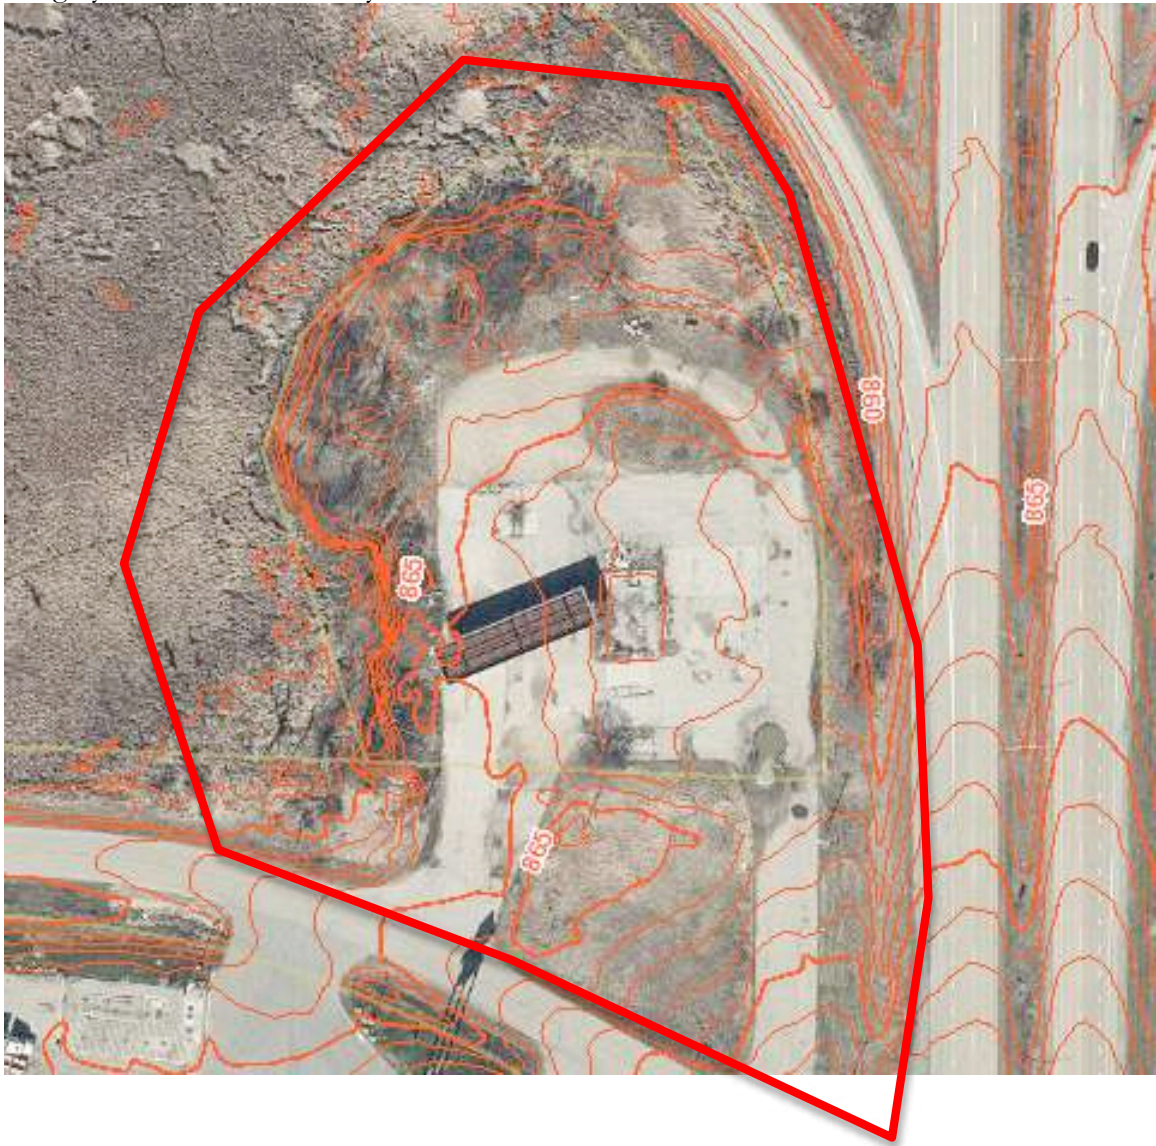
Figure 3: Topography – 2-foot Contour Map.

The 2-foot contour map shows that the terrain is level to gently sloping in the developed area and that it forms steep embankments to the west and north leading down to the low

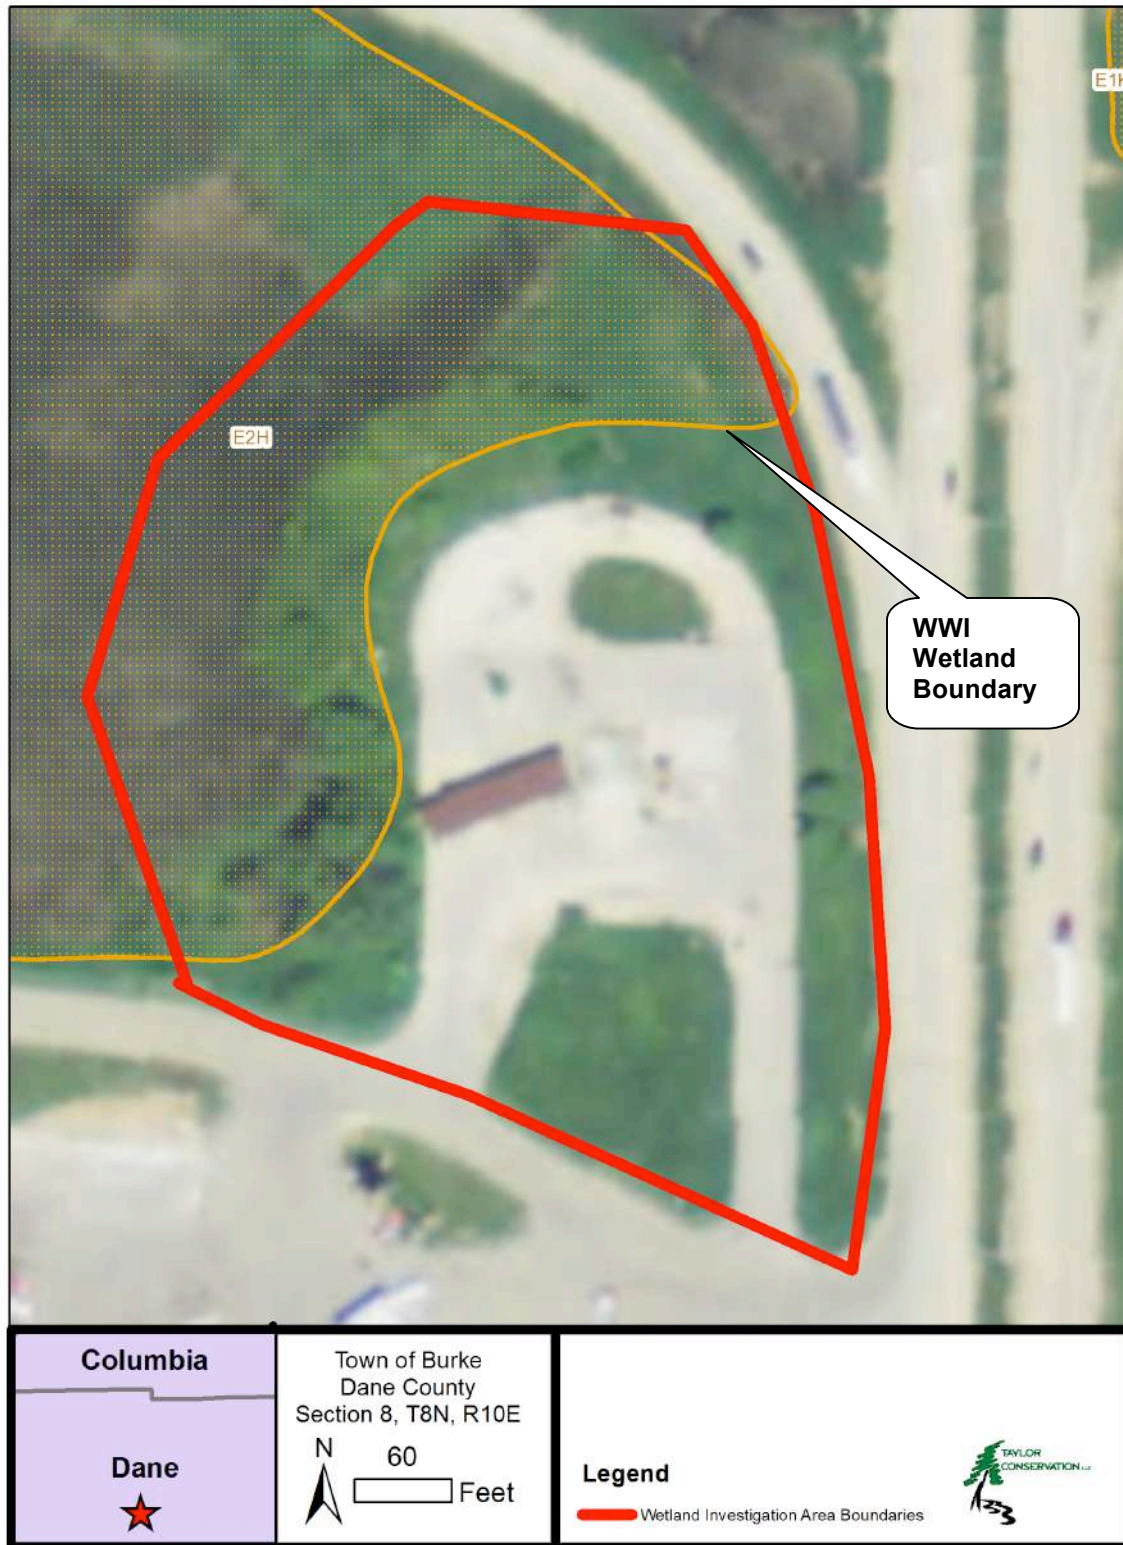
Figure 6: Wisconsin Wetland Inventory Map.

The Wisconsin Wetlands Inventory (WWI) identifies emergent plant-dominated wetlands (E2H) on the low plain surrounding the developed area (Figure 6). Mapped wetland boundaries matched the field-identified wetland boundaries relatively closely. Discrepancies between the W.W.I. and field-identified wetland boundaries reflect the greater accuracy of field methods over interpretation of wetland boundaries from aerial photographs, which is the method used in the W.W.I.

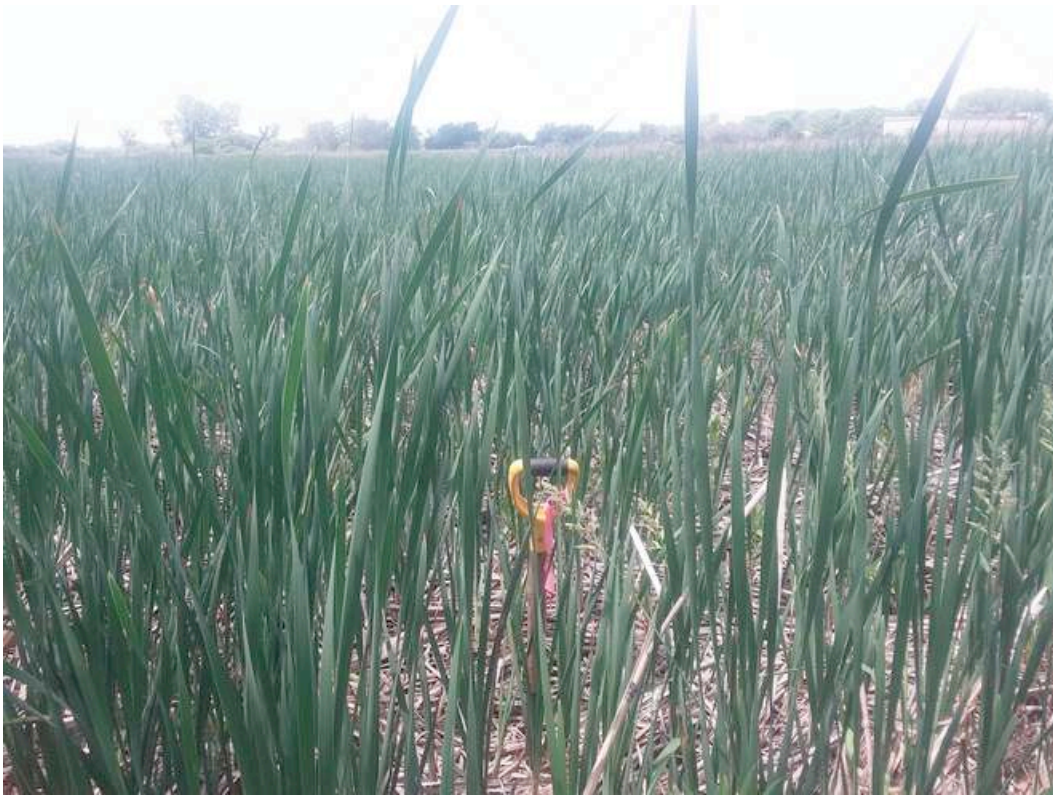
Wetland - Plot 1A

- ❖ As a result of below normal antecedent precipitation the investigator did not necessarily expect to observe a primary wetland hydrology indicator. Nonetheless, “Surface Water” was noted in Plot 1A. No primary hydrology indicators were noted in Plot 2A.

The plot occupied a cattail marsh.

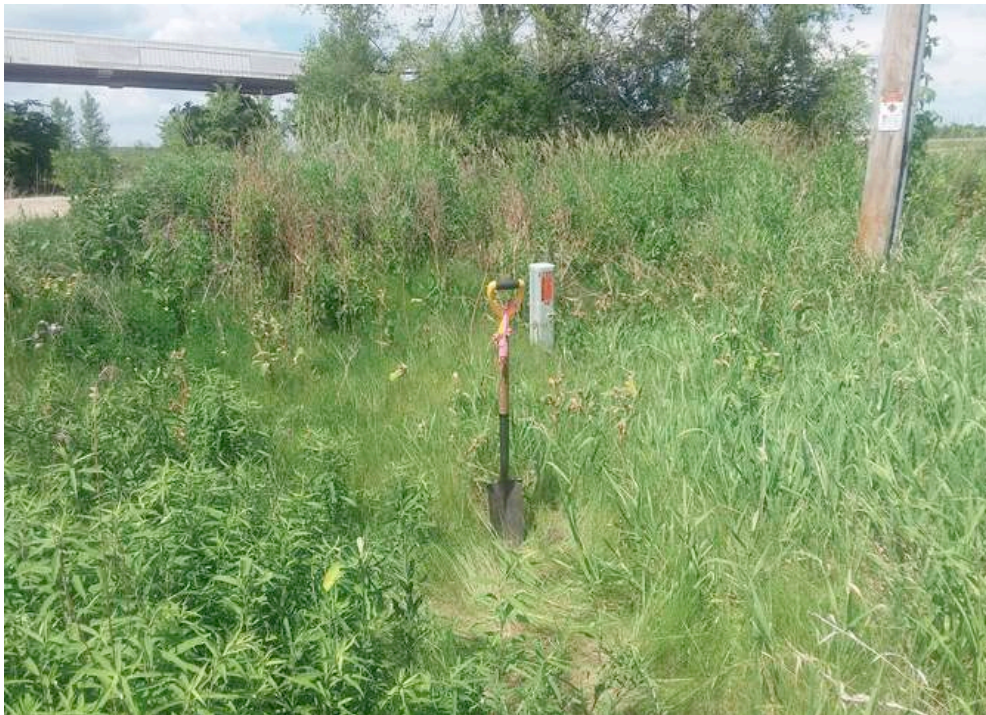
Upland - Plot 4

- ❖ No hydrology indicators were noted in any of the upland sample plots. Except for upland plot 4, which showed one secondary hydrology indicator, Geomorphic Position, since it occupied the bottom of closed depression in a low area. No other hydrology indicators were observed in plot 4.

The plot occupied the bottom of a closed depression in a relatively low area. Nonetheless, this site was not found to possess wetland hydrology.
