Dane County Rezone & Conditional Use Permit

Zoning Change Application

CERTIFIED SURVEY MAP

ASSURED WETLAND DELINEATION REPORT

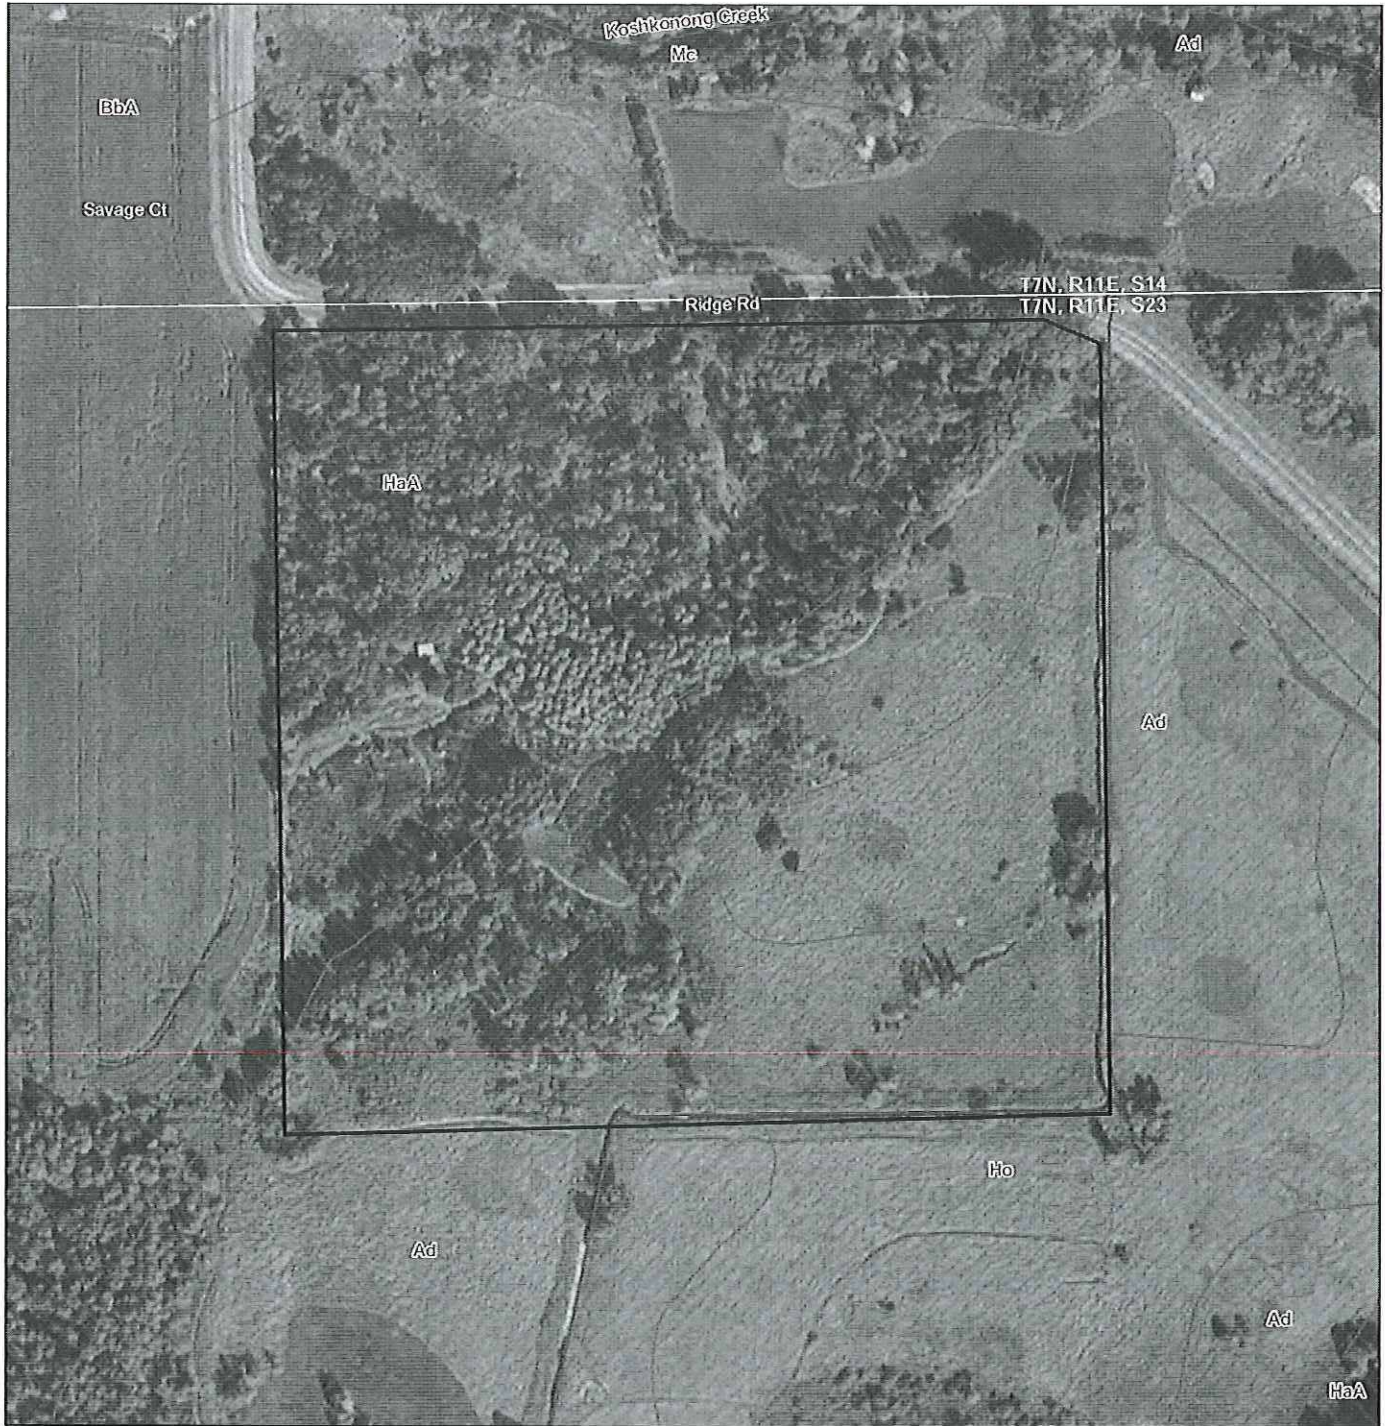
- Approximate Project Boundary
- DNR 24k Hydrography
- NRCS Soil Survey Data
- Perennial Stream
- Intermittent Stream
- Predominantly Hydric
- Partially Hydric
- Non-Hydric
- Waterbody

Soils within the wetland are mapped by the NRCS as Adrian muck (Ad), Houghton muck (Ho), and Hayfield silt loam (HaA) (Appendix A, Figure 2). The soils observed at the sample points were generally consistent with the Hayfield series characteristics as silty clay loam textures were observed. Field indicators of hydric soil identified at sample points within W-1 consisted of NRCS

Soils within the wetland are mapped by the NRCS as Hayfield silt loam (HaA) (Appendix A, Figure 2). The soils observed at the sample points were generally consistent with the Hayfield series

Soils within the wetland are mapped by the NRCS as Hayfield silt loam (HaA) (Appendix A, Figure 2). The soils observed at the sample points were generally consistent with the Hayfield series characteristics. Field indicators of hydric soil identified within W-3 included NRCS field Indicators A11-Depleted Below Dark Surface and F3-Depleted Matrix. Therefore, the hydric soil criterion was satisfied.

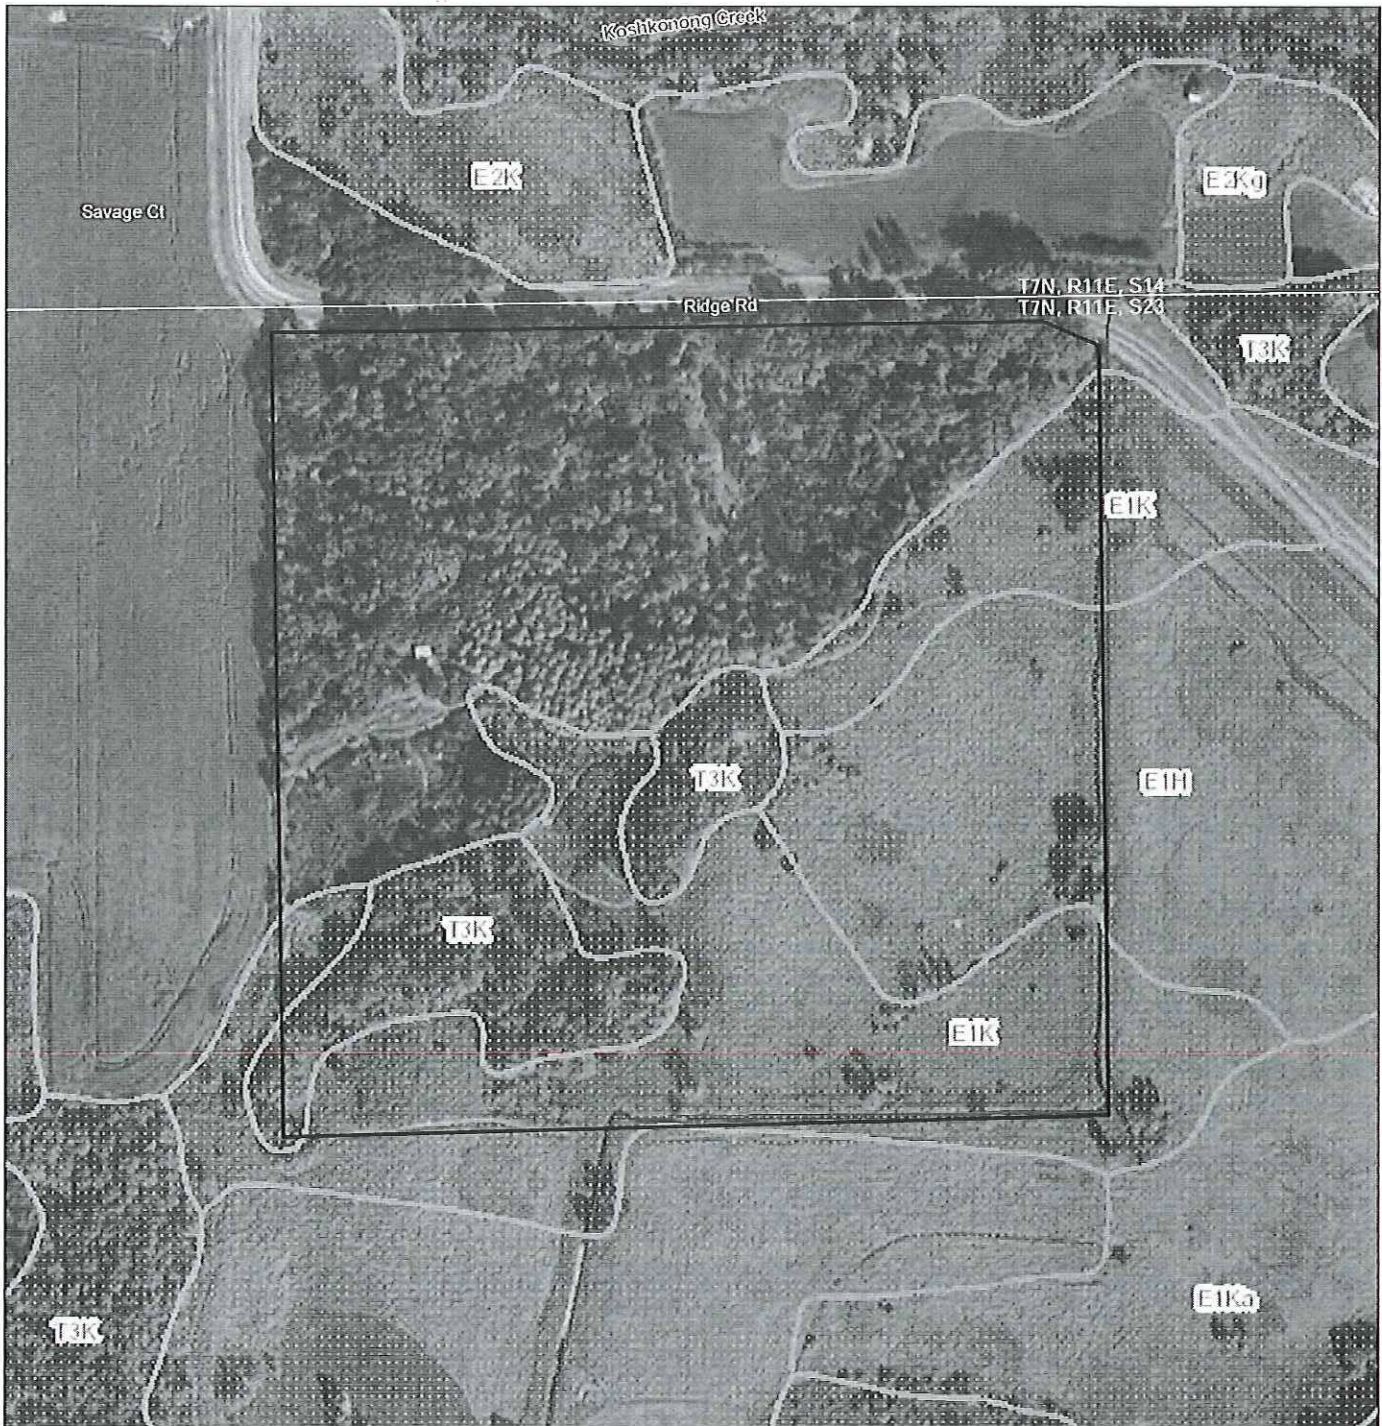
- Approximate Project Boundary
- WWI Wetland Class Areas
- Wetland
- DNR 24k Hydrography
- Perennial Stream
- Intermittent Stream
- Waterbody

Wetland 2 (W-2) is a seasonally inundated shallow depression within the wooded portion of the Study Area. W-2 appears to be isolated and no direct surface water connections were observed in the field and none are identified on the 24k hydro layer mapped by USGS (Appendix A, Figure 1) or the WDNR 24k hydrography layer (Appendix A, Figure 4).

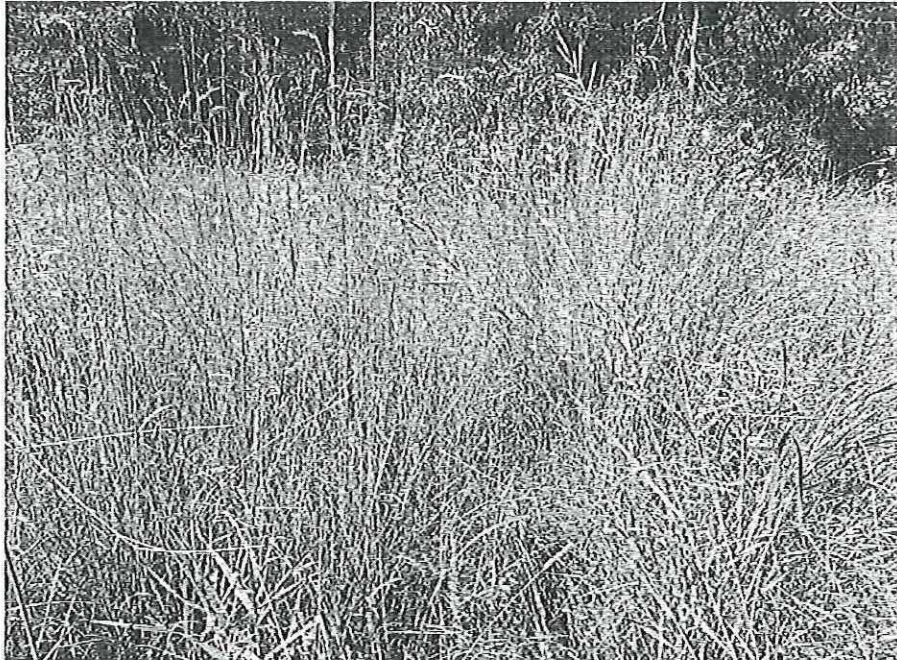
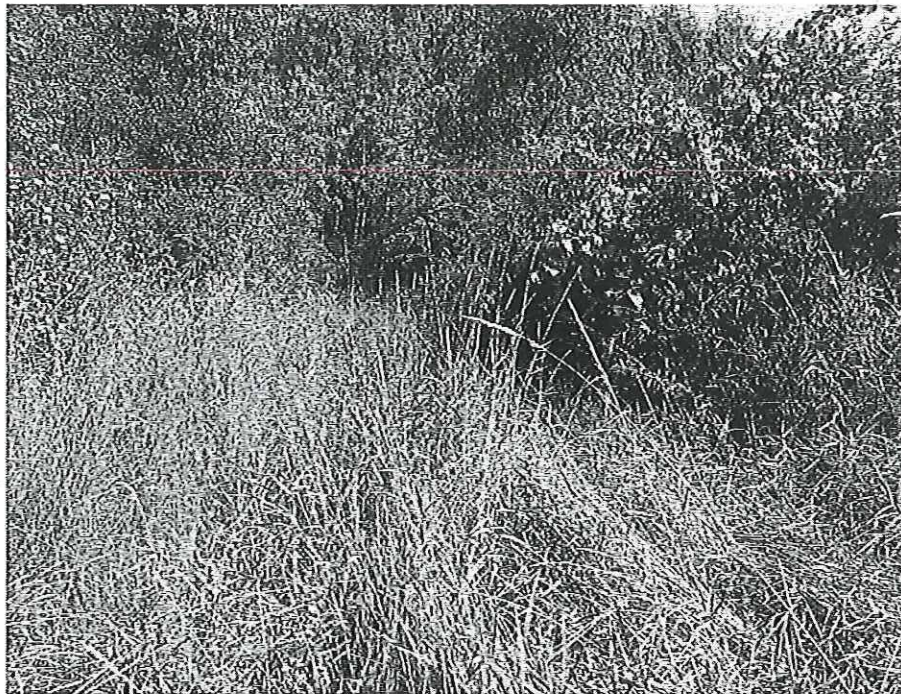
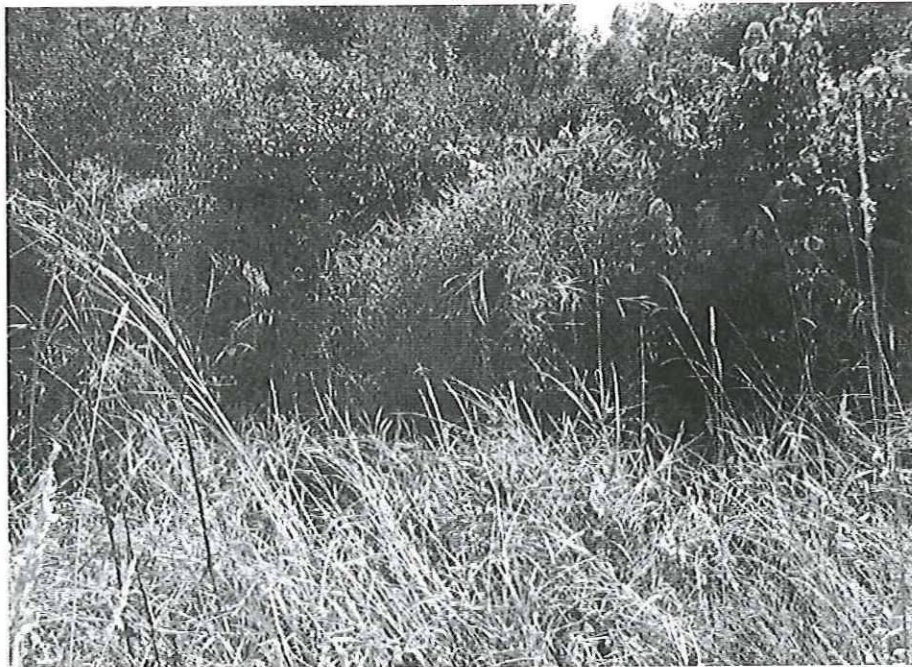
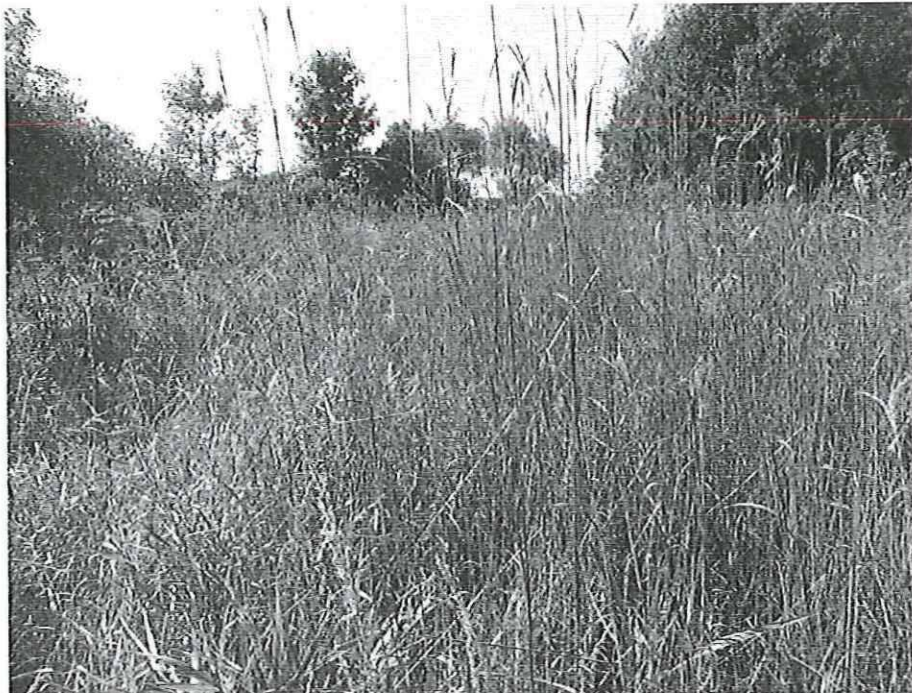
Photo 5. Sample Point P-2; view north

Photo 6. Sample Point P-2; view east

Photo 7. Sample Point P-2; view south

Photo 8. Sample Point P-2; view west

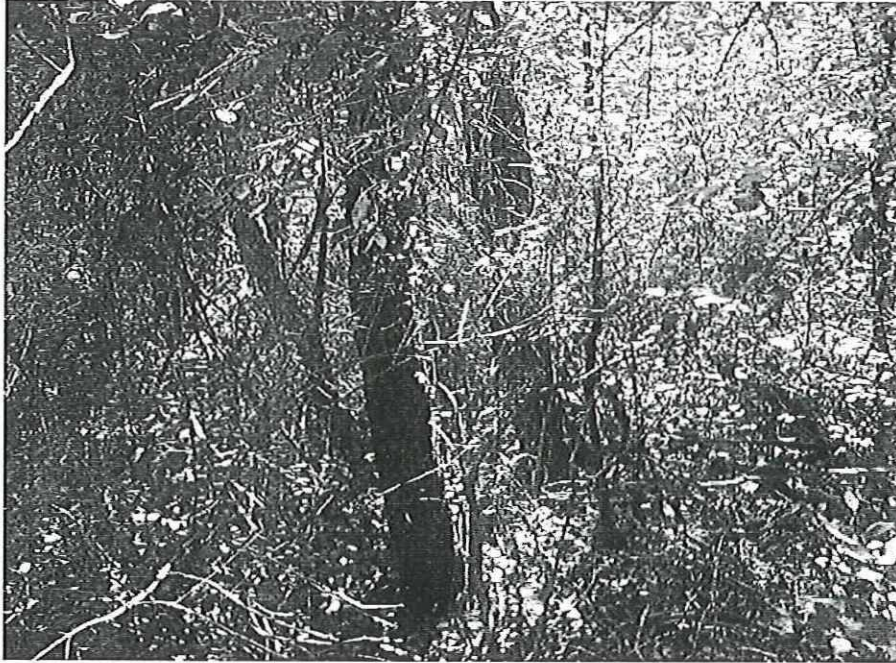
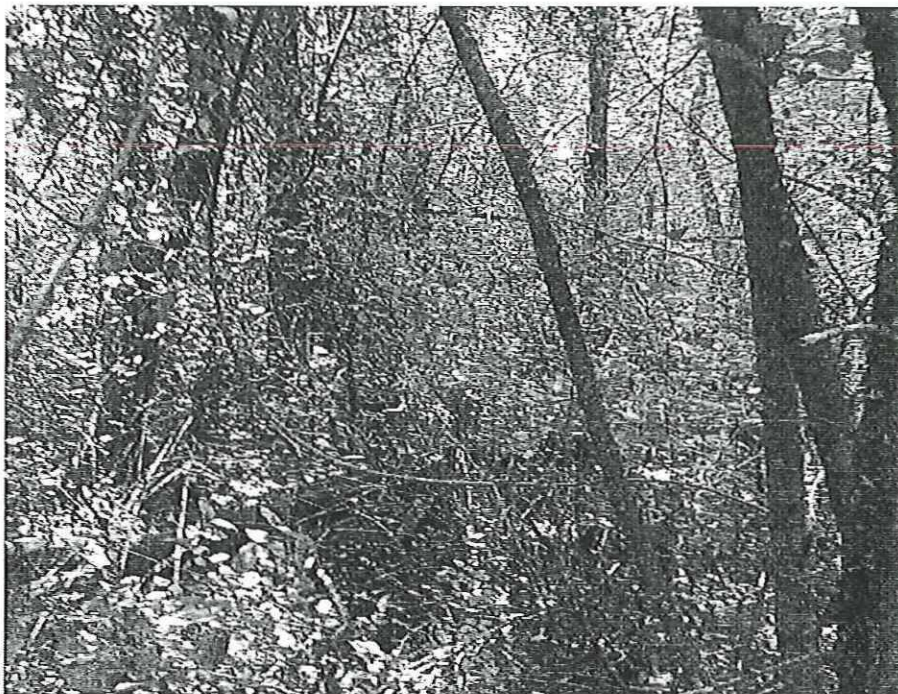
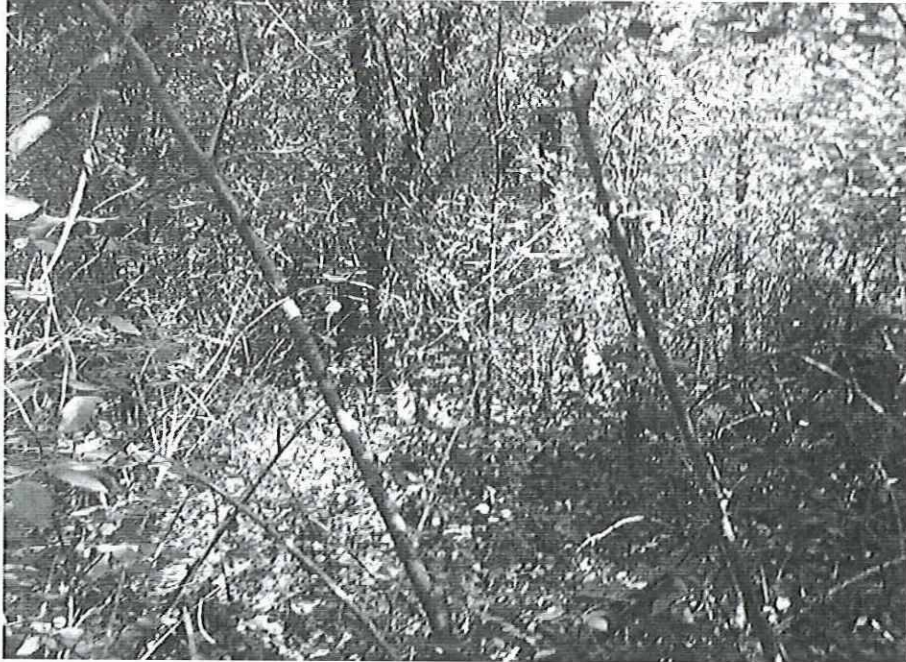
Photo 9. Sample Point P-3; view north

Photo 10. Sample Point P-3; view east

Photo 11. Sample Point P-3; view west
