RUTLAND FLOOD STUDY

PREPARED BY FRESHWATER ENGINEERING

April 2021

RE: Rutland Floodplain Encroachment Study

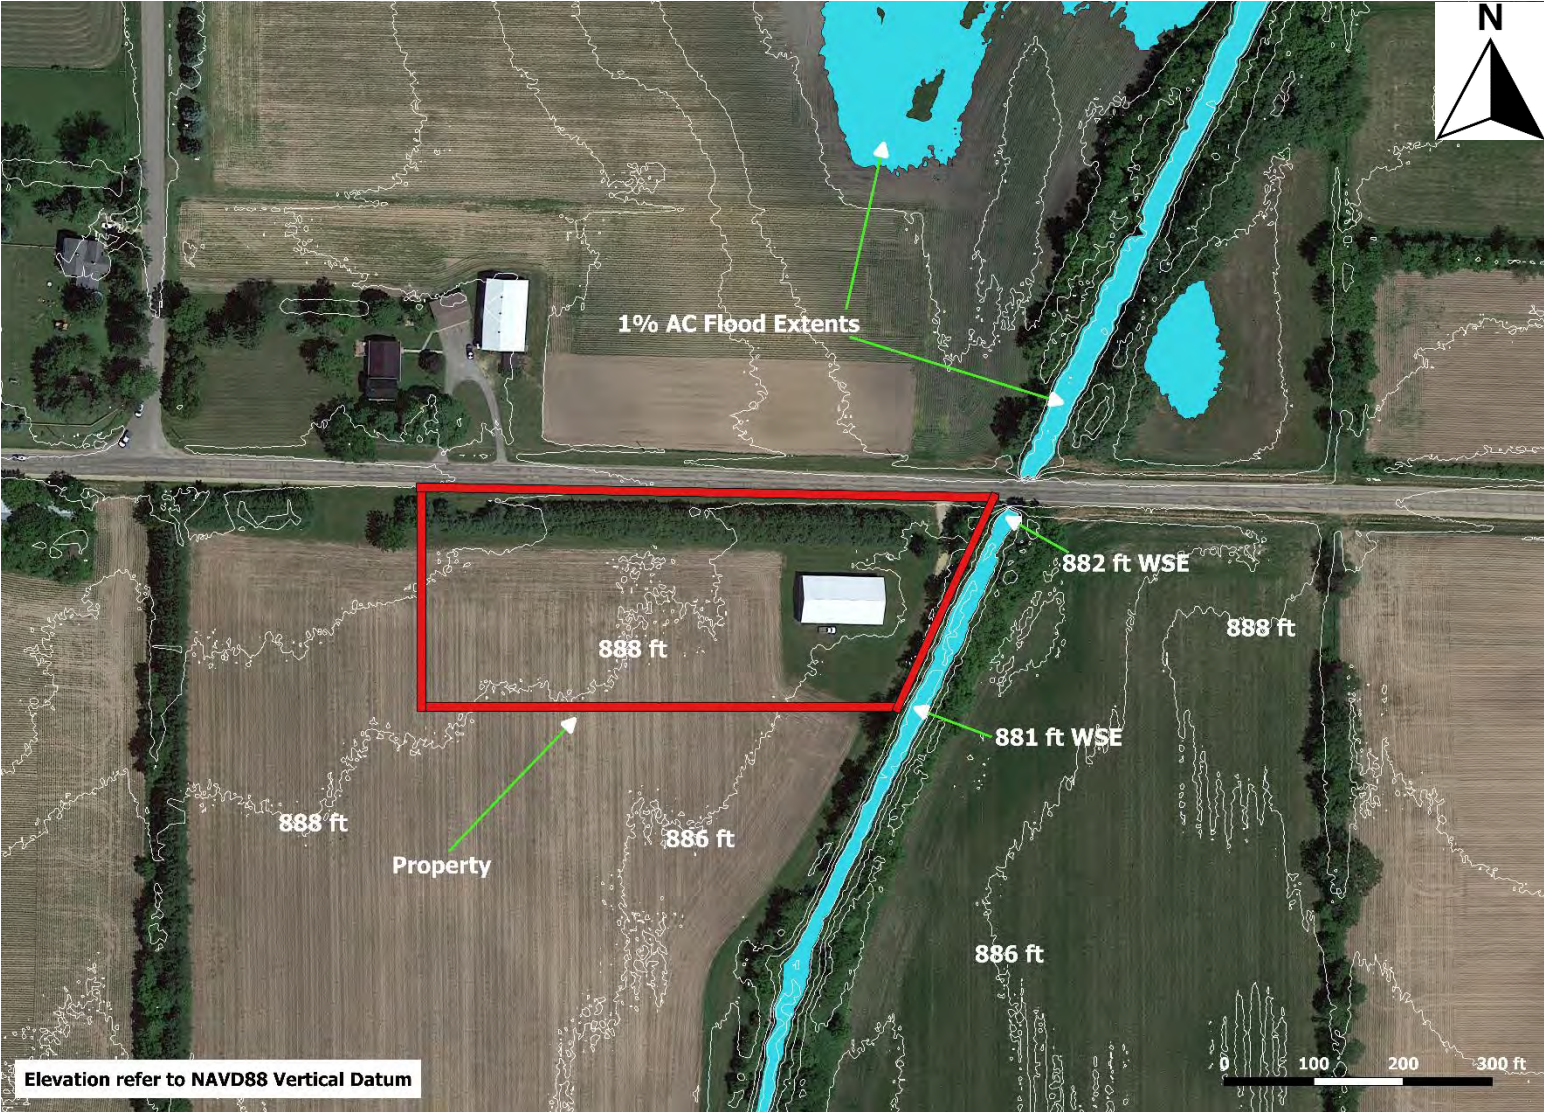
Figure 5. Maximum 1% AC flood WSE (ft) near property boundary along with 2-foot contour intervals extracted from 2017 LiDAR.

Results of the hydraulic model for the 1% AC event in the unnamed tributary are provided in *Table A1* in Appendix A. The flood extents and maximum WSE's of the 1% AC event for the property of concern along with 2-foot contour intervals extracted from 2017 Lidar are shown in *Figure 5*. *Figure 6* shows the flood extents and flood depths for the entire modeling reach.
