# **Soil Phosphorus Eutrophies Lake Monona. Soil comes from Hudson Park Steep Slopes and the North Shore of Lake Monona, Dane County**

Prepared by Matthew Miller, PhD, Soil Scientist (608)-245-3995, [sandpiper@edaphos.com](mailto:sandpiper@edaphos.com)

for Dane County Lakes & Watershed Commission  
and Dane County Land & Water Resources Department, August 5, 2019

## Photos of Shoreline and Steep Slopes of Hudson Park

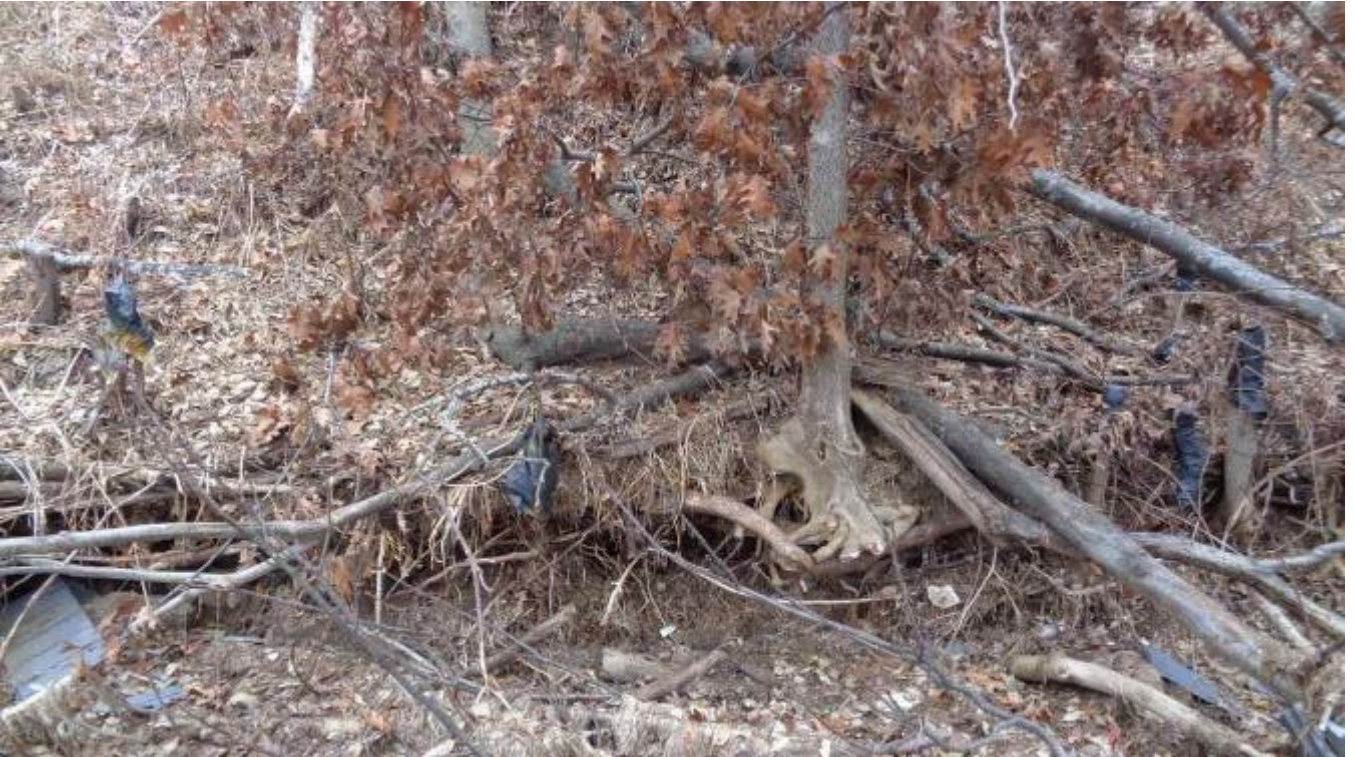
3. Undercutting the shore can lead to significant tree loss.

Trees close to the shore are at continual risk of collapsing into Lake Monona if the shoreline is not repaired (for visual, see Photos 3, 4, 6, 7, 12 and 15). It would be appropriate to have Dane County shoreline people examine the shoreline when leaves are off the trees, to ascertain the severity and amount of eroded shoreline, and also determine those areas in greatest need of repair before developing a repair plan. Controlling shoreline erosion would help keep soil phosphorus and other nutrients from entering the lake (Photo 16).

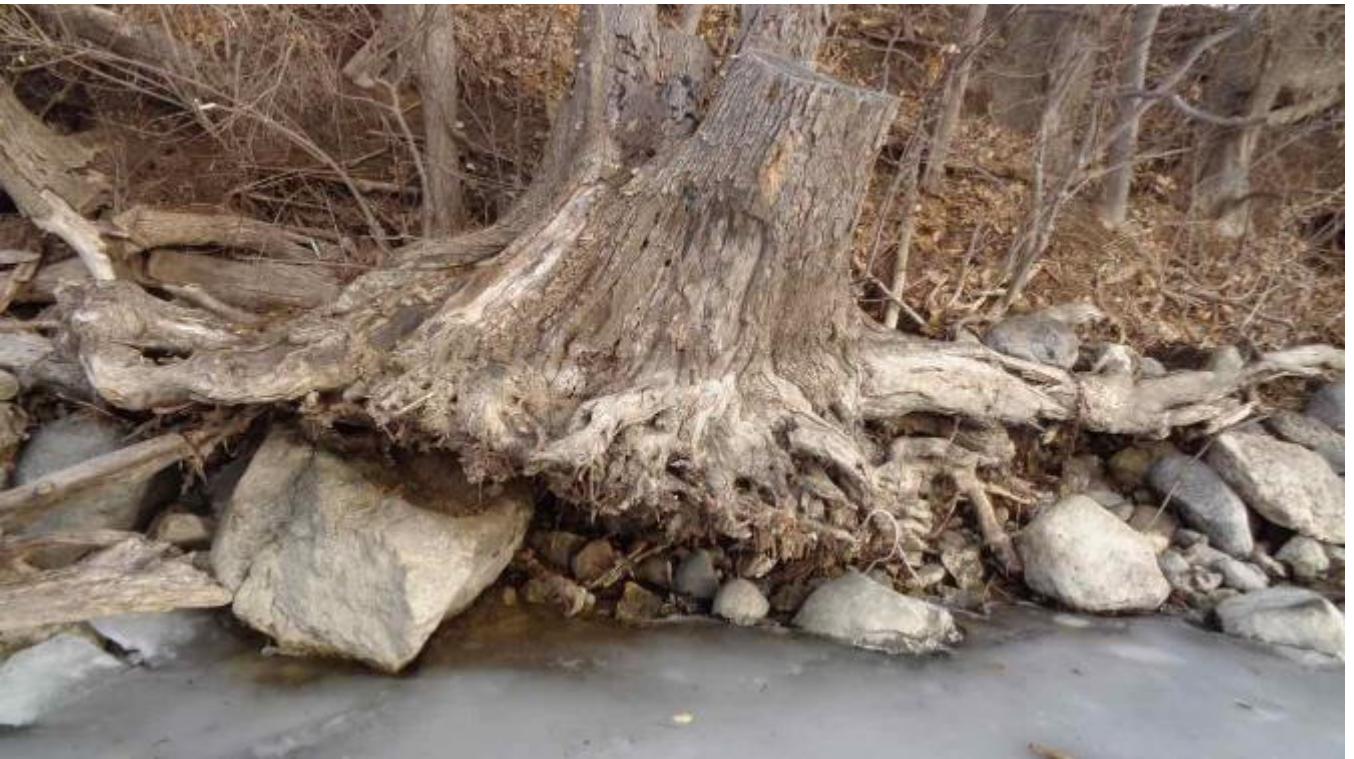
4. An undercut tree that had its top removed. No live roots.

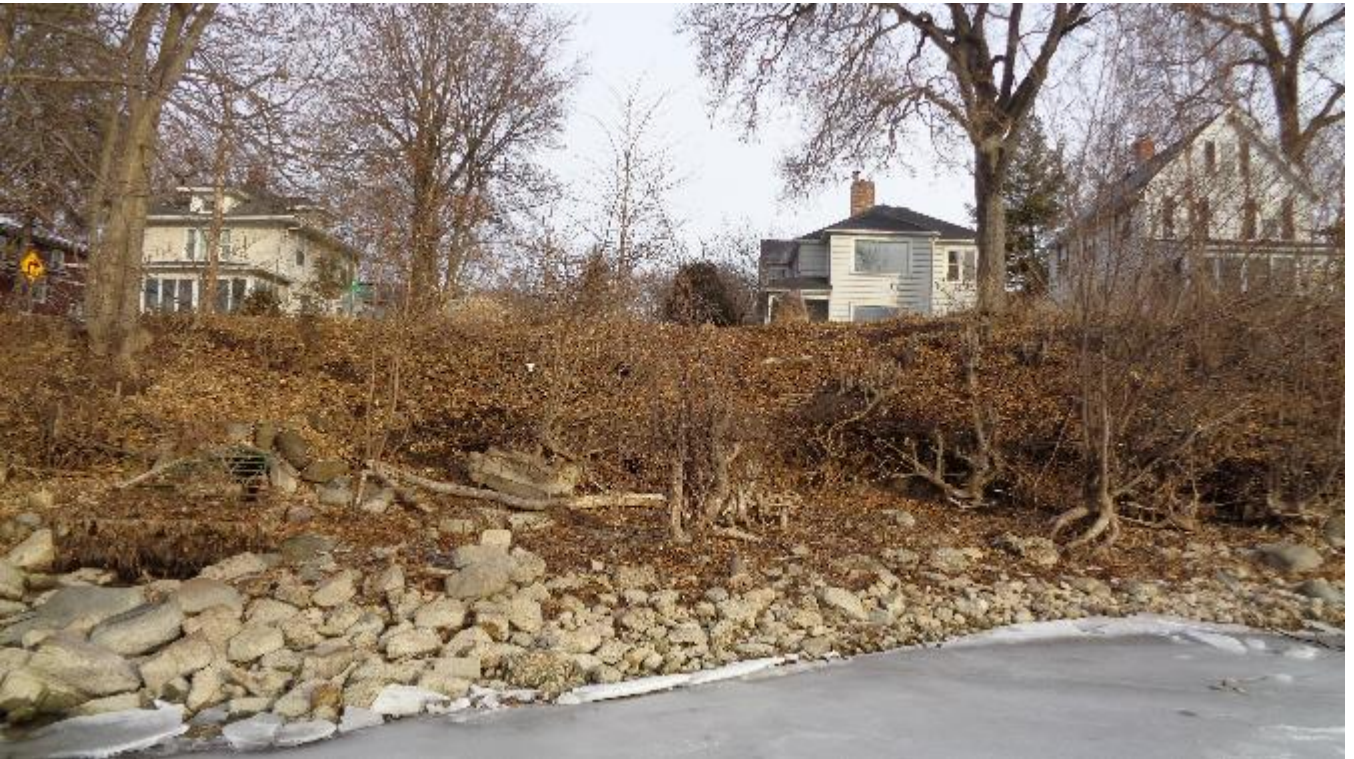
5. Shoreline at Miller and Lakeland used to be more than five feet further into the lake in the 1980s'.

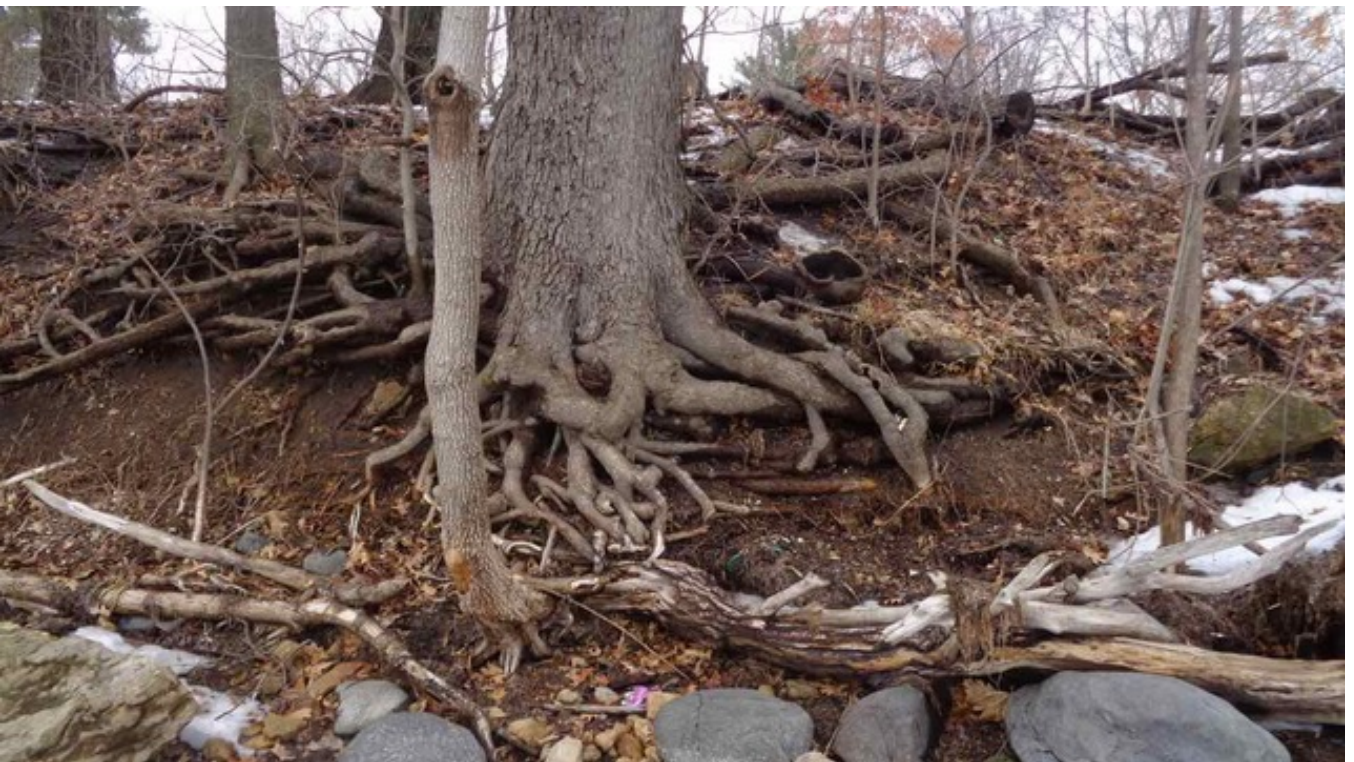
During the leaf-off season, it is possible to see many of the effects of sheet erosion on the slopes: soil piled on the uphill side of a tree, soil removed on the downhill side of the tree, stone pillars, many bare roots (Photos 6, 9 and 10), and at places stranded tree stumps where feet of soil have been eroded underneath the stump, leaving the stump hanging in the air. Tree roots grow in soil, not in air. Exposed roots and stumps are evidence of severe soil erosion. Visit after a light snowfall.

6. For some trees, it is just a matter of time before they too succumb to gravity. When the tree falls the slope will follow.

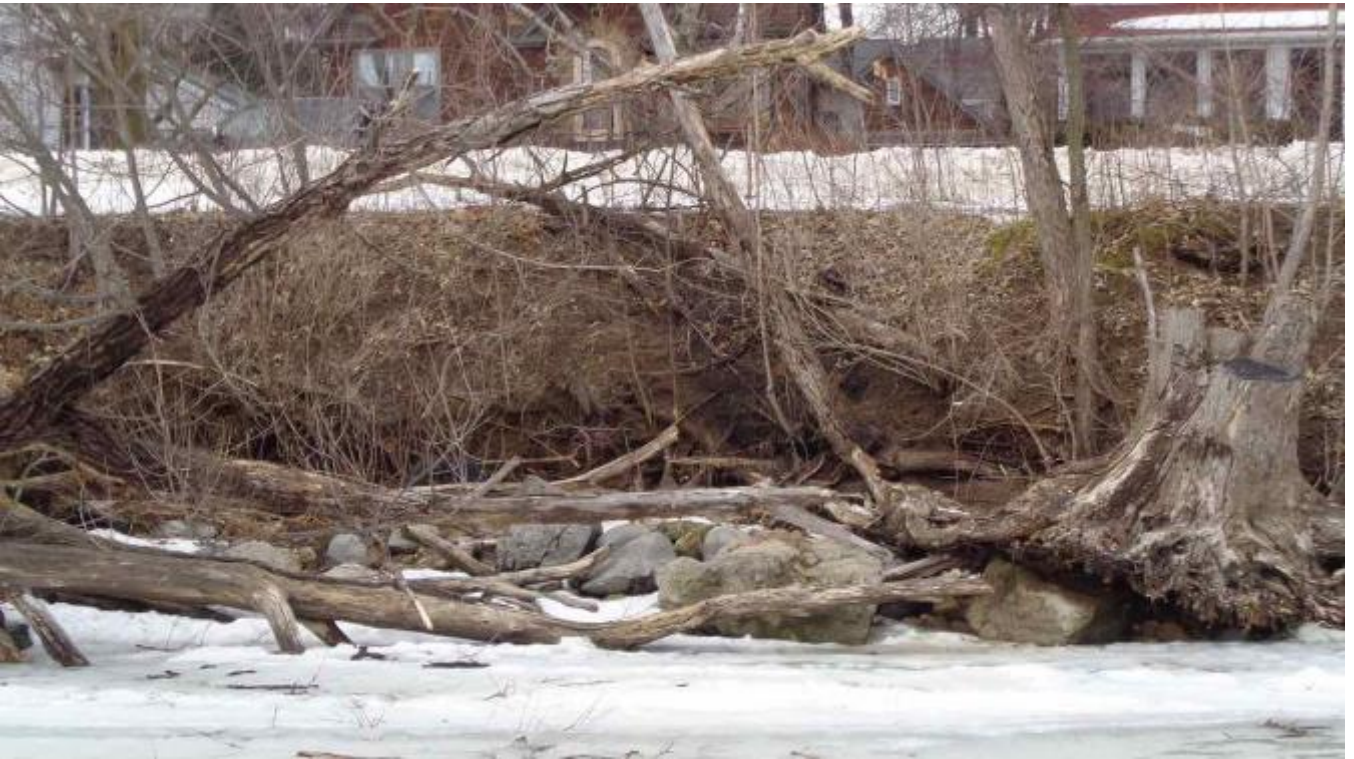
7. Example of slope collapse after trees were undercut. East of Hudson Beach.

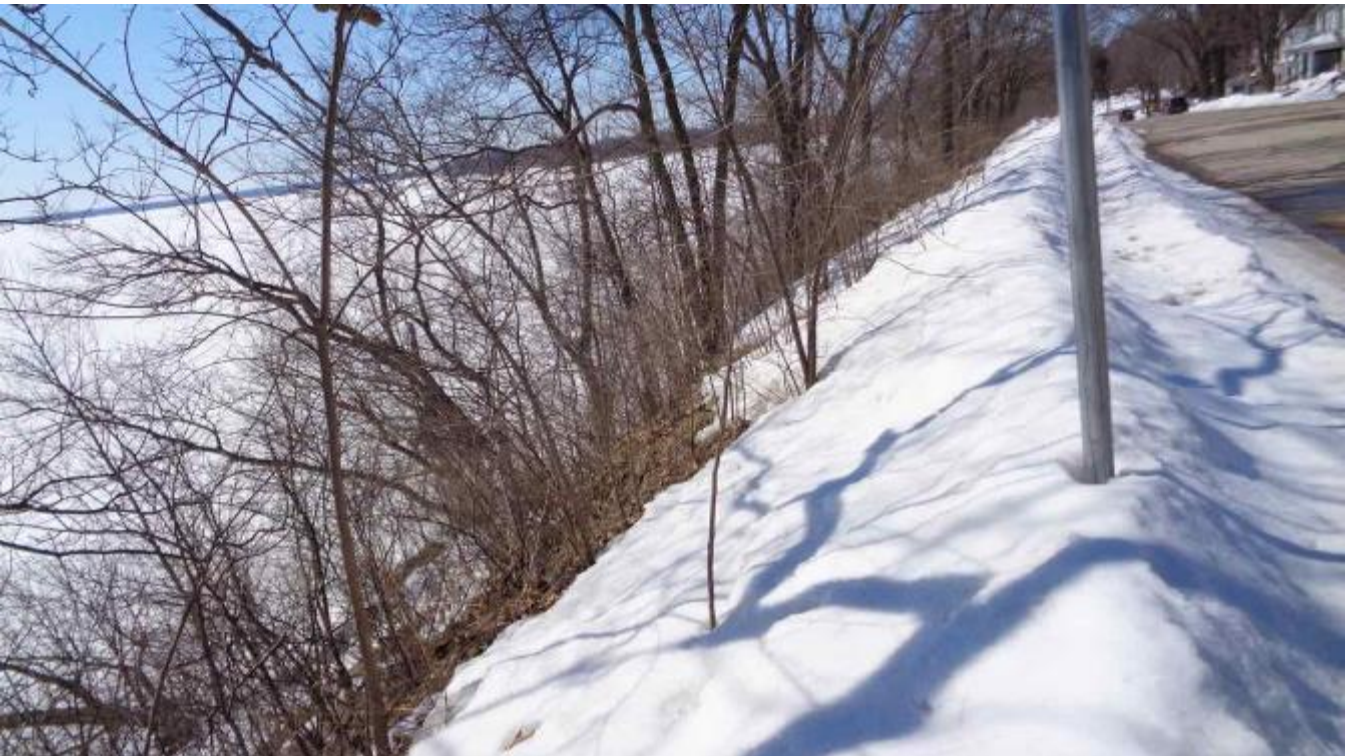
There are approximately 1,500 linear feet of steep slopes along the Hudson Park shore. Many slopes are about 50% slope (assumed average), and slope lengths average 50 feet (Photos 8 and 11). A crude estimate for the amount of soil loss per year can be made using the USLE erosion index.

8. Steep slopes are easiest to see in winter. Slopes here exceed 50% (23 degrees).

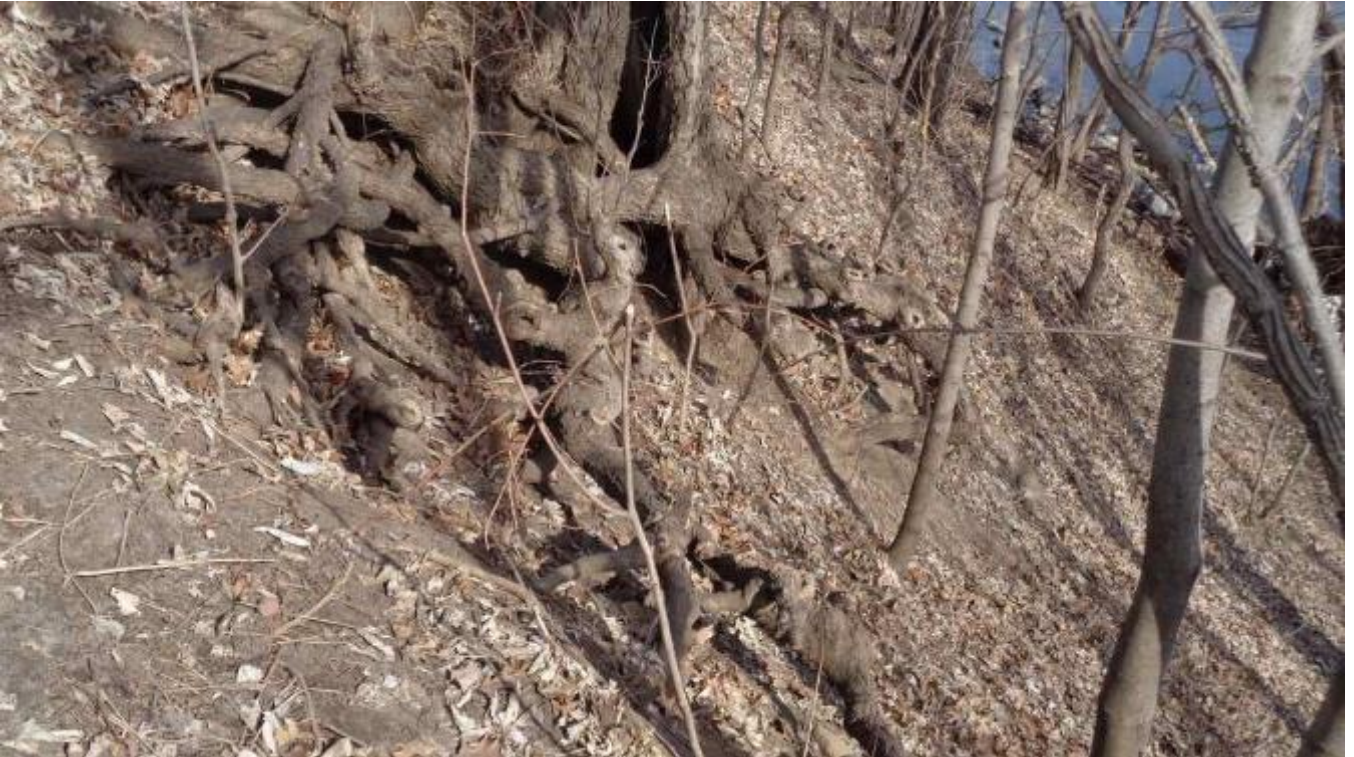
Even after the leaves are on the trees there is a significant amount of bare soil under the shrubs exposed to the erosive summer rains. When there are no leaves (November to April) and the bare soil on the slopes (Photos 9 and 10) is subjected to extremely large precipitation events, a large amount of soil is washed down the slopes as sheet erosion into Lake Monona.

9. An example of a long steep slope. There are several characteristics of the steep slopes that can be seen when leaves are off the trees. See bare patch of soil in lower left of photo. Note the extensive bare root system of Hackberry trees in upper left. Since roots of Hackberry will not grow in air, the roots must have grown in soil that is now in the lake.

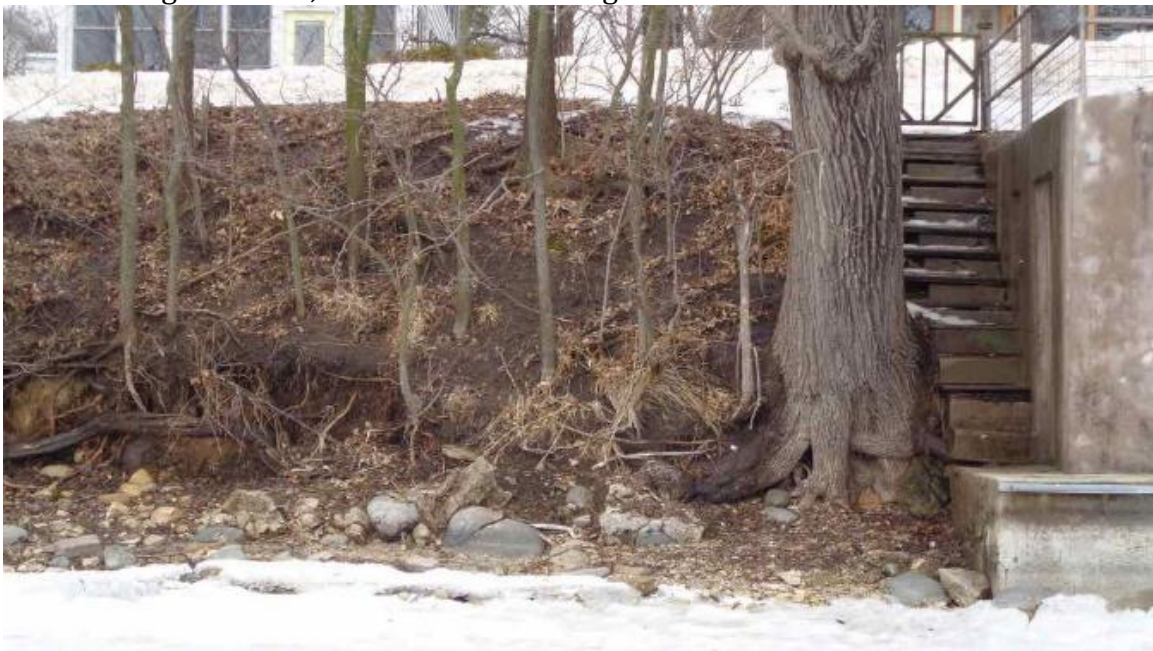
10. An example of a short steep slope, undercut shore, and bare soil exposed during winter. Solar radiation is much more intense on the south-facing steep slopes than on level ground and this extra heat input leads to rapid snowmelt after most snows. This subjects the soil to more wetting and drying cycles that can speed along the erosive forces caused by gravity.

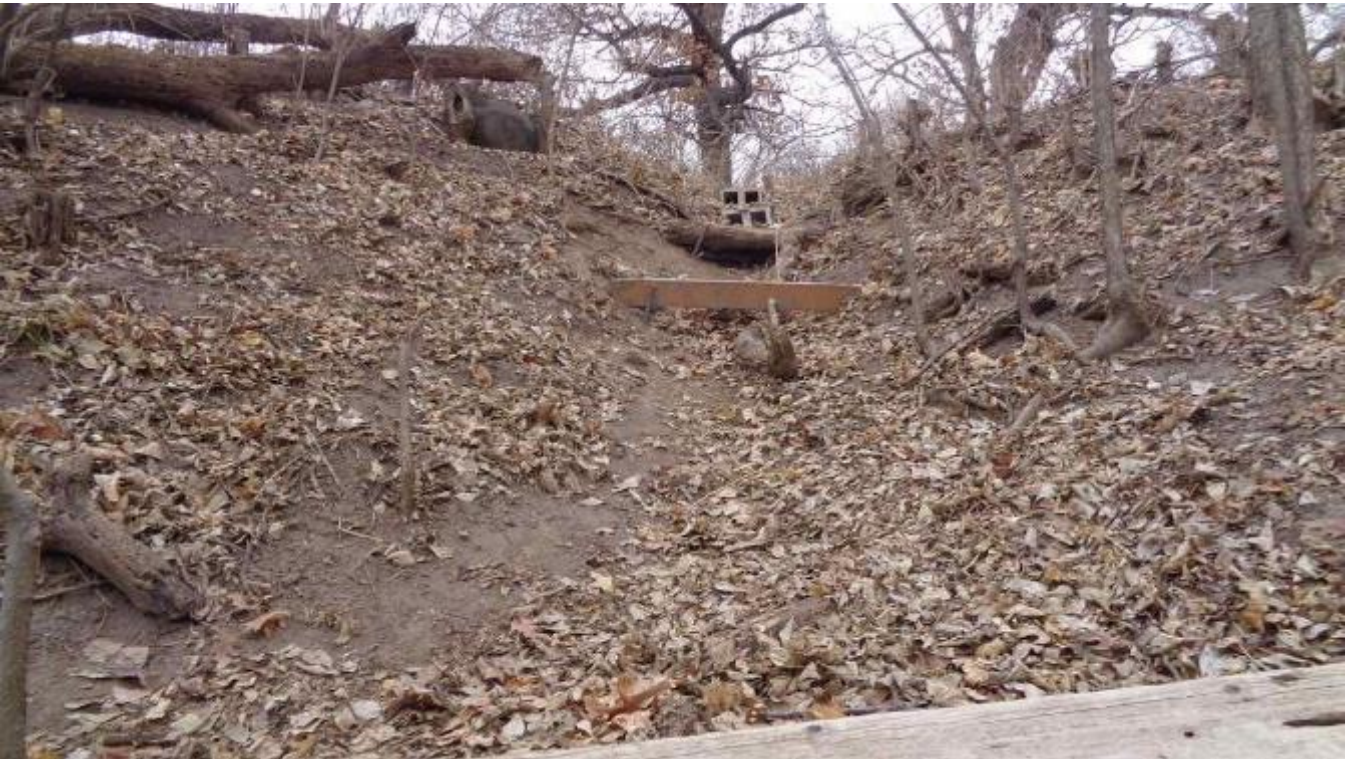
Right now (July 30, 2019) there is too much vegetation to look through to see the erosion clearly. I estimate over the whole shore length, there are more than 10 long steep gullies (Photo 11) and more than 10 short steep gullies (Photo 12) that undergo soil erosion year round and do not have ground cover. Stairs should replace several long steep gullies to provide access to lake and discourage the use of other gullies for public access.

11. An example of a long steep gully used to gain access to the shore (@Maple Ave). It would be instructive to calculate the volume of soil that has been lost from the gully and ended up in the lake.

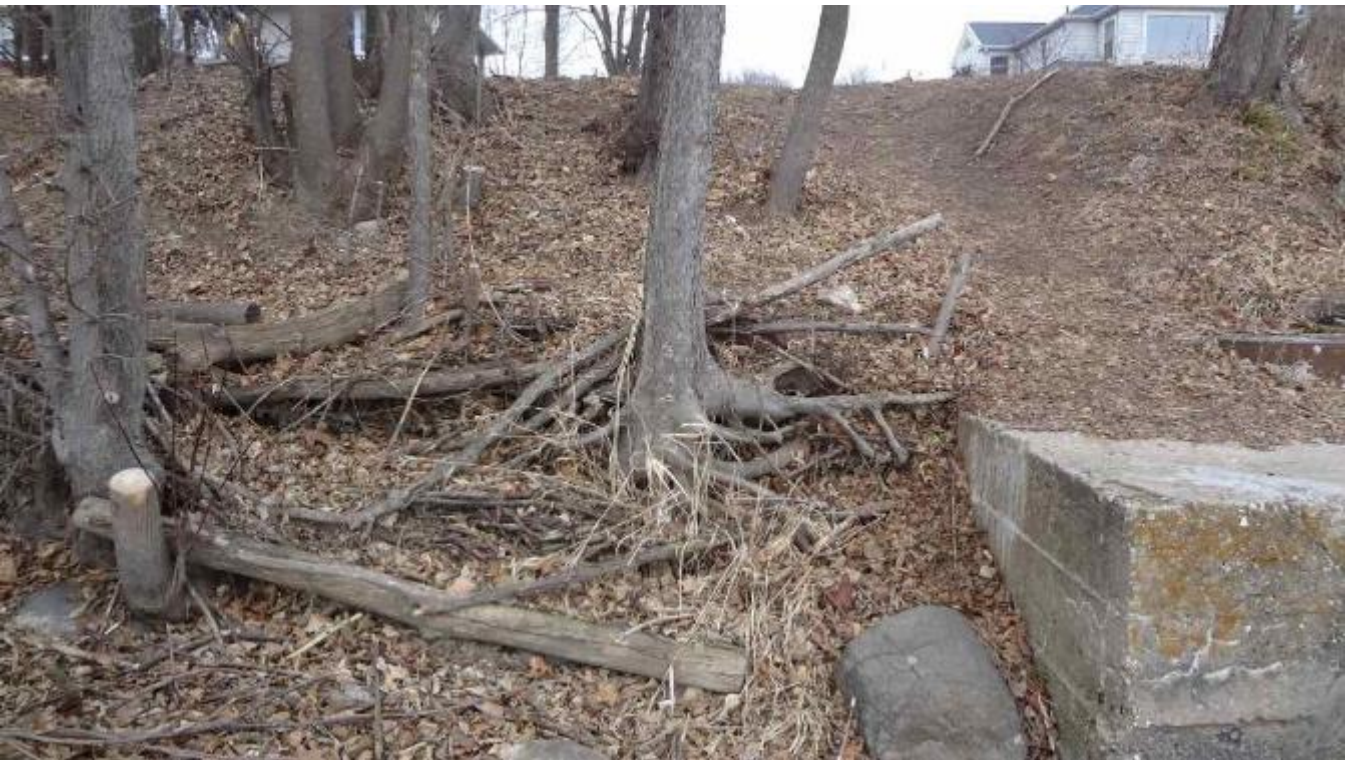
12. An example of a short steep gully; the undercut trees are along the shore at Lakeland and Miller.

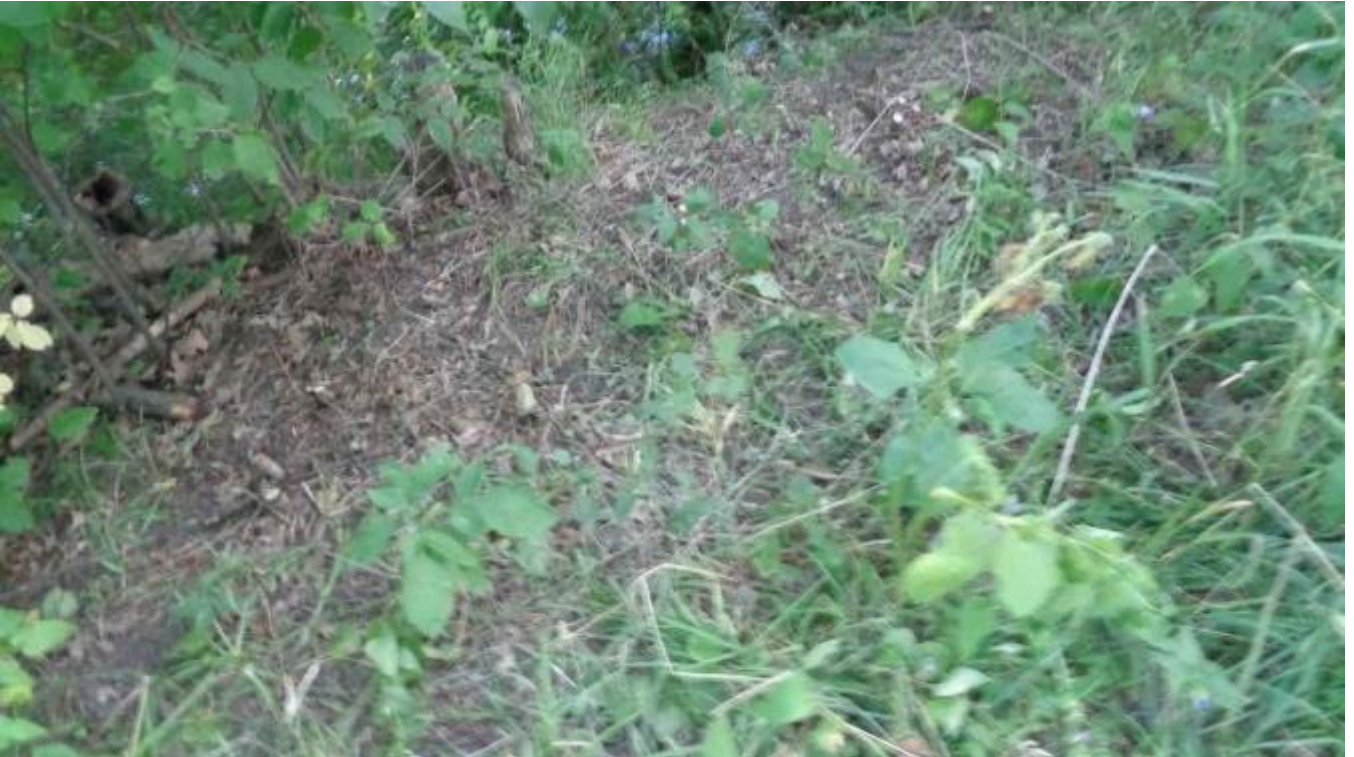
Recent trimming along Lakeland Ave (East) removed many invasive species next to the road (Photo 13). City Parks came through and marked the trees and shrubs to cut and applied some herbicide to the stumps to prevent future sprouting. Neighbors cut the marked vegetation and hauled it to a place where it could be processed by the chipper or hauled to Olin Ave mulching site by the City.

13. When pruning activities occur there is a resulting area of bare soil that is quite susceptible to erosion until the vegetation becomes established. Seeding and mulching cover crops on bare soil will control erosion.

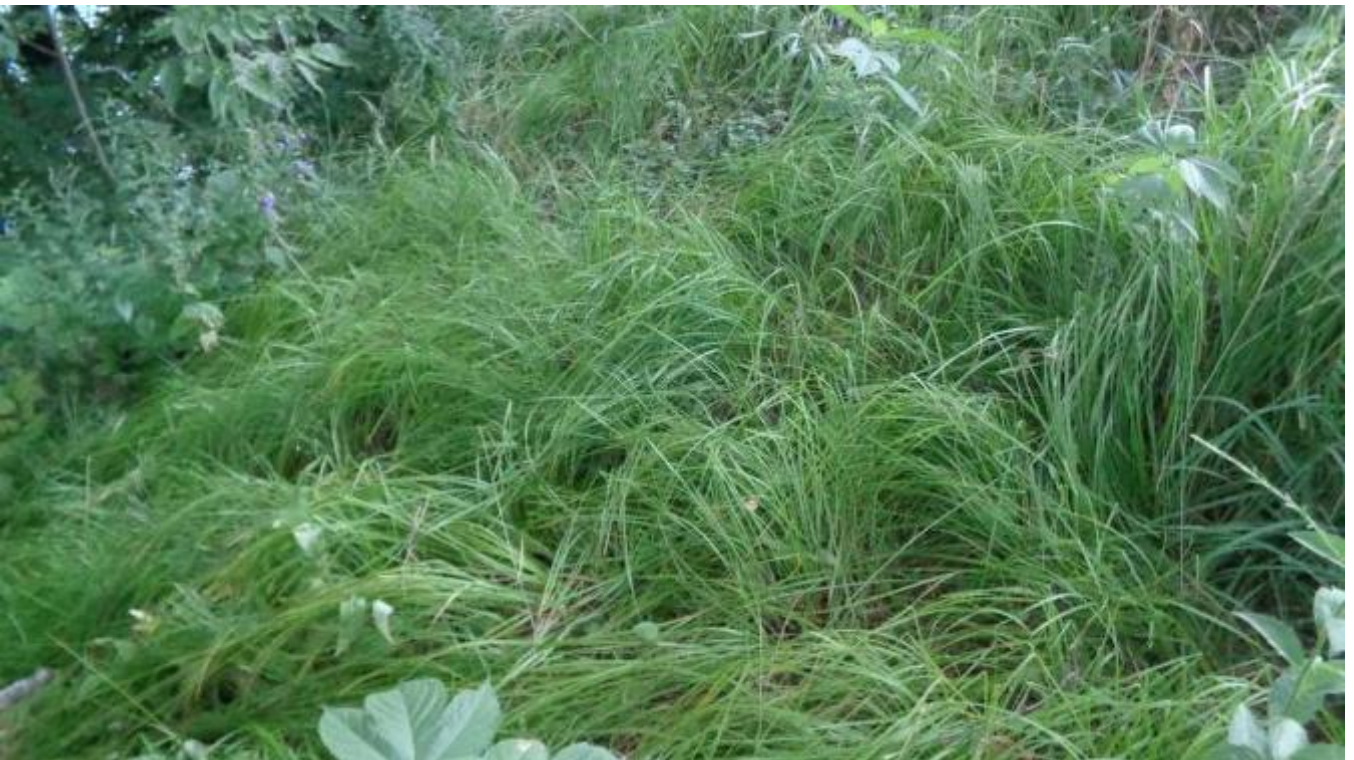
Existing trees, shrubs, forbs, sedges and grasses decrease the amount of erosion. Planting additional grasses and sedges on existing bare soils (Photo 1) could greatly reduce the input of phosphorus-rich topsoil into Lake Monona. Fortunately the soil surface is not all bare (Photo 14), sedges make an excellent groundcover!

14. Sedges provide an excellent ground cover. Some shade tolerant grasses in the mix would help. When thinning of the invasive shrubs occurs, sedge seeds and mulch could be laid on the resulting bare soil.

By thinning the understory, we can create a more favorable micro-environment for the establishment of ground cover. This means selectively removing invasive understory brush such as chokecherry, honeysuckle and some of the hackberry saplings. This will allow extra light down to the soil surface for the shade tolerant grasses and the sedges to gain a foothold. Mulching over the seed with the appropriate materials will ensure a good seed set. We could train High School students after school as well as others to achieve these tasks.

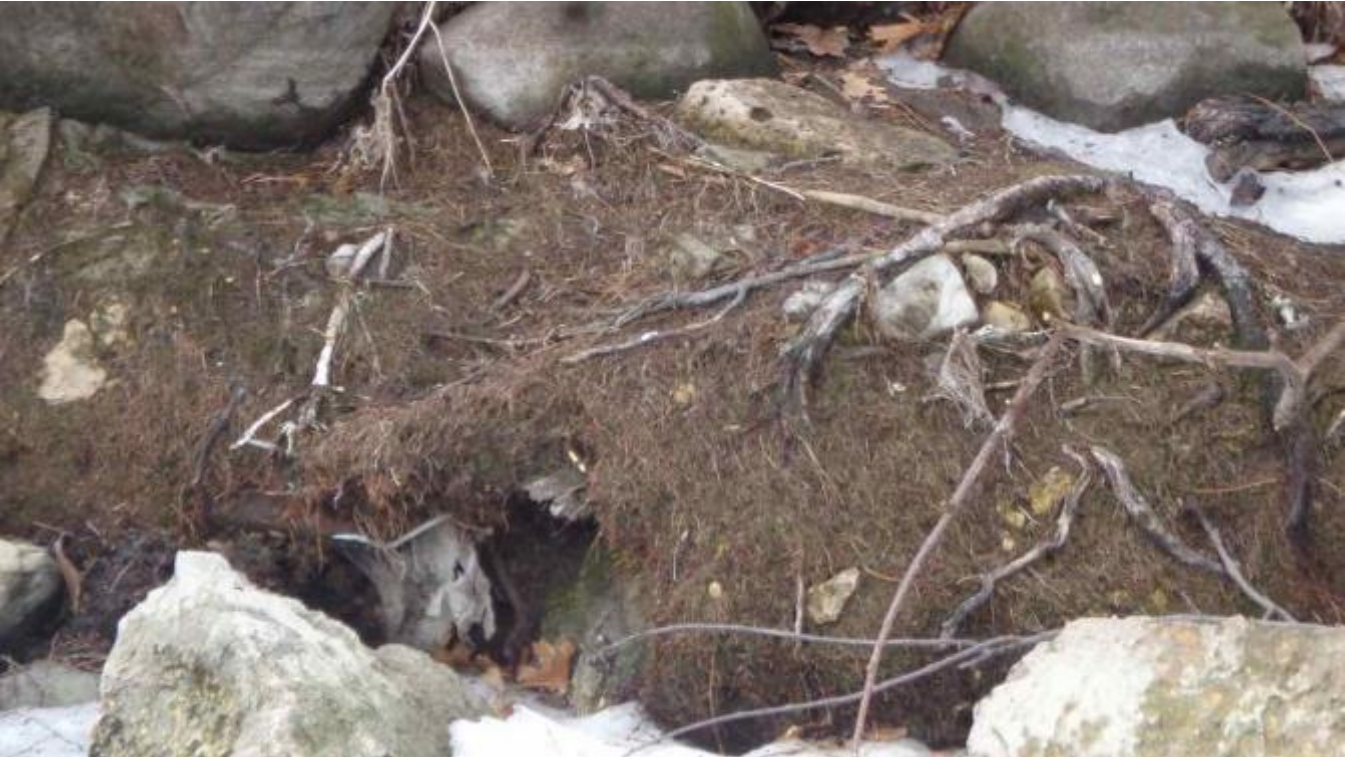
15. Willow roots provide some shoreline protection until the trees die and are not replaced.

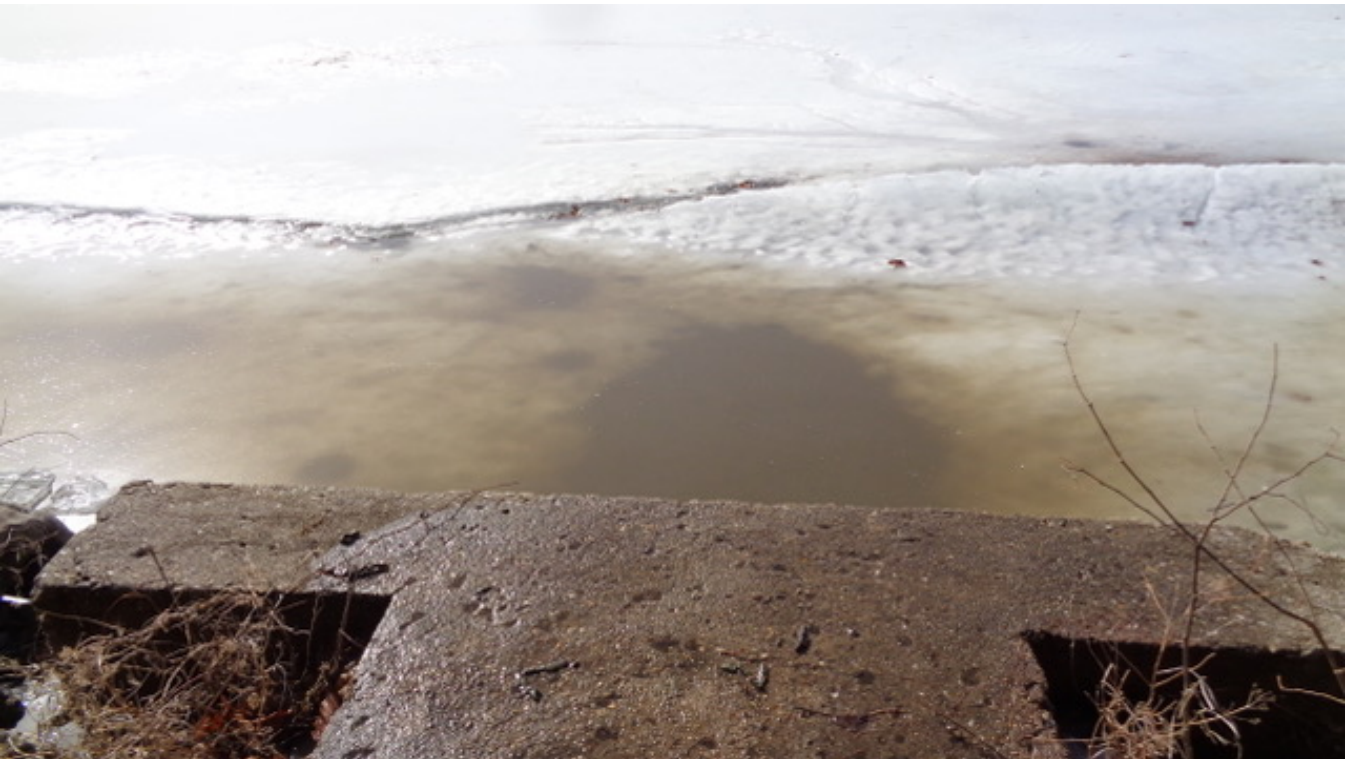
16. So, let us keep the shore and slopes in good shape  
and keep the soil out of the water. Thank you.
