DEPARTMENT OF  
**Soil Science**

UNIVERSITY OF WISCONSIN-MADISON

Report to Town of Primrose and Primrose Gun and Conservation Club

Topic: Lead levels in soil within club sporting clay area

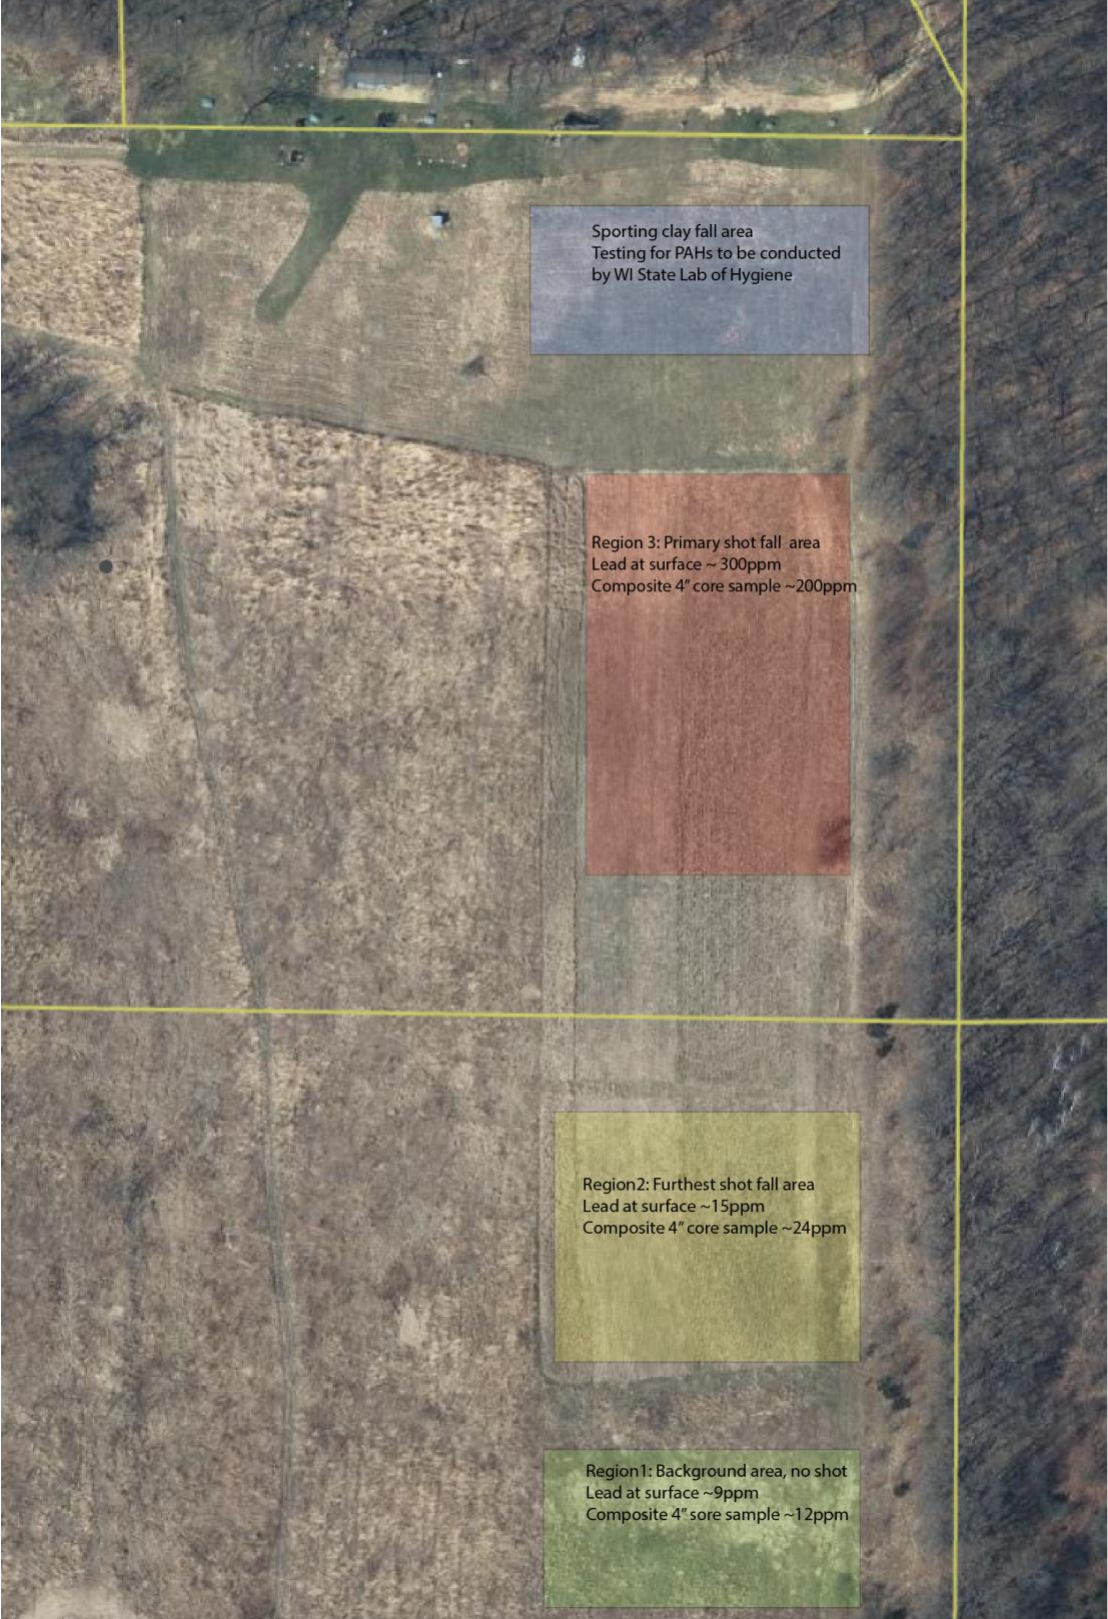
Sporting clay fall area  
Testing for PAHs to be conducted  
by WI State Lab of Hygiene

Region 3: Primary shot fall area  
Lead at surface ~ 300ppm  
Composite 4" core sample ~200ppm

Region2: Furthest shot fall area  
Lead at surface ~15ppm  
Composite 4" core sample ~24ppm

Region1: Background area, no shot  
Lead at surface ~9ppm  
Composite 4" core sample ~12ppm

The composite samples were collected from three regions within the shooting area. Region 1 is beyond the further range that shot is expected to fall and can be considered to give background soil elemental values. Region 2 is from the furthest range that shot can be expected to fall to where shot is estimated to likely fall (per club member estimates). Region 3 is the area where shot is expected to fall most heavily. Surface XRF Pb sample analysis confirmed estimates of shot fall density. One additional composite sample was collected within the area closest to the gun stands for analysis for PAH compounds. A map of the sample locations is attached.

Sample analysis showed that the soil lead background values for the area are approximately 12ppm (mg/kg) (Region 1). Region 2 showed a slight increase to 24ppm. Region 3 soil averaged 198ppm. The region 3 surface sample were generally higher than the composite. This is likely due to dilution from soil with lower lead concentrations from below the surface being mixed with higher Pb surface soil. The variation (79-307ppm) seen in the samples analyzed from Region 3 are typical of that expected with discrete sample analysis as soil is a highly heterogeneous matrix. Composite sampling helps to smooth out the variation and give more
