## Non-Wetland Determination Report

3128, 3130, and 3132 Sunnyside Street  
Stoughton, WI 53589

PRJ109314 | June 23, 2023

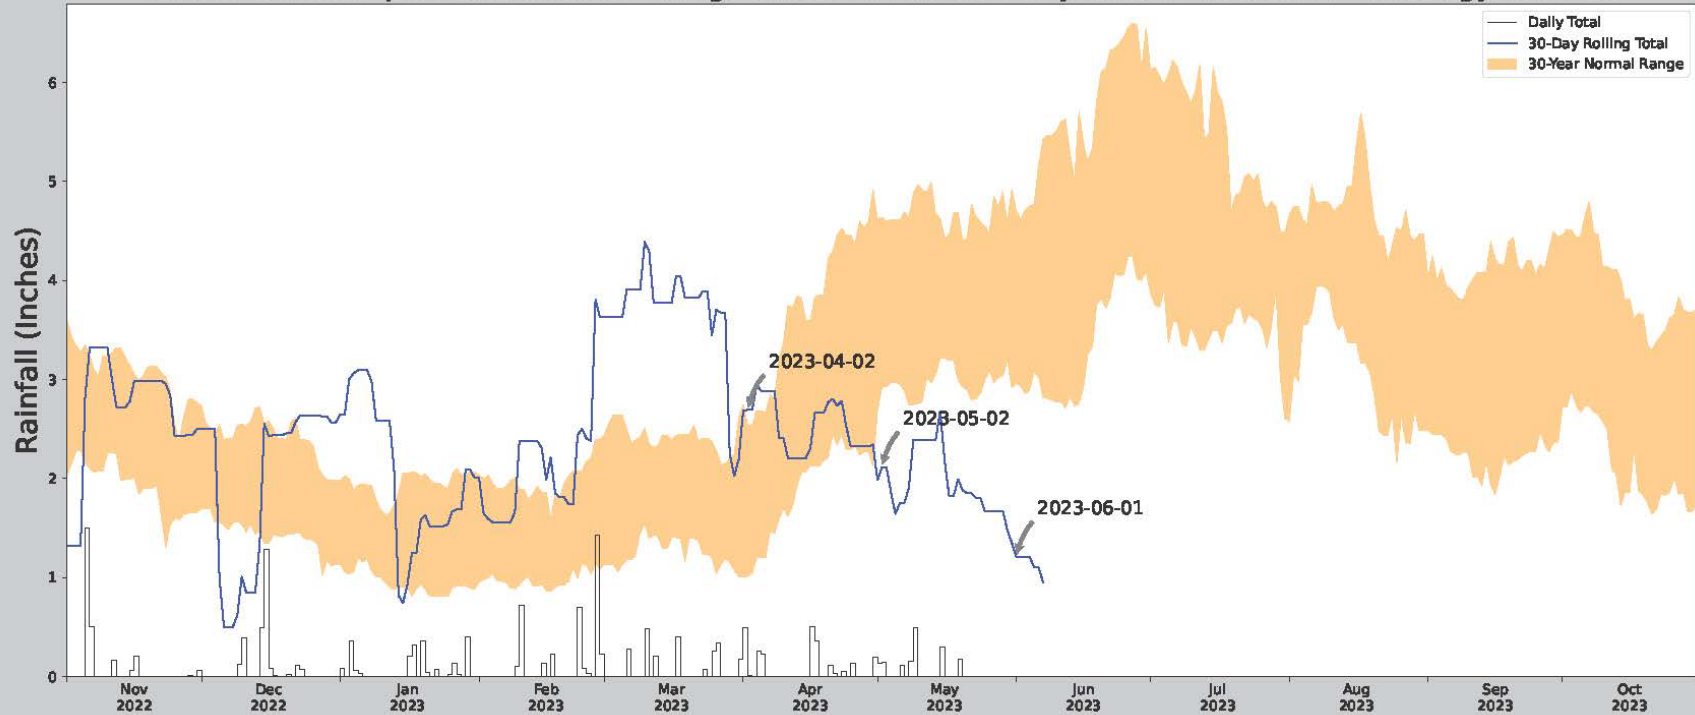
**Table 2. Antecedent Precipitation Analysis**

Climate data were obtained using the USACE Antecedent Precipitation Tool version 1.0. Precipitation from the 90-day period preceding the wetland survey was approximately 6.01 inches at the site (Table 2). Precipitation in March was above normal and below normal in April and May. Precipitation data analysis in Table 2 resulted in a weighted condition value sum of 8 indicating climatic/hydrologic conditions in early June 2023 were drier than normal. This delineation also took place during the dry season.

Coordinates	42.980927, -89.245459
Observation Date	2023-06-01
Elevation (ft)	845.522
Drought Index (PDSI)	Mild wetness (2023-05)
WebWIMP H <sub>2</sub> O Balance	Dry Season

30 Days Ending	30 <sup>th</sup> %ile (In)	70 <sup>th</sup> %ile (In)	Observed (In)	Wetness Condition	Condition Value	Month Weight	Product
2023-06-01	2.959055	4.697244	1.208661	Dry	1	3	3
2023-05-02	2.927165	4.634646	2.114173	Dry	1	2	2
2023-04-02	1.01063	2.535827	2.692913	Wet	3	1	3
Result							Drier than Normal - 8

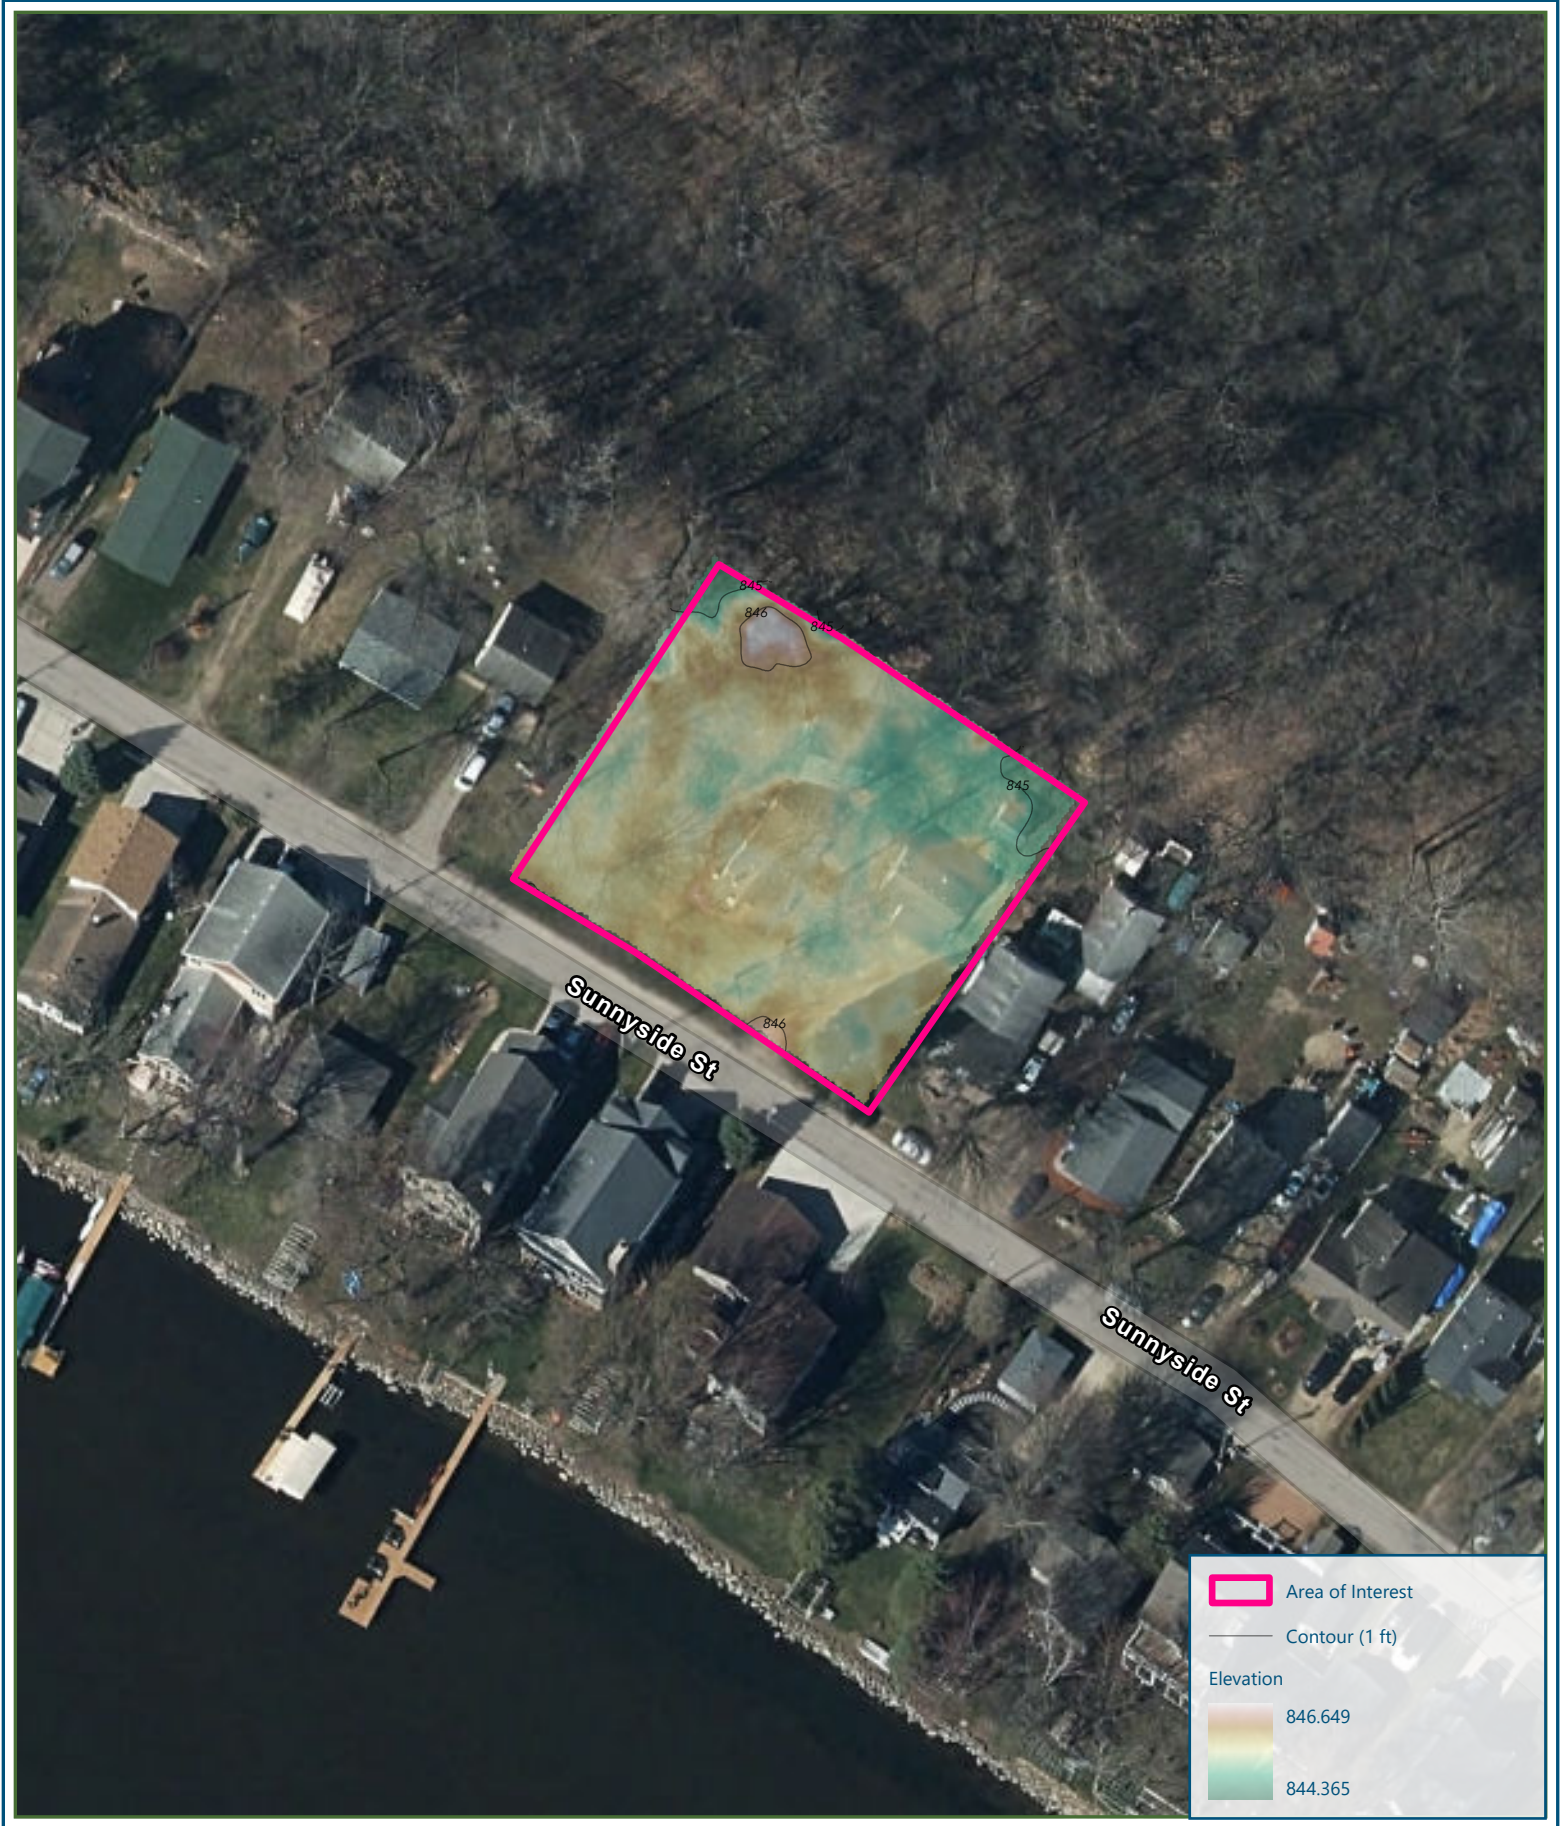
**Figure 2**  
Topography

- Dane County Topographic Map – The topographic map (Figure 2) shows the general elevations of the site. The site is flat with elevations that range from 845 to 846 feet.
- Soil Survey Map – The NRCS Web Soil Survey Map (Figure 3) identifies two soil map units within the site boundaries: Cut and fill land (Cu) and Houghton muck (Ho). Data associated with each soil map unit are presented in Table 1.
- WWI Map – the WWI map of the area (Figure 4) indicates that one wet soil, palustrine, broad-leaved,

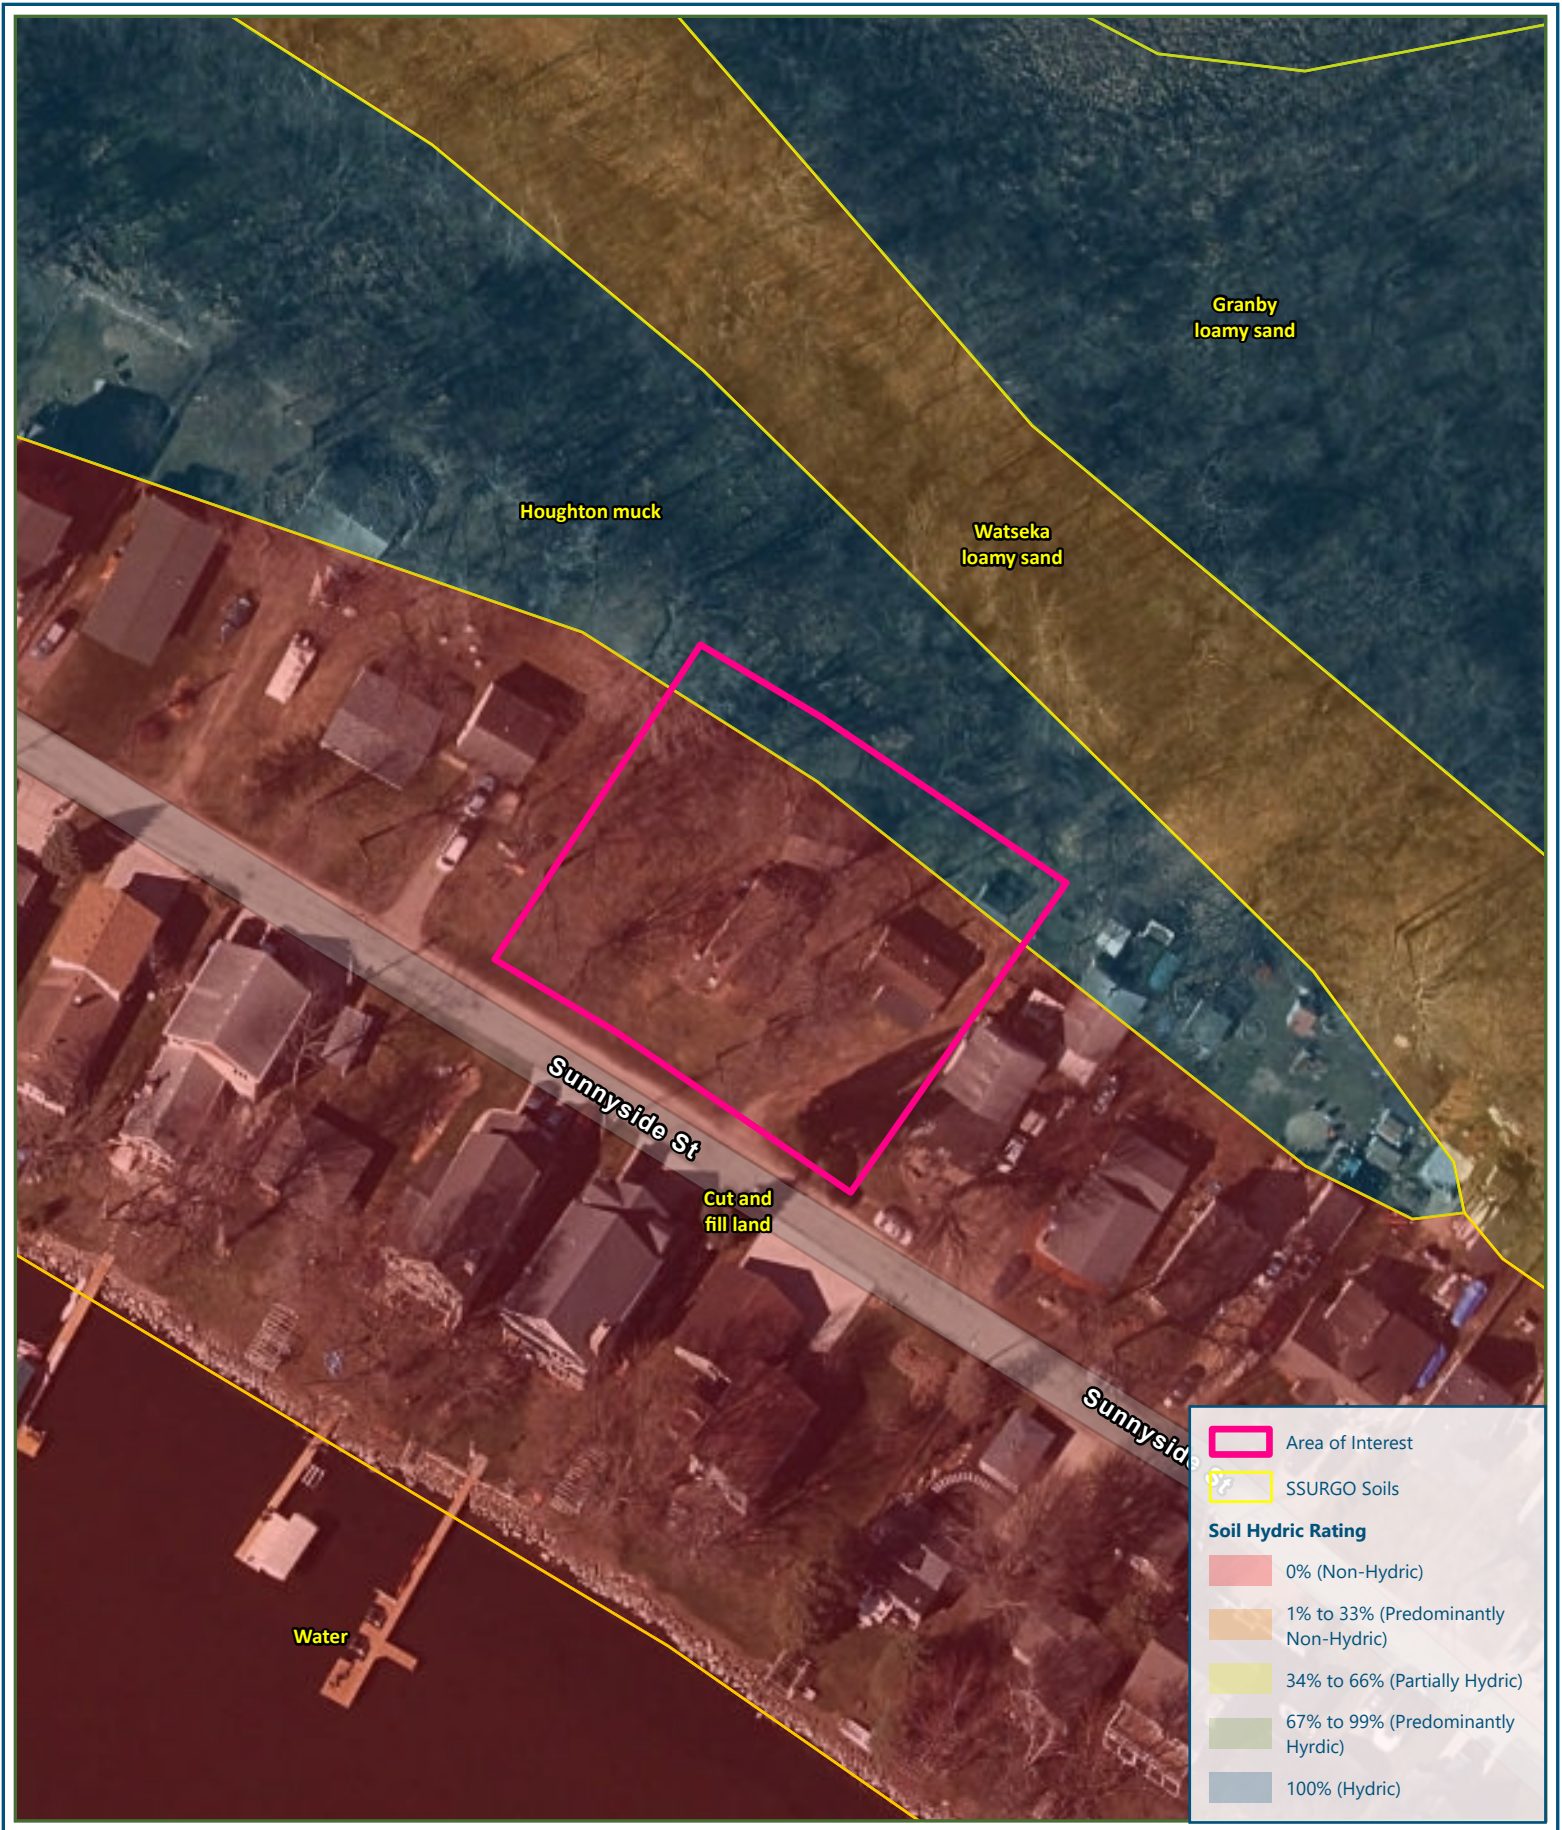
**Figure 3**  
**SSURGO Soils**

**Table 1. Soils Data**

Soil Map Unit Symbol and Name	% of AOI	Drainage Classification*	Major/Minor Components	Map Unit % Composition	Hydric Soil Rating
Cu – Cut and fill land	90%	Moderately well drained	Cut and fill land	100%	No
Ho – Houghton muck	10%	Very poorly drained	Houghton	100%	Yes

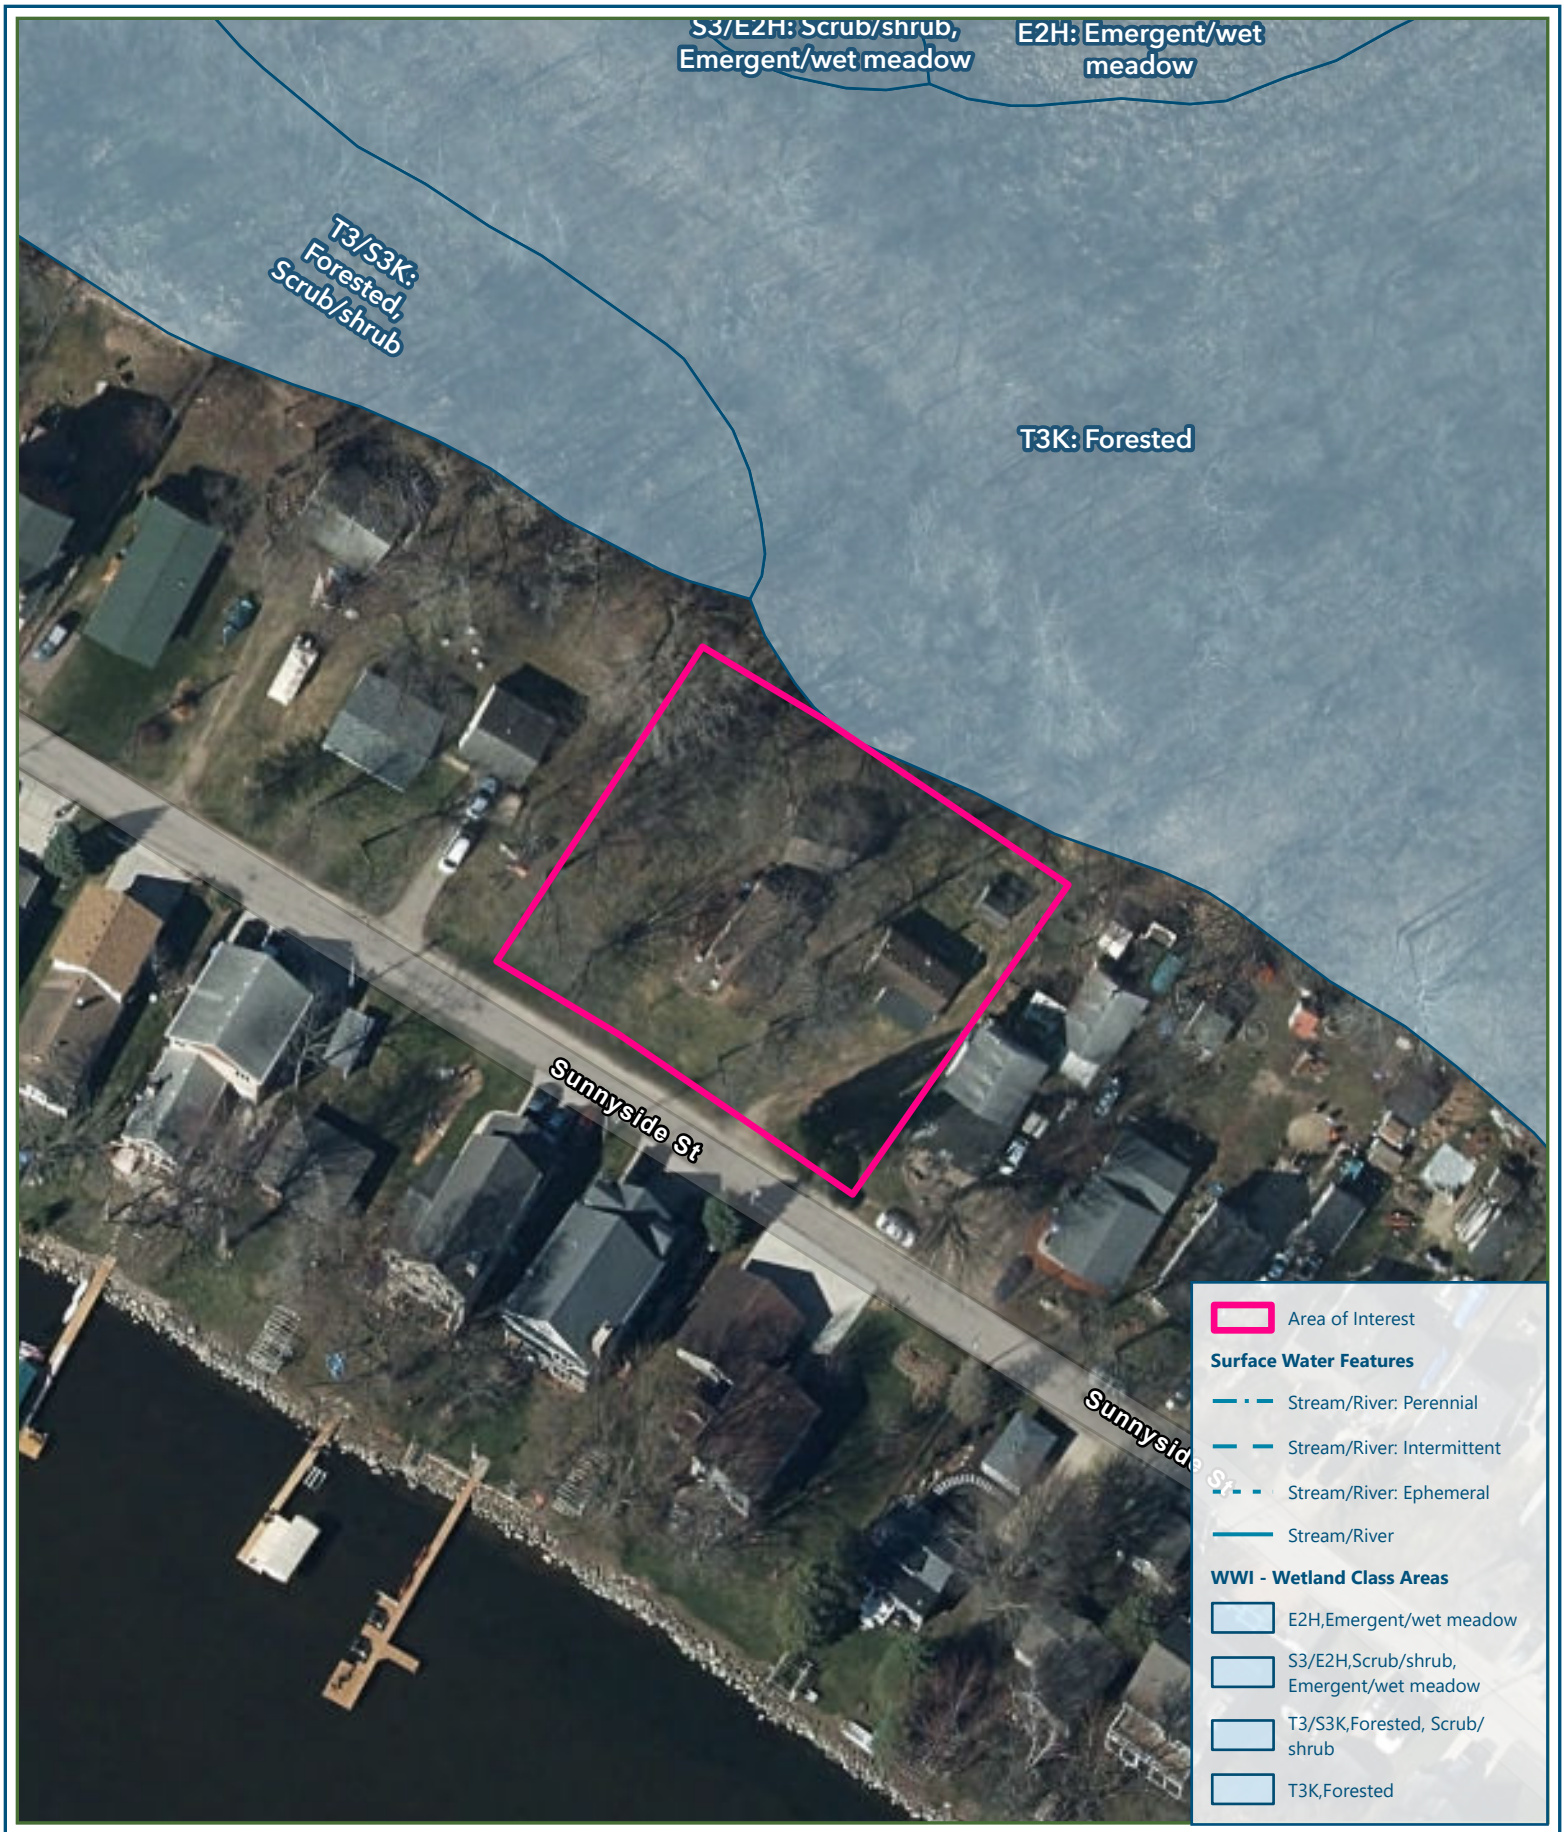
**Figure 4**  
**Wisconsin Wetland Inventory**  
**Scheffler WD**  
 Dane County, WI | 89.2454°W 42.9809°N

deciduous, forested wetland (S3K) is present just outside the northeastern AOI boundary.

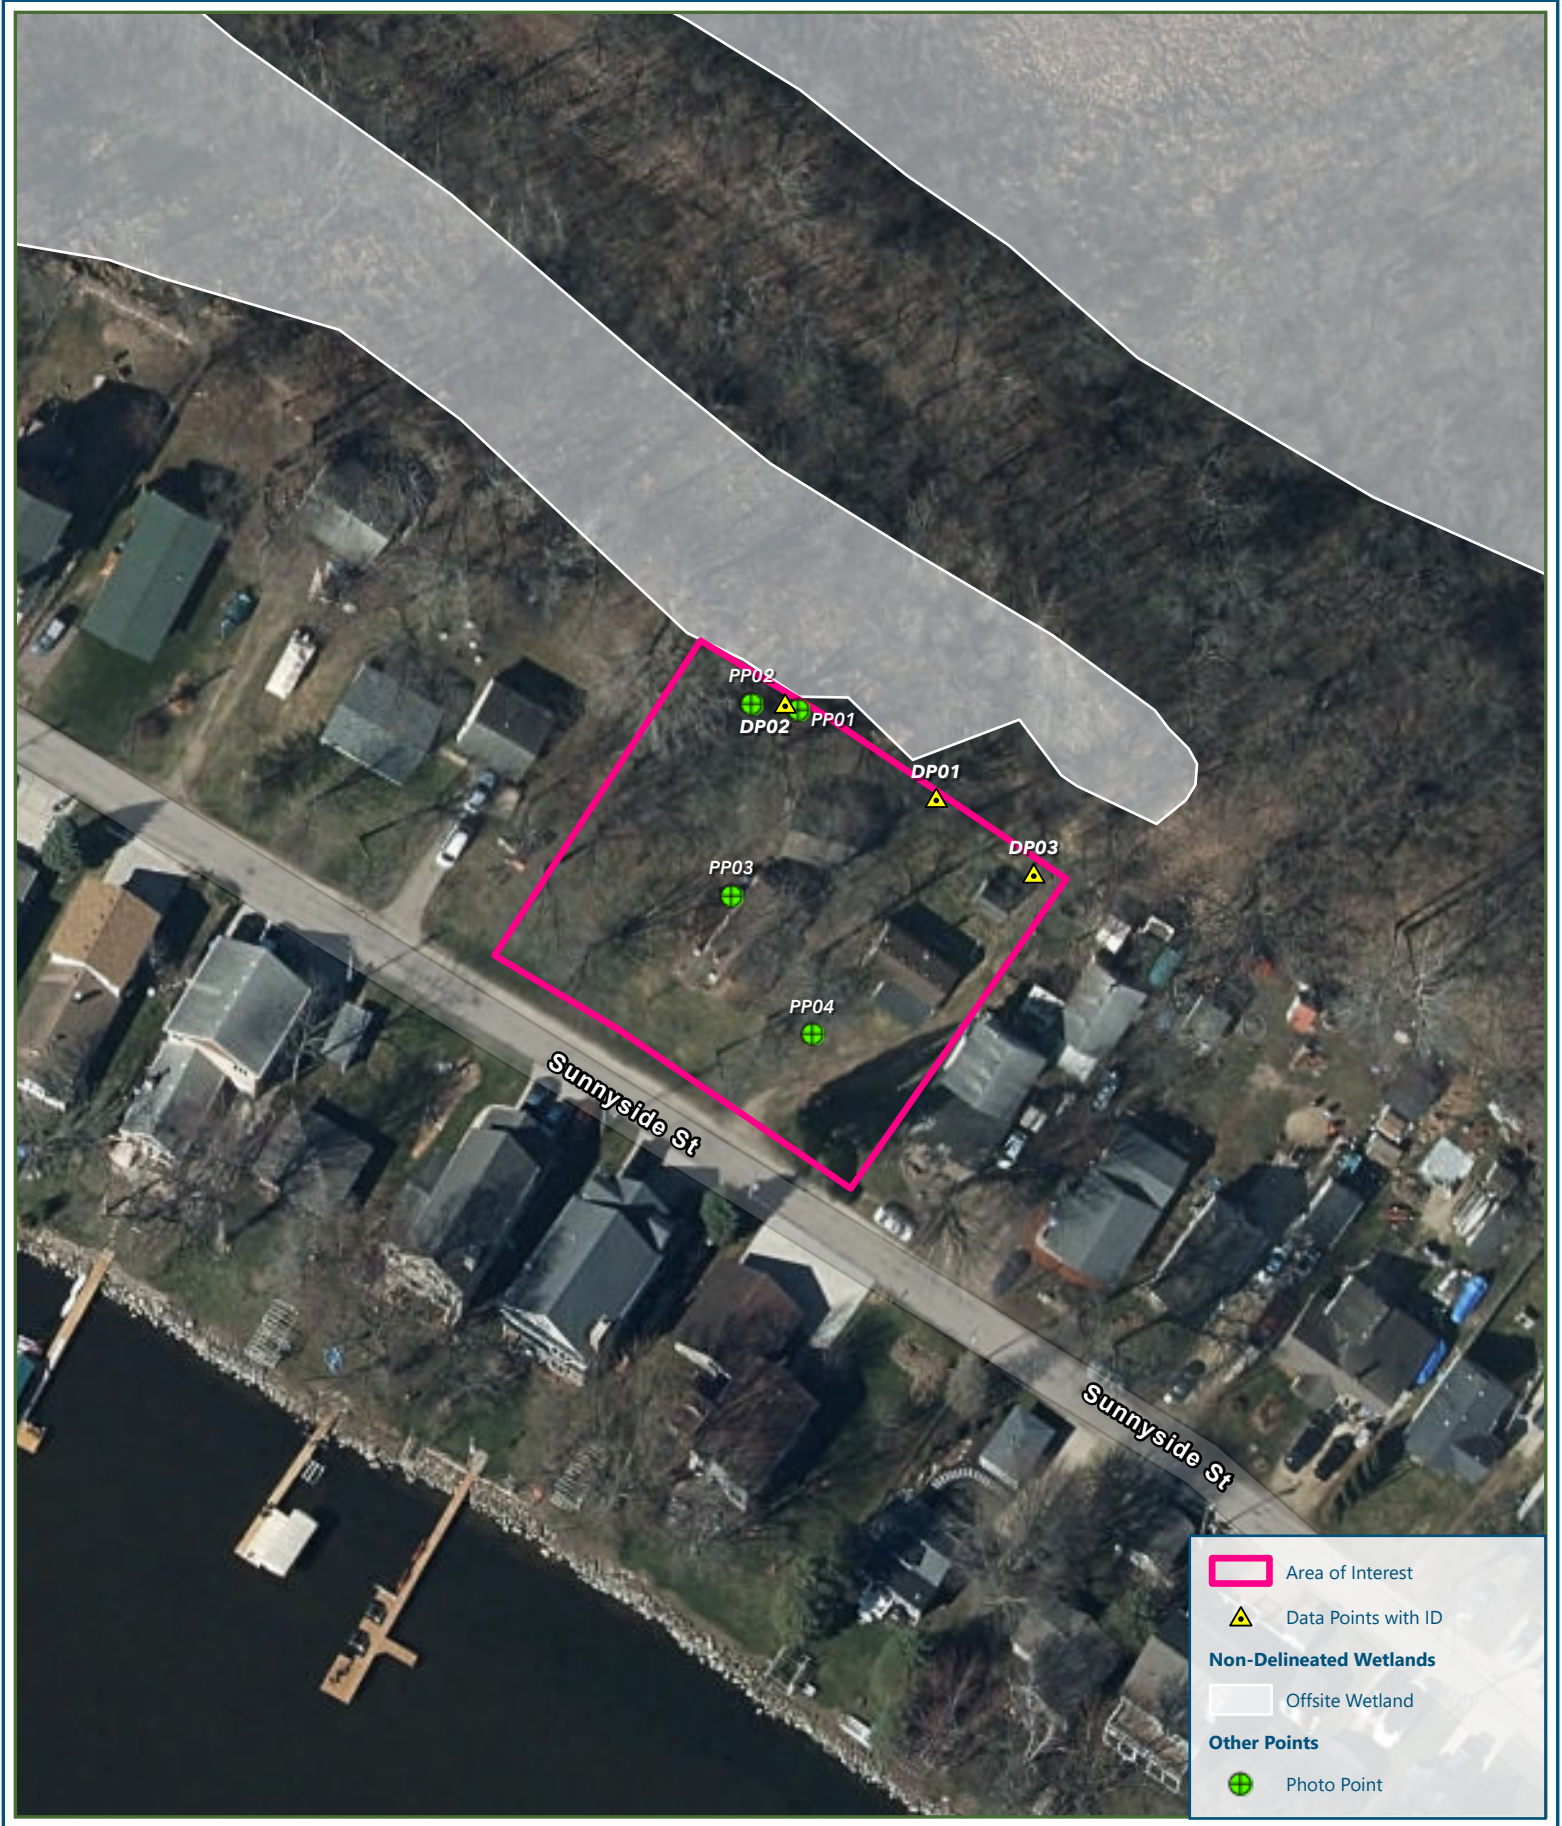
On June 1, 2023, RES searched for wetlands contained within the 0.6-acre AOI; however, wetland conditions were absent and no wetlands were delineated. An offsite wetland is present immediately northeast of the northeast property boundary (Figure 5). The boundary of this wetland was surveyed using a Global Positioning System (GPS) receiver where the wetland nears the property boundary. However, because the wetland was offsite, no soil pits were excavated and no data points were established in the wetland.

Three (3) soil test pits that were representative of the AOI were excavated and investigated for evidence of wetland conditions (Figure 5). At each soil pit a Northcentral/Northeast Region wetland delineation data form was prepared and a determination was made as to whether each was in a wetland or upland based on the three criteria: vegetation, soils, and hydrology.

Field observations revealed that wetland conditions (i.e., positive indicators of wetland hydrology, vegetation, and soils) were not present on the day of inspection (Figure 5). There is, however, an offsite wetland located immediately northeast of the northeast property boundary.

Representative data points were taken to confirm non-wetland conditions in upland areas. Upland data points include DP01-DP03 (Figure 5).

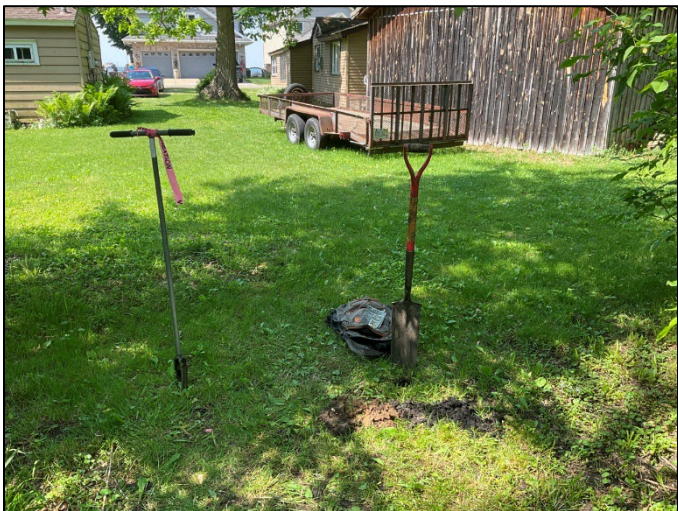
**Photo 1. DP01 looking southwest at upland area (June 1, 2023).**

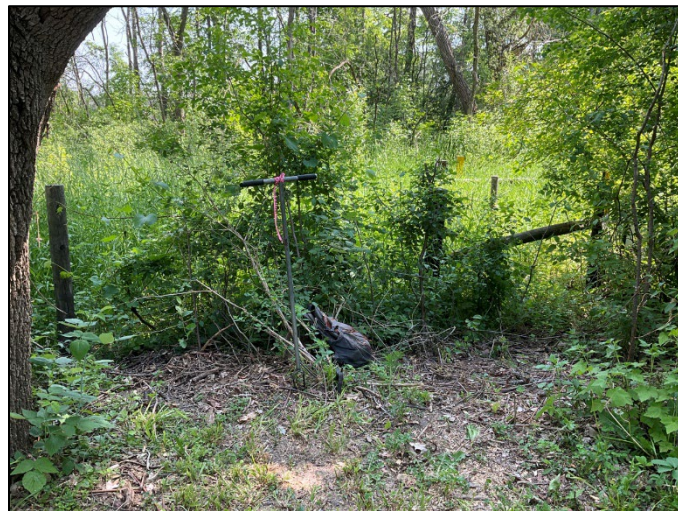
**Photo 2. DP02 looking northeast at upland area (foreground) and offsite wetland (background) (June 1, 2023).**

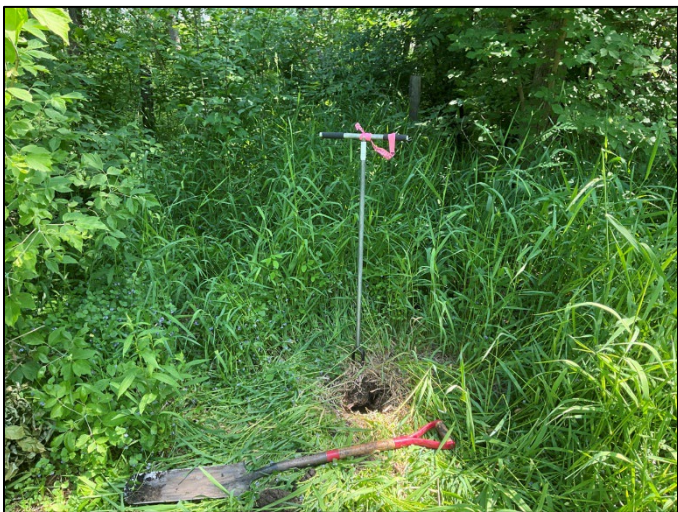
**Photo 3. DP03 looking northeast at upland area (June 1, 2023).**

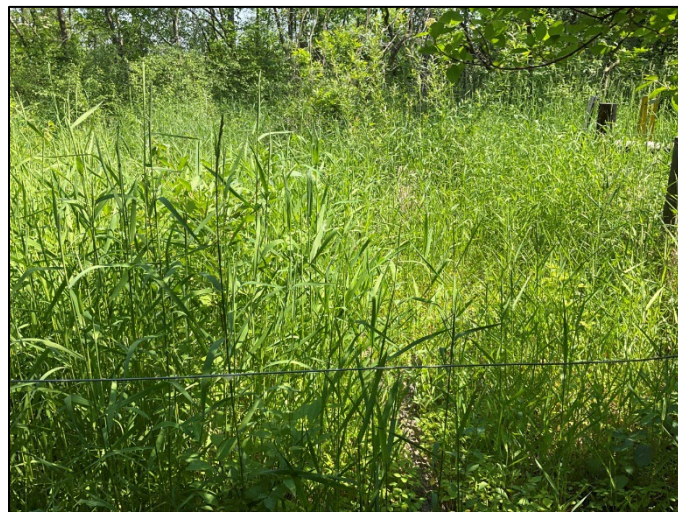
**Photo 4. Photo-point 01 looking northeast at offsite wetland (June 1, 2023).**

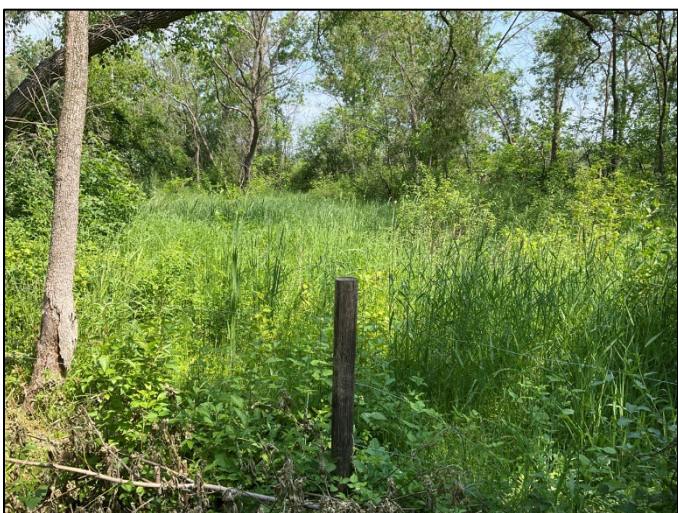
**Photo 5. Photo-point 02 looking north at offsite wetland (June 1, 2023).**
