June 20, 2025

Project/File: 193711400

**Reference: Summary of Squire Parcel Wetland Determination  
Town of Dunkirk, Dane County, Wisconsin**

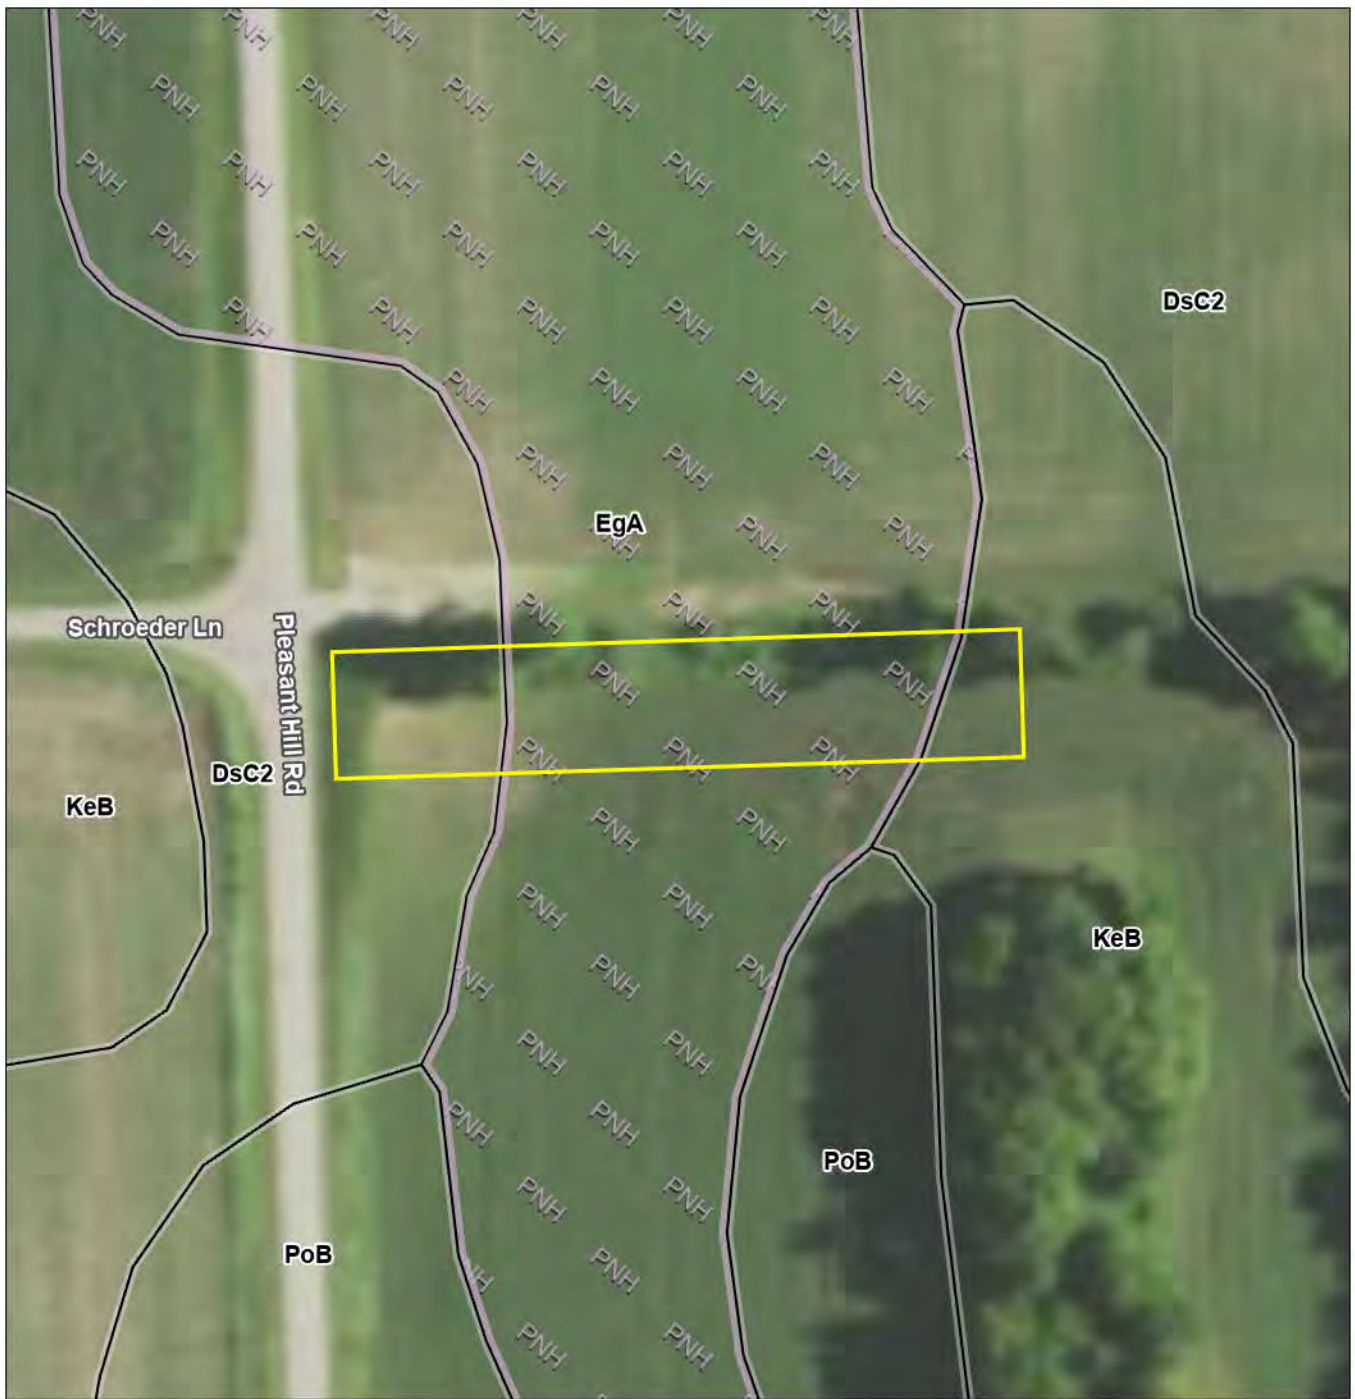
**Figure No.**  
2

A review of desktop resources found soils mapped within the Study Area by the NRCS Soil Survey of Dane County include Dresden silt loam (DsC2), Elburn silt loam (EgA), and Kegonsa silt loam (KeB) (Attachment B, Figure 2). The Elburn series can contain hydric inclusions in drainageways but is mapped as a predominantly non-hydric soil. The WDNR WWI mapping (Attachment B, Figure 3) identifies wetland and indicator soils within the Study Area that correspond with the area of mapped Elburn silt loam.

**Title**  
NRCS Soil Survey Data  
Hydric Ratings

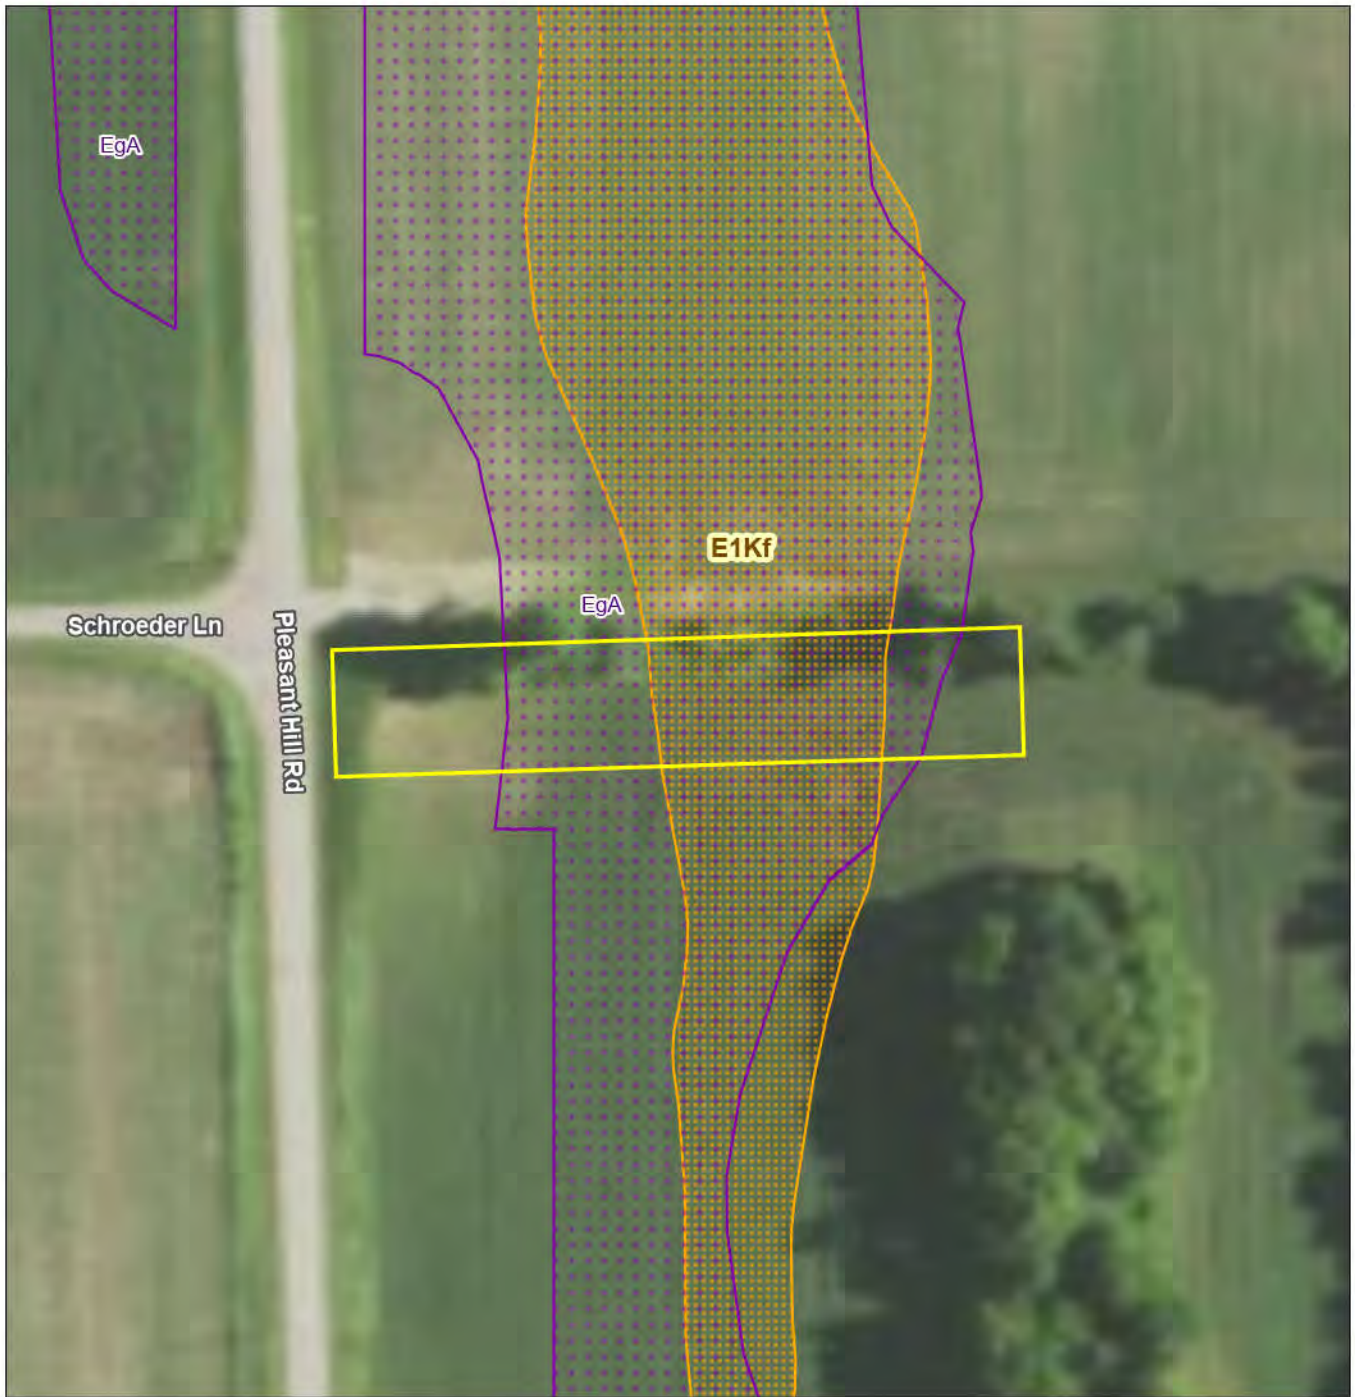
**Figure No.**  
 3

the center of the Study Area. The topographic low point corresponds with the area of mapped Elburn silt loam, as well as the mapped WWI wetland and indicator soils, and is associated with a broad relatively flat draw between topographic high points. A review of available aerial imagery from 2005-2022 (Attachment D) showed consistent wetness signatures in only two years, in a wet and a normal year. The wetness signatures aligned with the area of mapped Elburn silt loam, mapped WWI wetland and indicator soils, and the topographic low point of the Study Area.

**Title**  
 Wisconsin Wetland Inventory

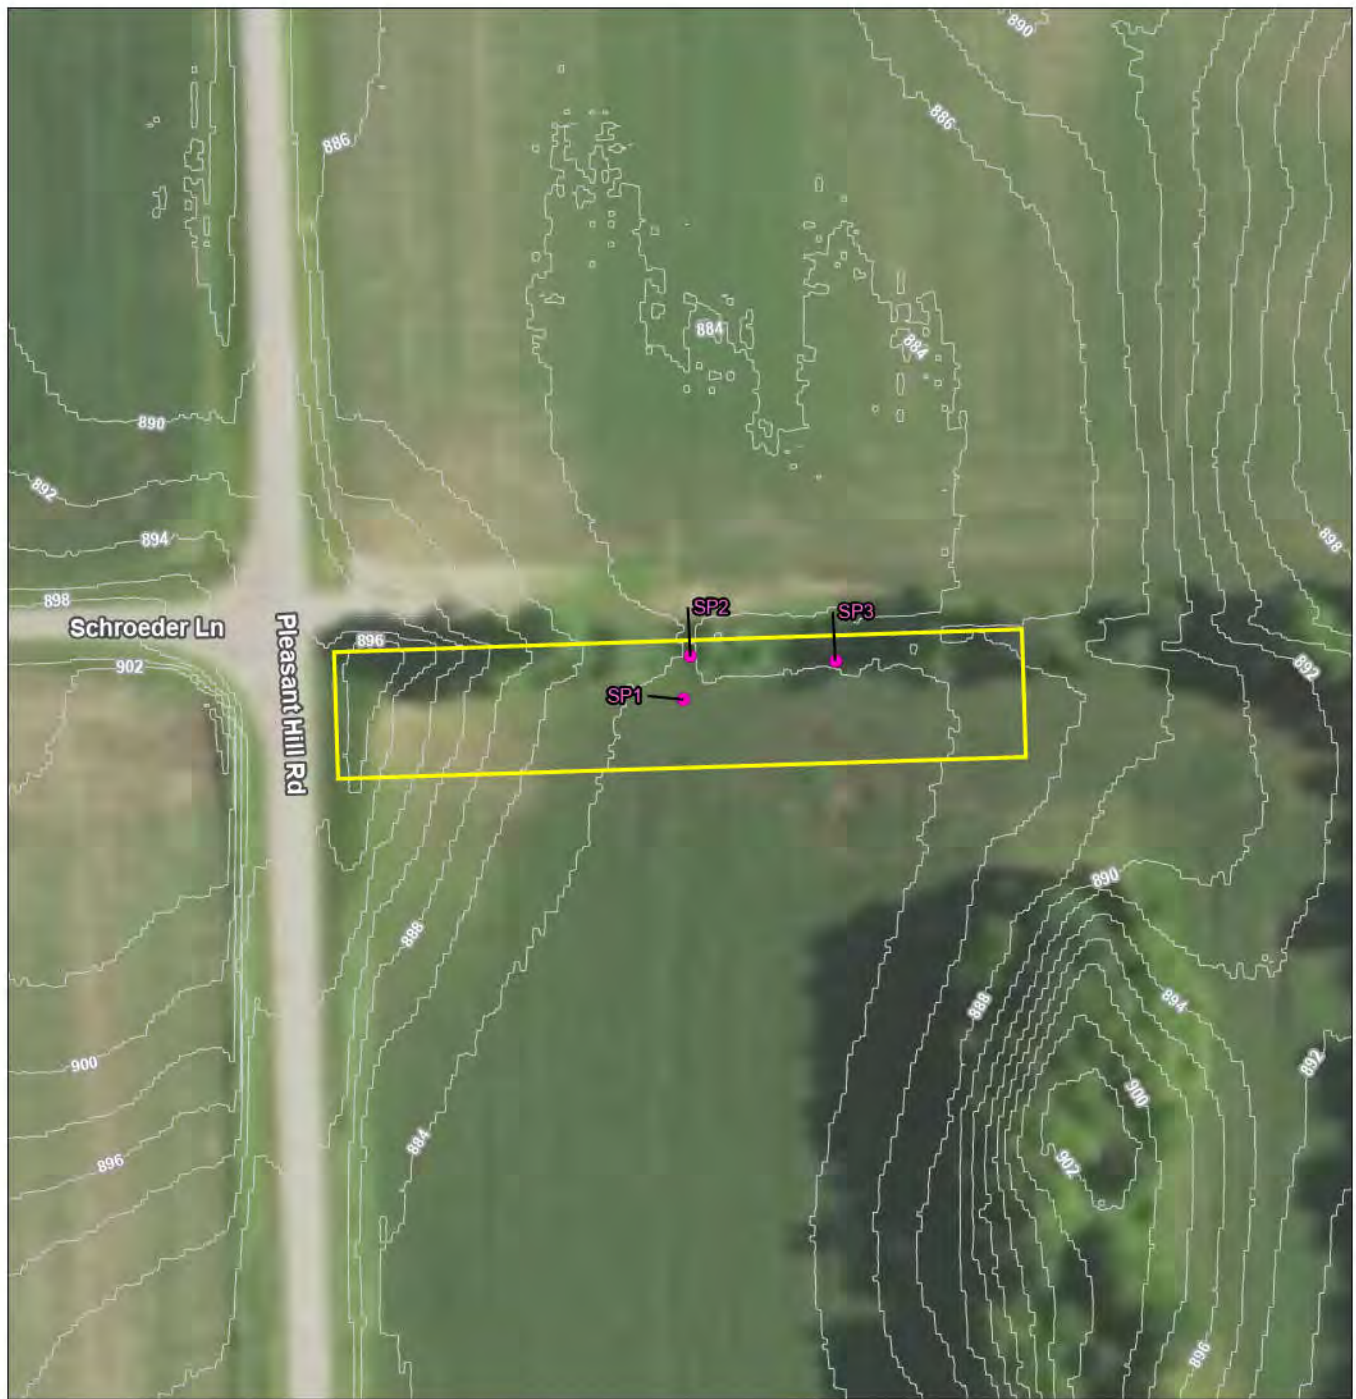
**Figure No.**  
**4**  
**Title**  
**Field Collected Data**

Three wetland determination sample points were completed within the Study Area to document non-wetland conditions (Attachment B, Figure 4). The data sheets completed for the sample points are provided in Attachment E. Representative photographs of the Study Area are included in Attachment F.

Sample point SP1 was recorded at the lowest topographic point within the active agricultural field in the mapped WWI wetland and wetland indicator soils. Sample point SP1 met the hydrophytic vegetation criteria based on the sparse, weedy species present, but did not meet wetland hydrology criteria or indicators of hydric soil and was determined to be non-wetland. Sample points SP2 and SP3 were both located within the unmaintained vegetated tree/fence line and within the mapped WWI wetland and wetland indicator soils. SP2 was placed within the lowest topographic point within the tree/fence line with SP3 located approximately 2-3 feet upslope from SP2. Neither SP2 nor SP3 met any of the three wetland criterion. While some of the dominant plants at SP2 and SP3 are considered hydrophytic (FACW, FAC), the overall vegetation assemblage was dominated by typical upland species (FACU, UPL). Additionally, based on the review of aerial imagery, the lowest topographic area within the Study Area, and extending north and south into the adjacent field, likely conveys overland flow during wet years or high precipitation events, but does not appear to hold water for a long enough duration for wetland conditions to develop. Overall, despite the presence of some hydrophytic vegetation, no primary indicators of wetland hydrology or hydric soil indicators were observed at any of the sample points and no wetlands were delineated within the Study Area.
