# Dane County Rezone & Conditional Use Permit

**NARRATIVE FOR PROPOSED PUD ON BARBER ROAD  
TOWN OF DUNN  
FOR  
A CLIMATE CONTROLLED STORAGE FACILITY  
AND  
A SINGLE FAMILY HOME**

## BARBER DRIVE CLIMATE CONTROLLED STORAGE

Town of Dunn Storage Lockers

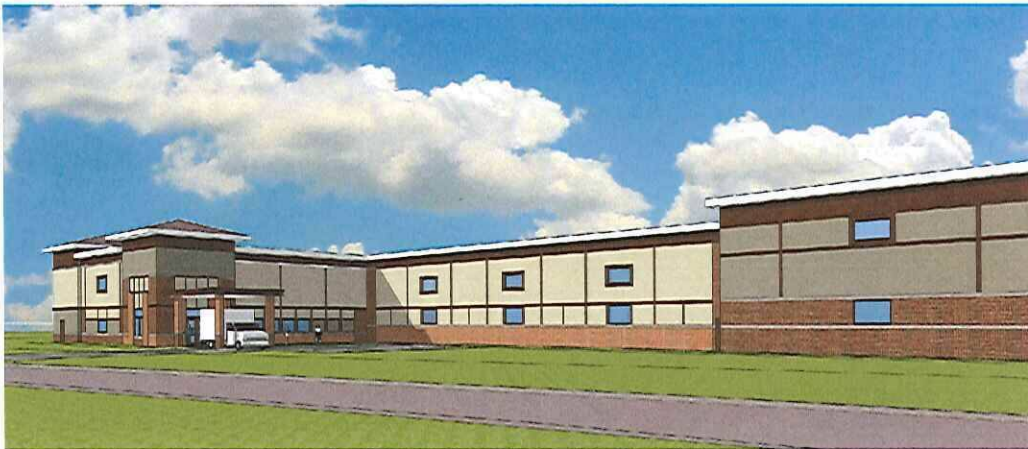
① Exterior View to SW  
1/8" = 1' = 0"

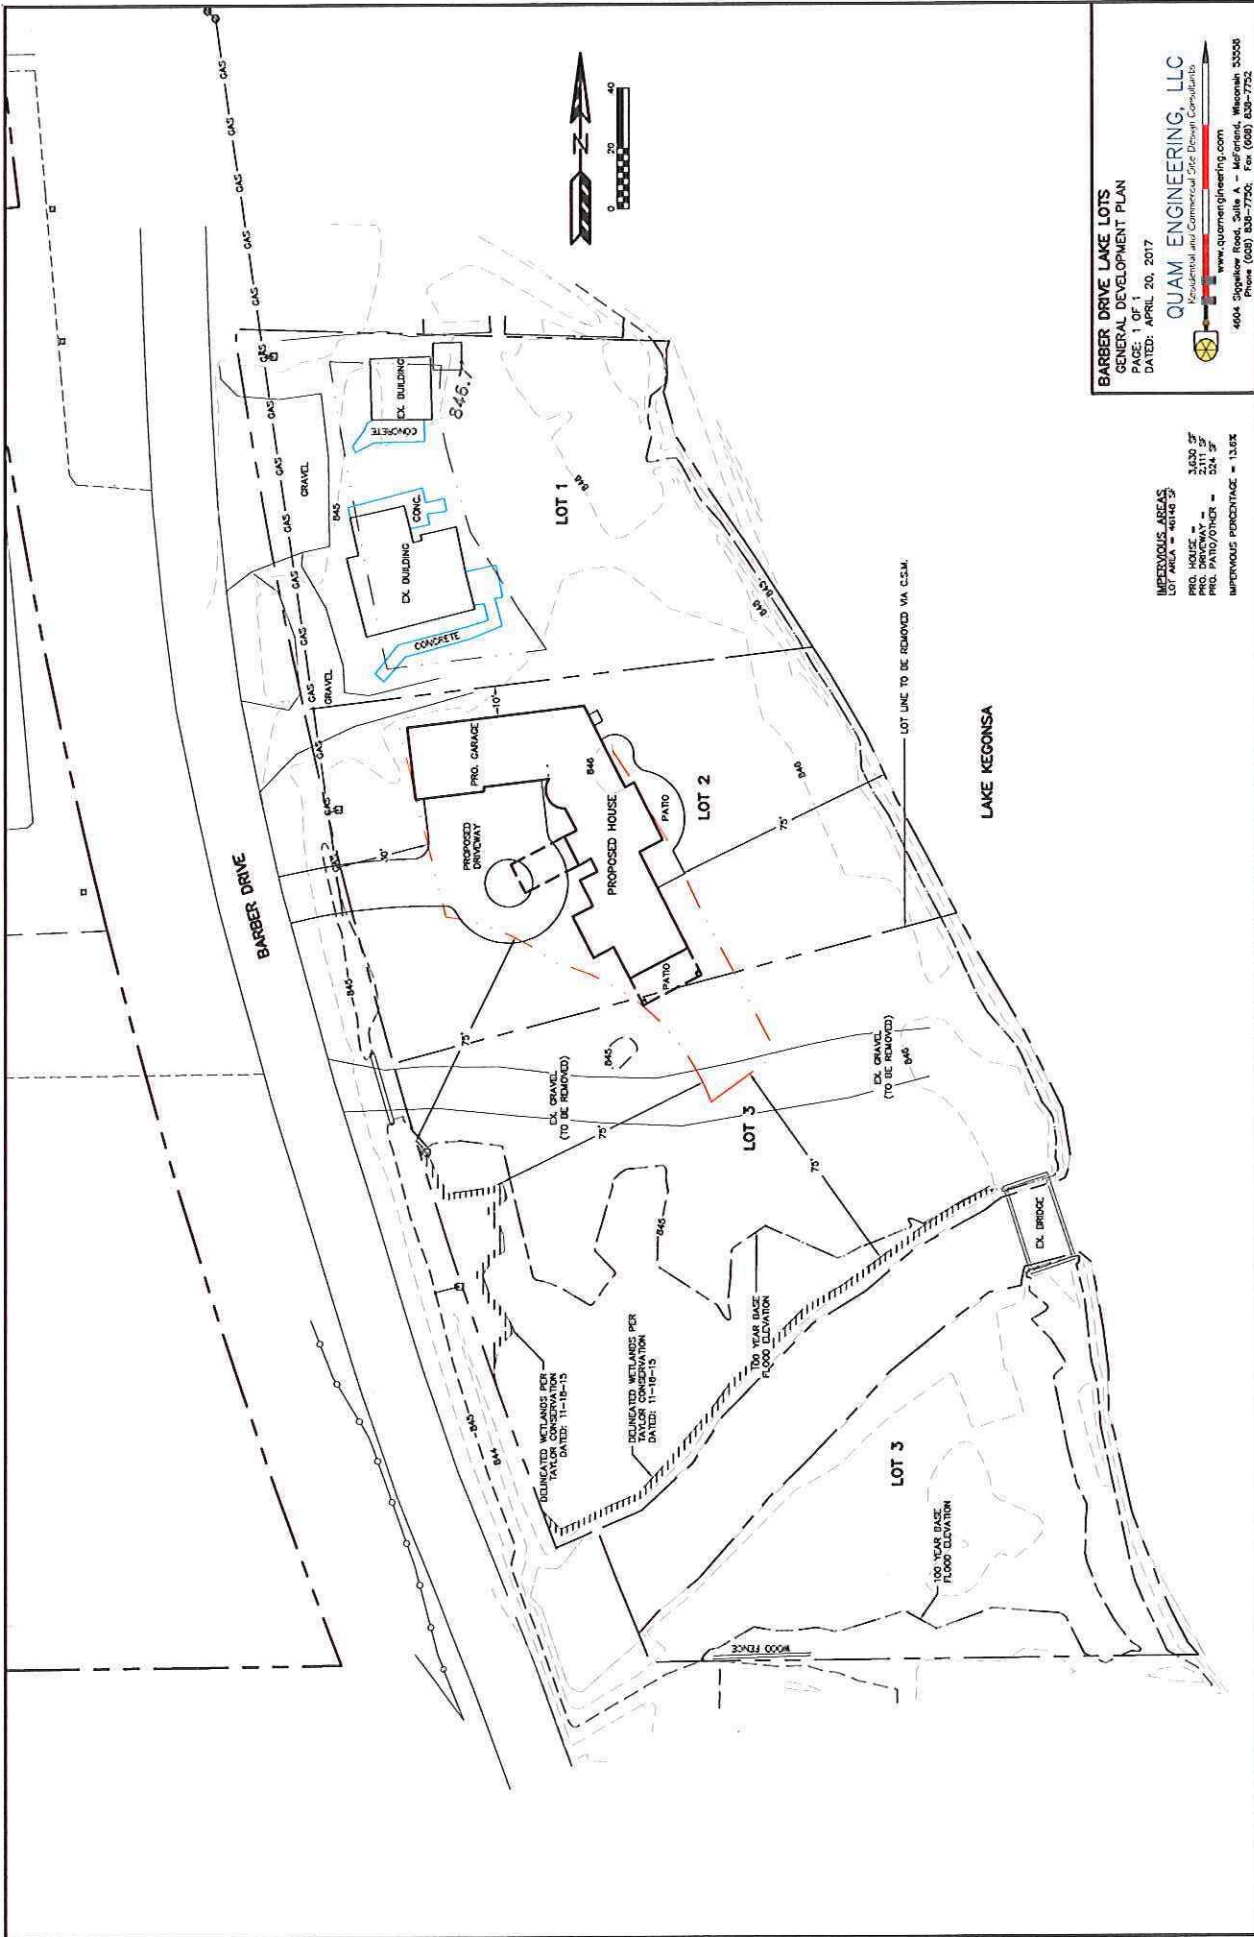
**BARBER DRIVE LAKE LOTS**  
 GENERAL DEVELOPMENT PLAN  
 PAGE 1 OF 1  
 DATED: APRIL 20, 2017

**IMPERVIOUS AREAS**  
 LOT AREA = 40143 SF  
 PRO. HOUSE = 3620 SF  
 PRO. DRIVEWAY = 2111 SF  
 PRO. PATIO/OTHER = 524 SF  
 IMPERVIOUS PERCENTAGE = 13.0%

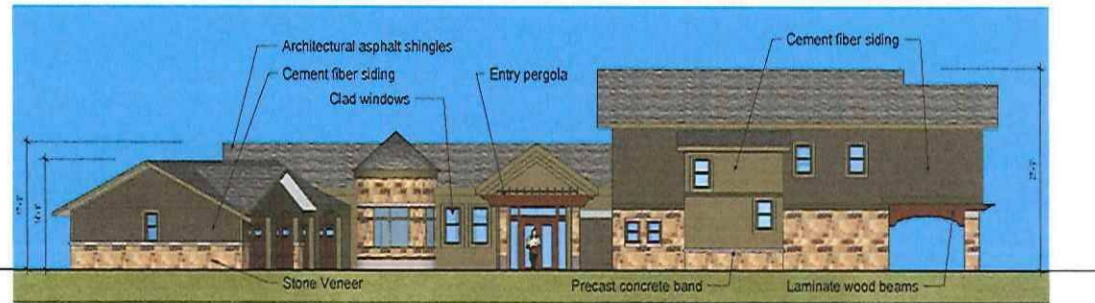
2 Elevation Front  
1/8" = 1'-0" ON 22x34 HALF SCALE ON 11x17

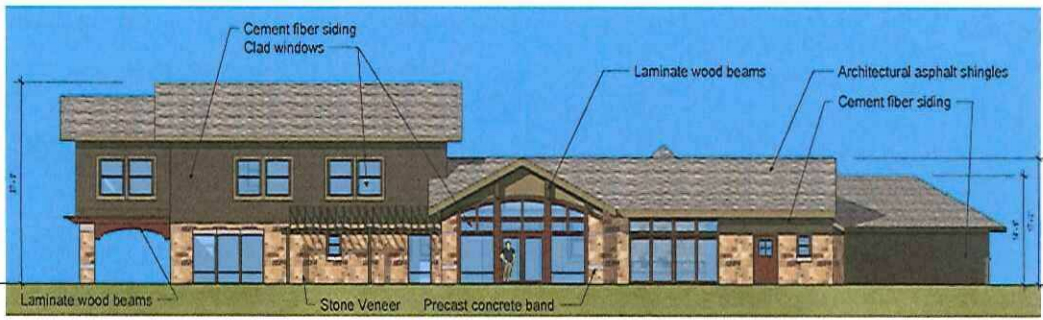
1 Elevation Lakeside  
1/8" = 1'-0" ON 22x34 HALF SCALE ON 11x17

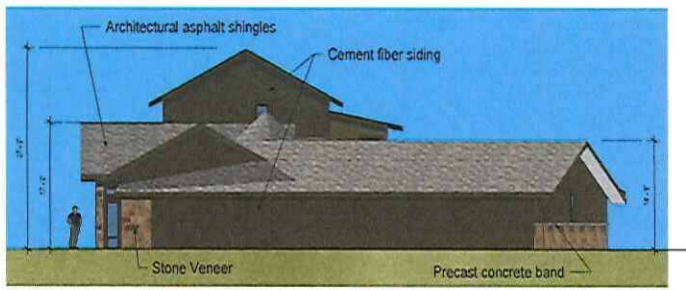
3 Elevation North End  
1/8" = 1'-0" ON 22x34 HALF SCALE ON 11x17

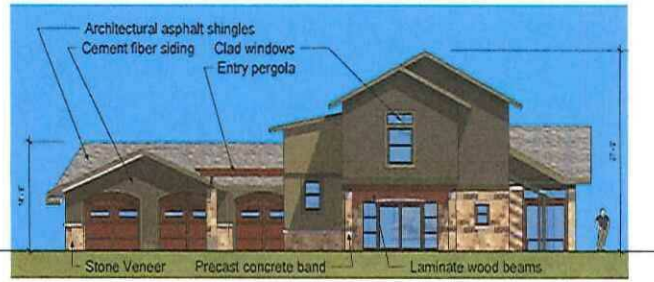
4 Elevation South End  
1/8" = 1'-0" ON 22x34 HALF SCALE ON 11x17

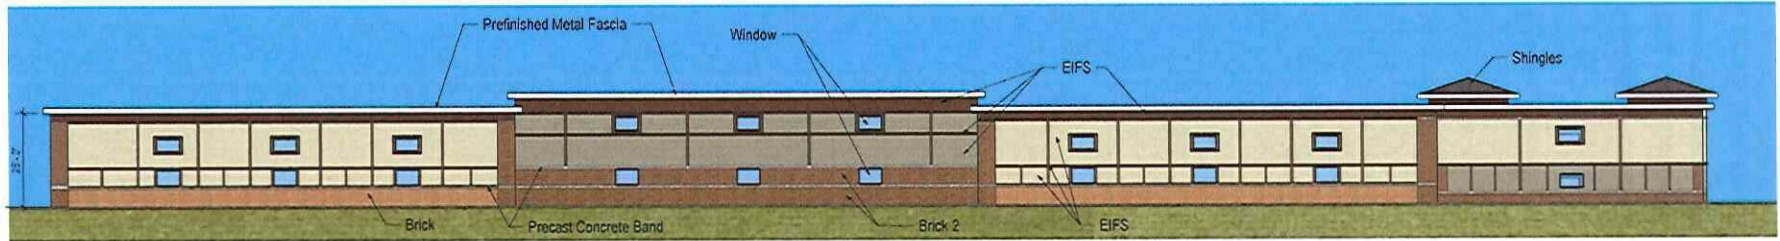
④ Elevation West (Back)  
1/8" = 1'-0"

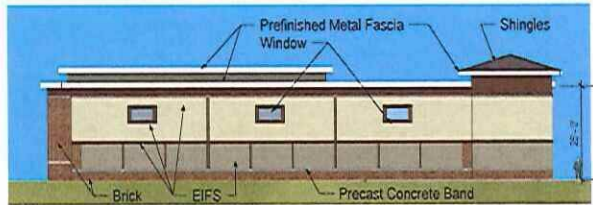
② Elevation South  
1/8" = 1'-0"

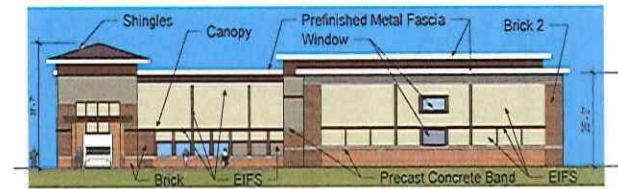
③ Elevation North  
1/8" = 1'-0"

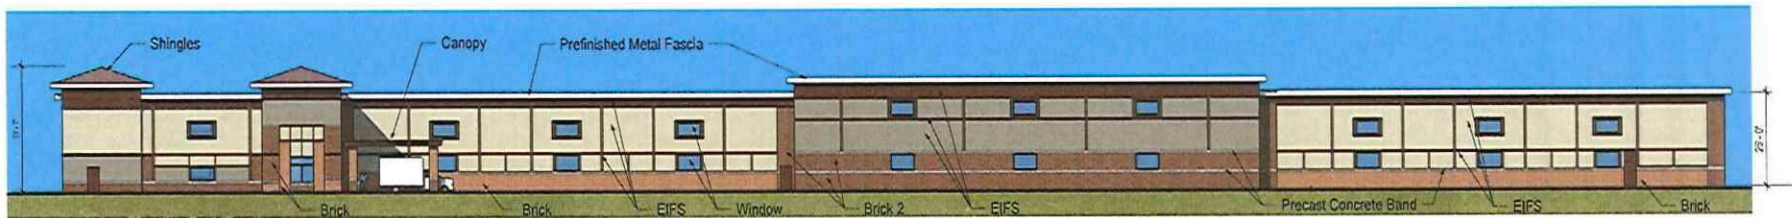
① Elevation East (Front)  
1/8" = 1'-0"

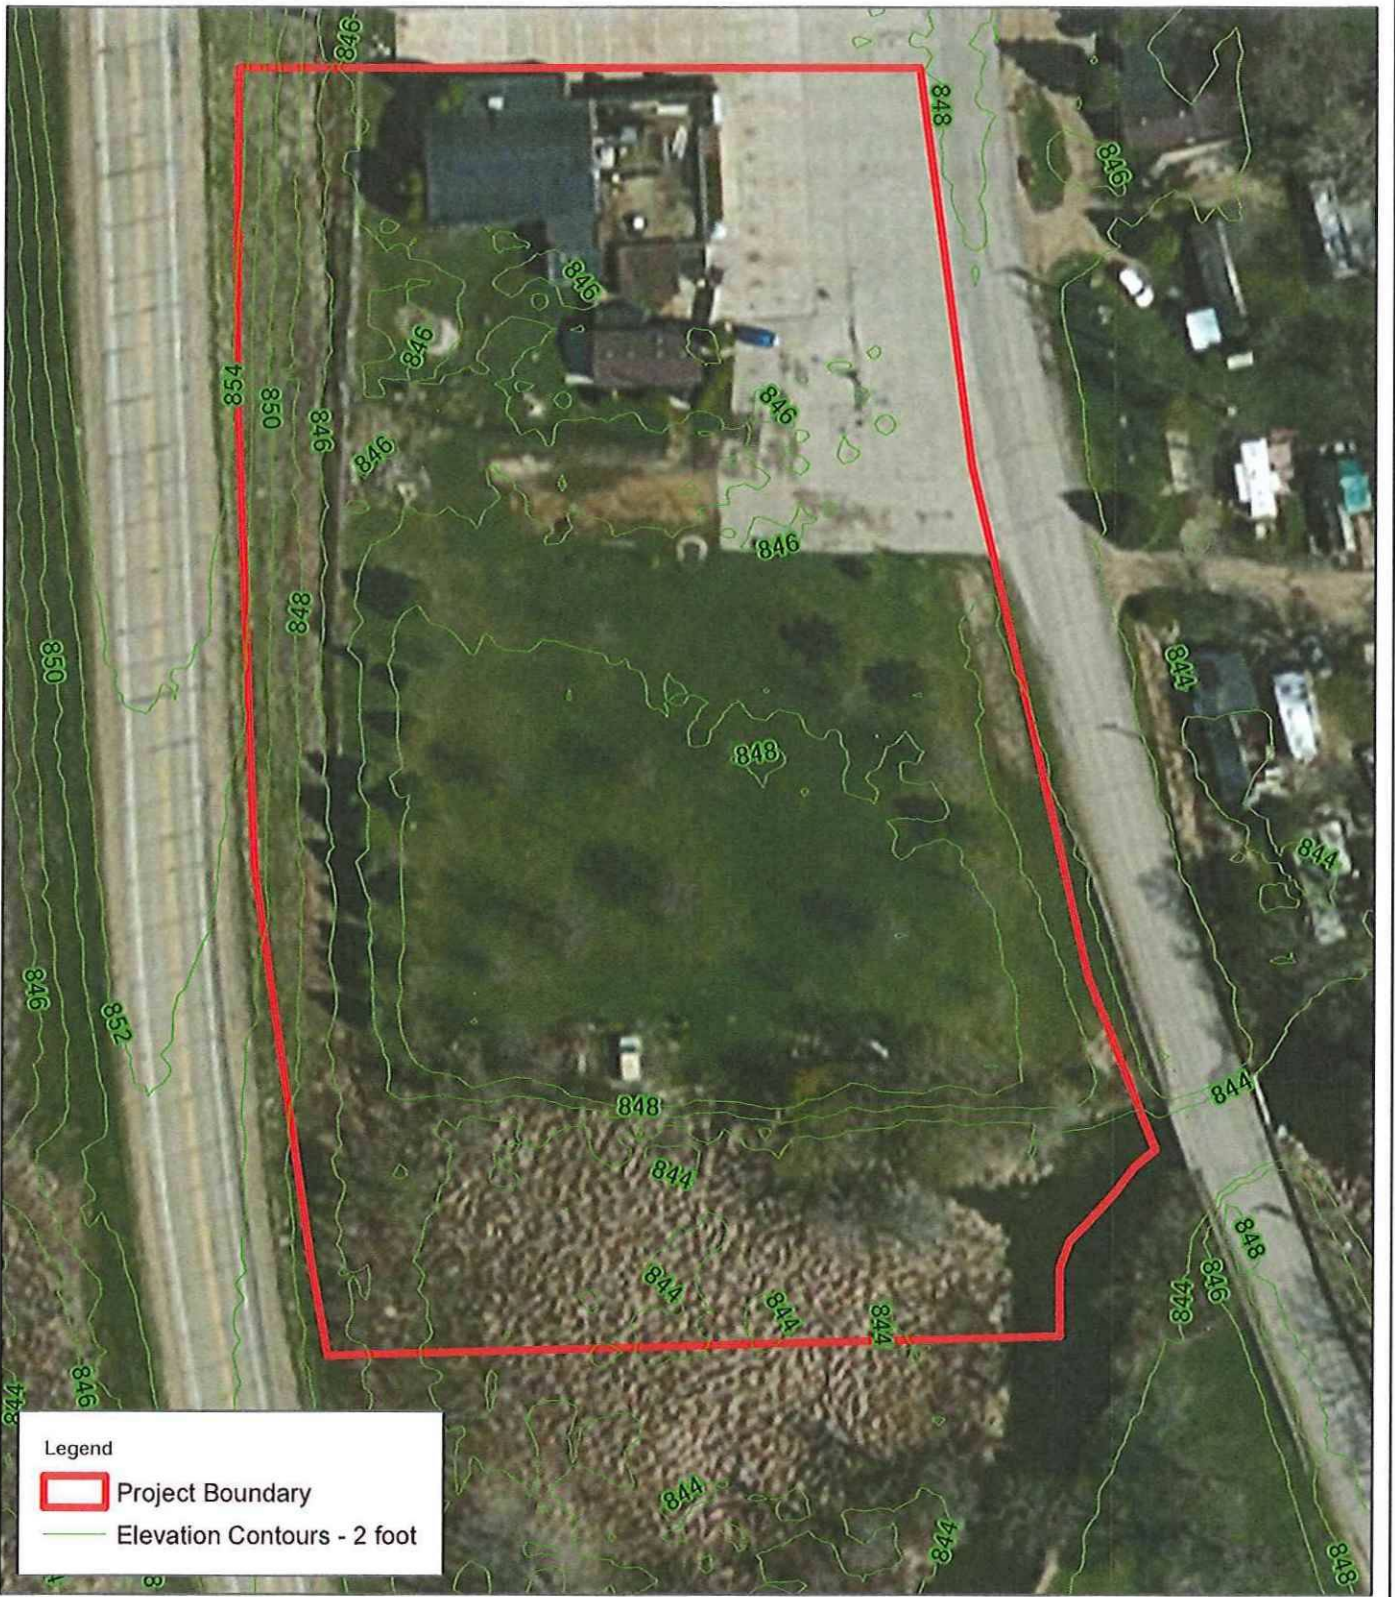
**FIGURE 2**

**Topographic Map**

- Project Boundary
- Elevation Contours - 2 foot

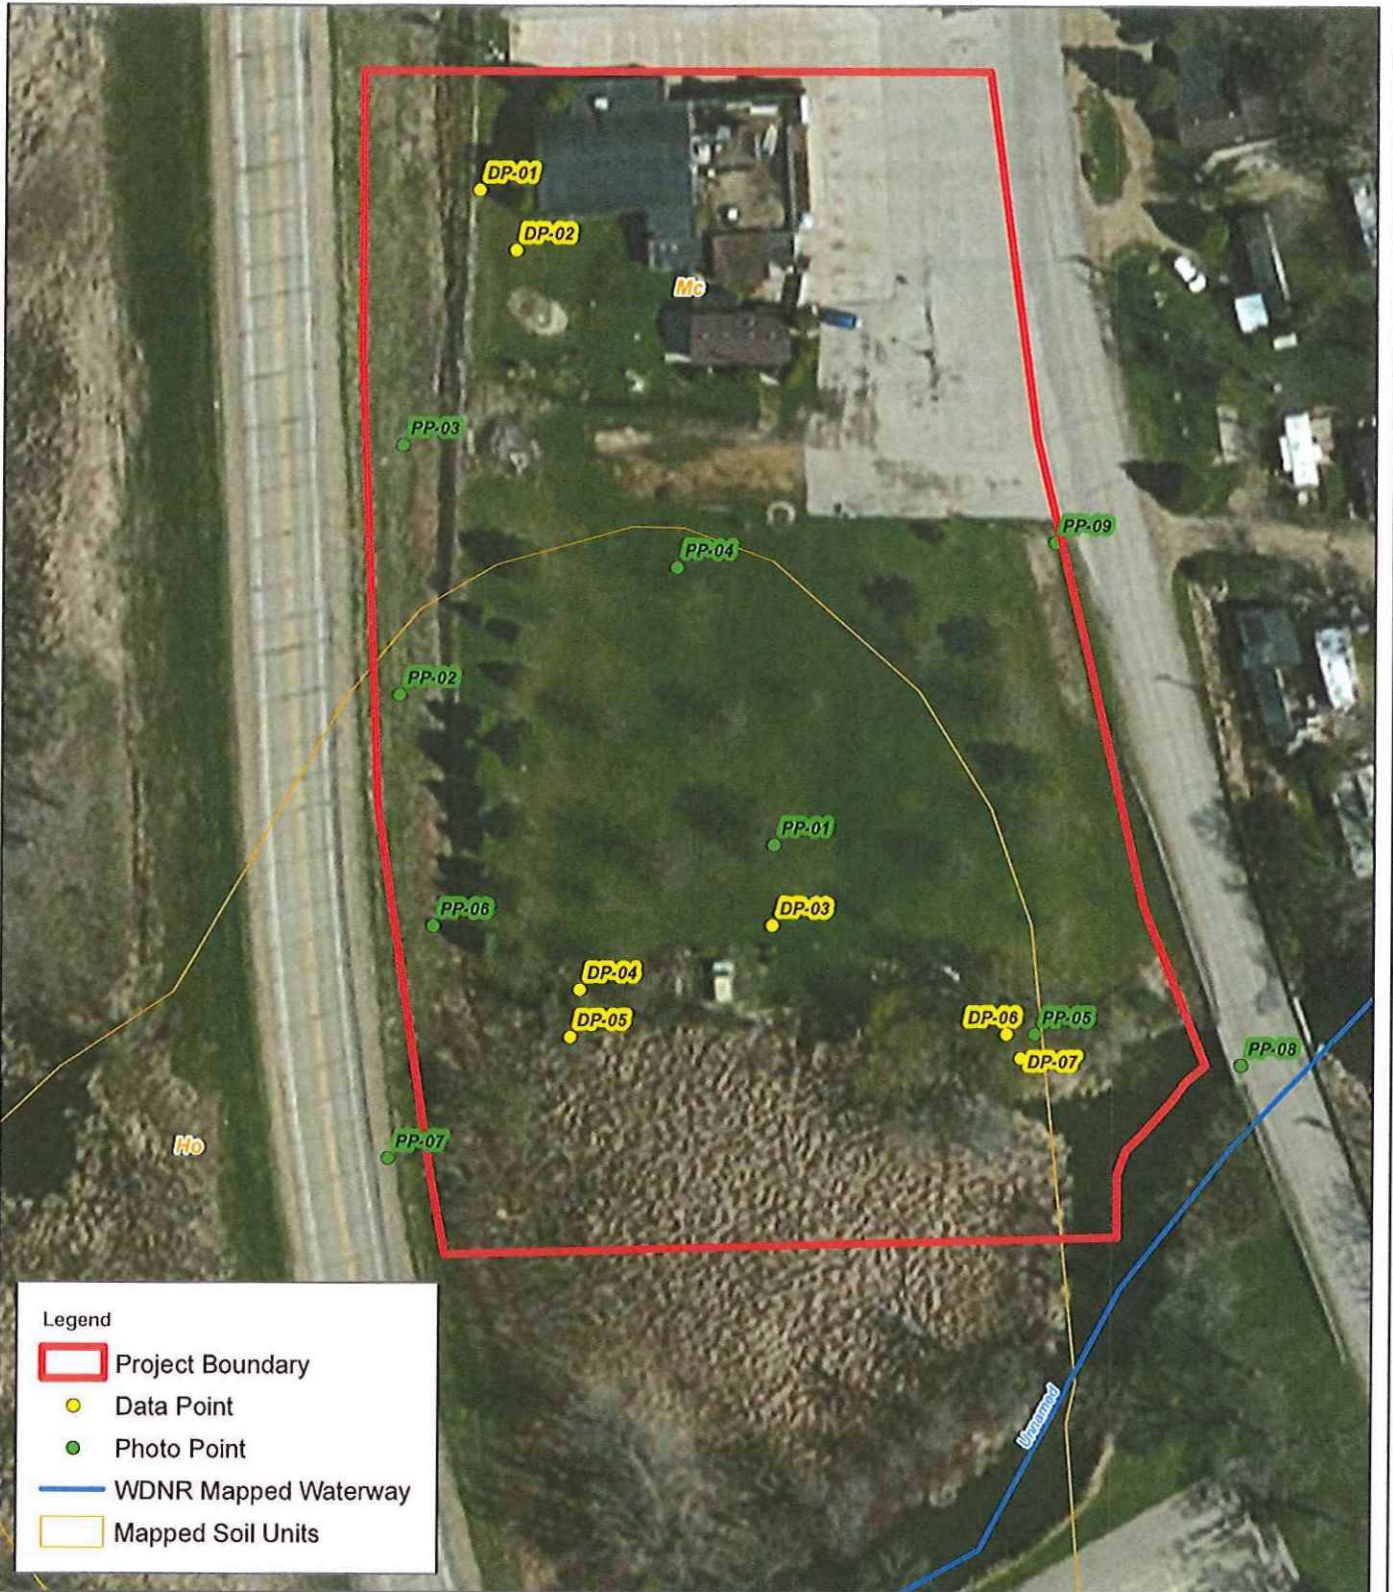
**FIGURE 3**

**Mapped Soil Units**

- Project Boundary
- Data Point
- Photo Point
- WDNR Mapped Waterway
- Mapped Soil Units

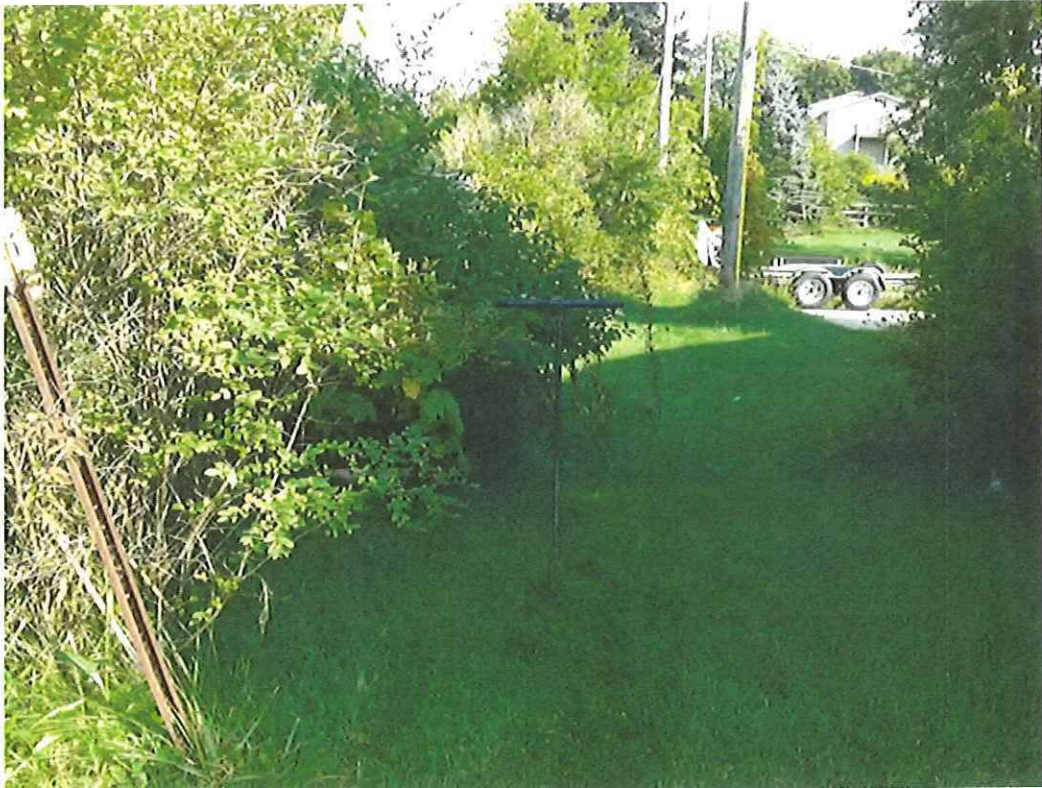
Photograph DP-01; Photograph facing north.

The Project Area contained areas that exhibited significantly disturbed conditions. Data Points DP-01, DP-02, and DP-03 where taken in manicured lawn that had been recently mowed. Although the vegetation was still able to be identified it should be considered significantly disturbed. The soil in DP-04 should also be considered significantly disturbed. This soil profile was entirely gravel fill which made it impossible to examine the field indicators of hydric soils.

WETS analysis determined that the antecedent precipitation conditions were wetter than normal. The sample point was located in a manicured lawn that had been recently mowed, although the vegetation was still able to be identified it should be considered significantly disturbed.

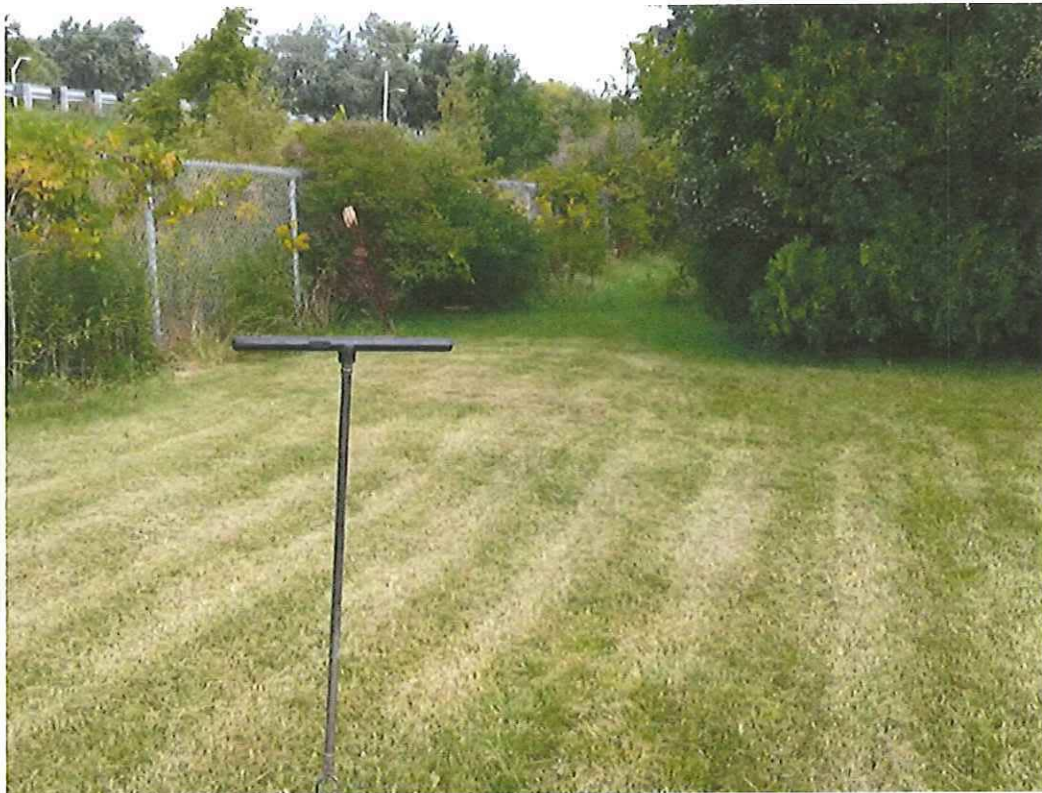
Photograph DP-02; Photograph facing north.

Describe Recorded Data (stream gauge, monitoring well, aerial photos, previous inspections), if available:  		
Remarks: No evidence of wetland hydrology was observed at the sample plot.

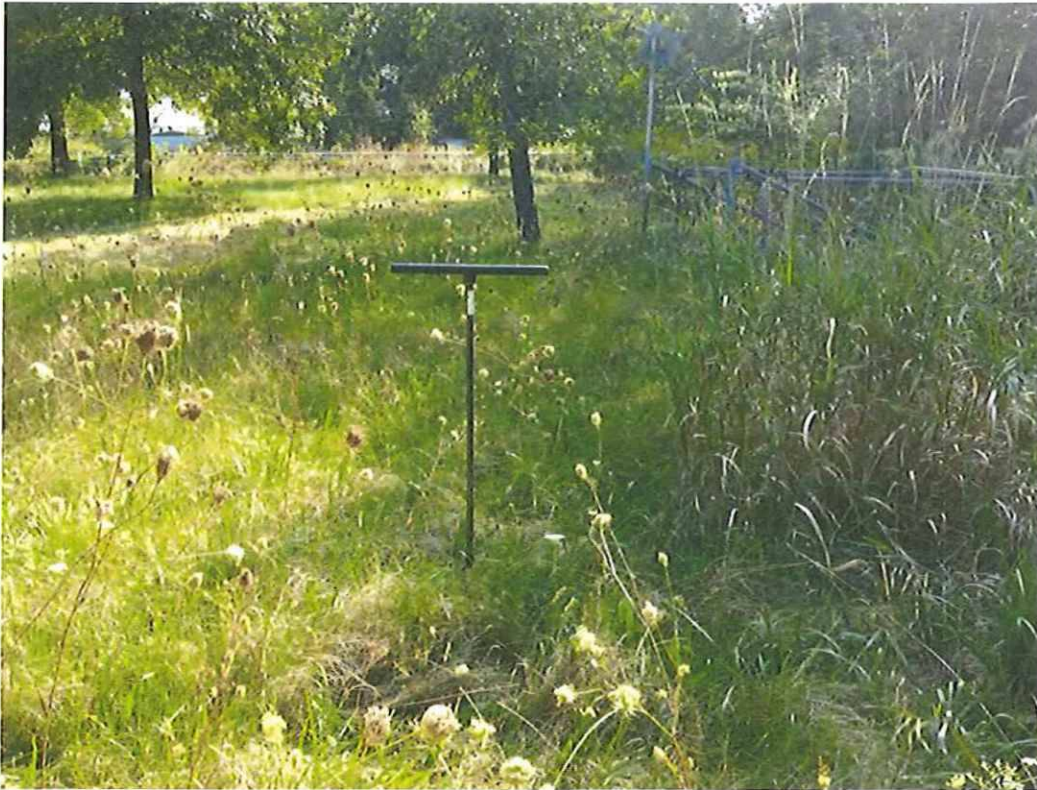
Photograph DP-03; Photograph facing east.

Hydrophytic Vegetation Present?	Yes <u>X</u>	No <u>    </u>	Is the Sampled Area within a Wetland? Yes <u>    </u> No <u>X</u> If yes, optional Wetland Site ID: <u>    </u>
Hydric Soil Present?	Yes <u>    </u>	No <u>X</u>	
Wetland Hydrology Present?	Yes <u>    </u>	No <u>X</u>	
Remarks: (Explain alternative procedures here or in a separate report.) WETS analysis determined that the antecedent precipitation conditions were wetter than normal. The sample point was located in a manicured lawn that had been recently mowed, although the vegetation was still able to be identified it should be considered significantly disturbed. According to the Army Corps of Engineers NC/NE Supplement, three parameters are required to meet jurisdictional wetland requirements. Although hydrophytic vegetation is present at the sample plot, the lack of hydric soils and wetland hydrology indicate the sample plot is none wetland.

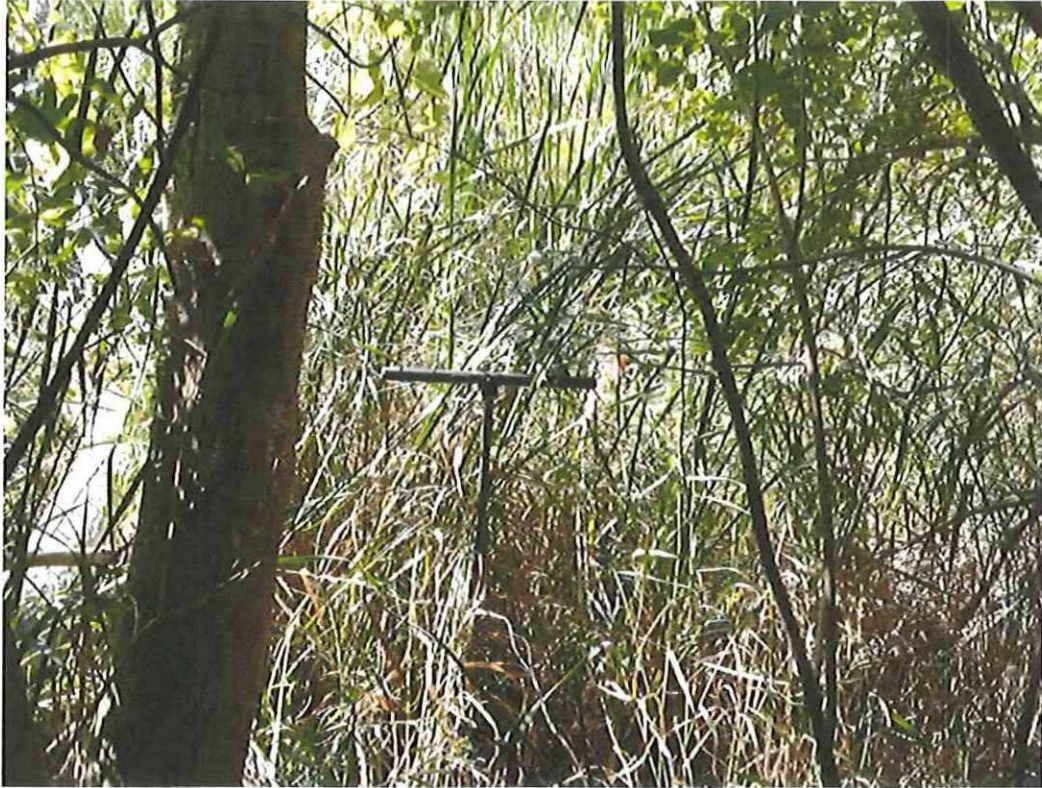
Photograph DP-05; Photograph facing south.

Depth (inches)	Matrix		Redox Features				Texture	Remarks
	Color (moist)	%	Color (moist)	%	Type <sup>1</sup>	Loc <sup>2</sup>		
0-14"	10YR 2/2						Muck	
14-18"	10YR 3/1	95	10YR 5/8	5	C	M	Silt	
18-24"	10YR 4/1	100					Loamy Sand

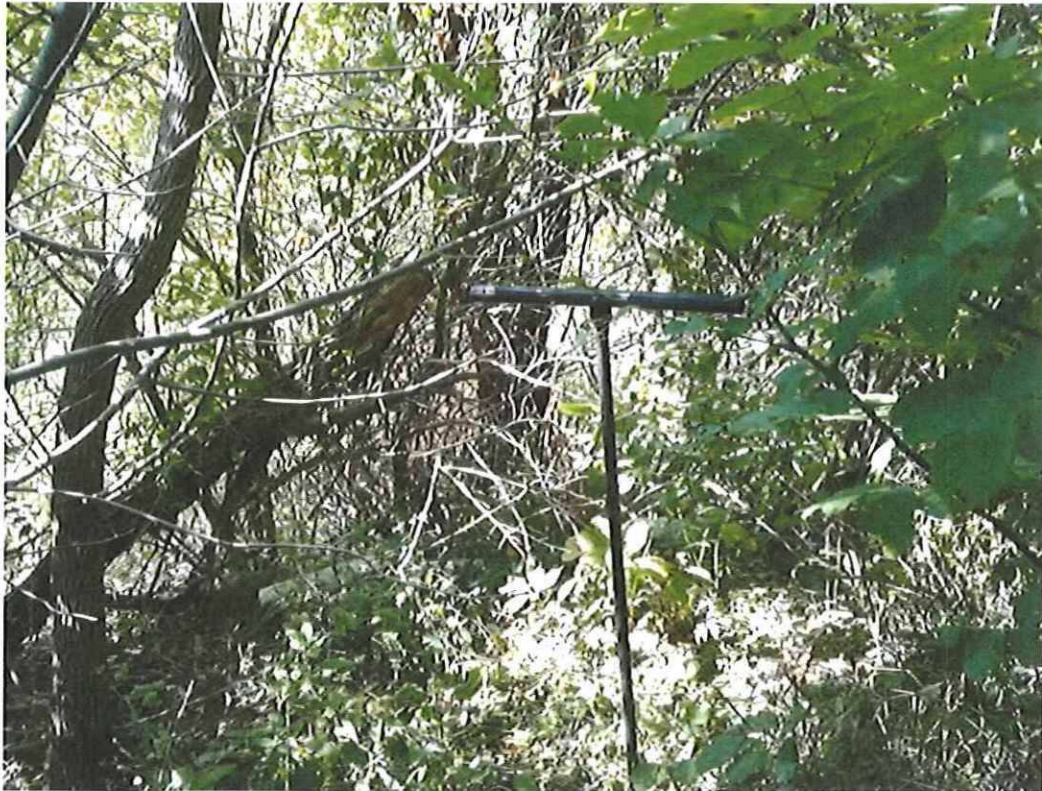
Photograph DP-06; Photograph facing south.

Remarks:  
 No evidence of wetland hydrology was observed at the sample plot.

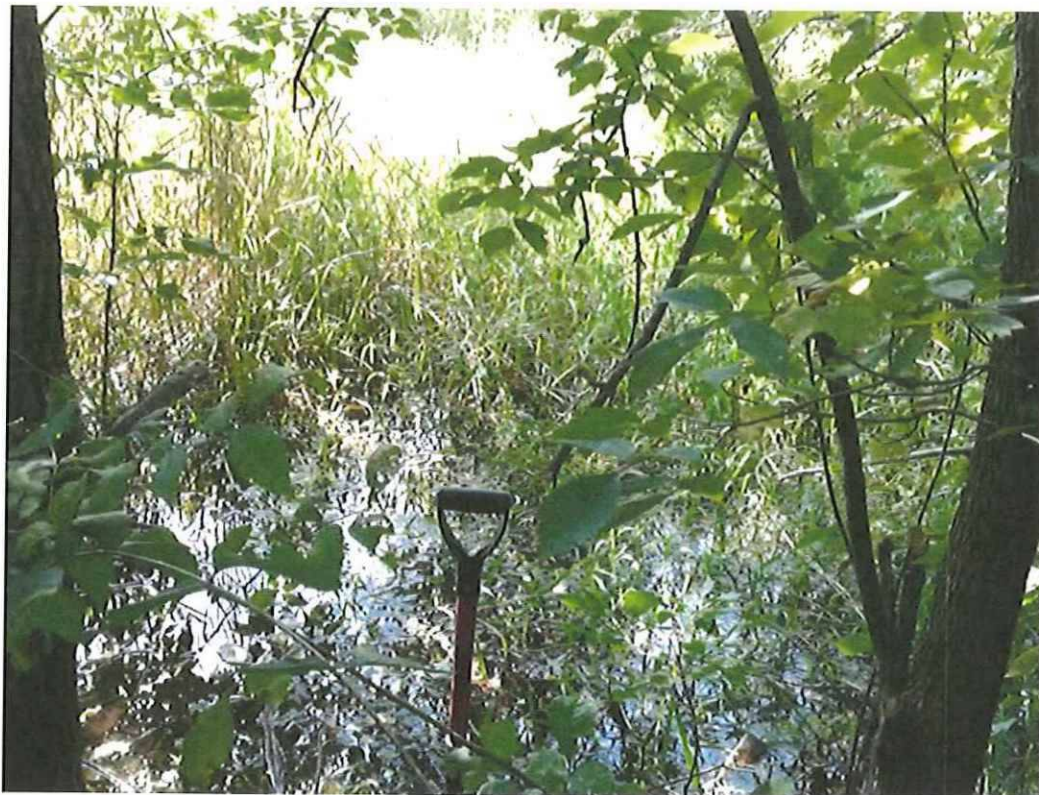
Photograph DP-07; Photograph facing south.

Depth (inches)	Matrix		Redox Features				Texture	Remarks
	Color (moist)	%	Color (moist)	%	Type <sup>1</sup>	Loc <sup>2</sup>		
0-12"	10YR 2/2	100					Mucky Loam	
12-24"	10YR 3/1	100					Silty Clay
