Town of Deerfield Comprehensive Plan

Checking the Movement of the Tombstones

Stone and Mortar Pieces Falling from the Bell Tower

Mortar Crack *Inside* the New Narthex

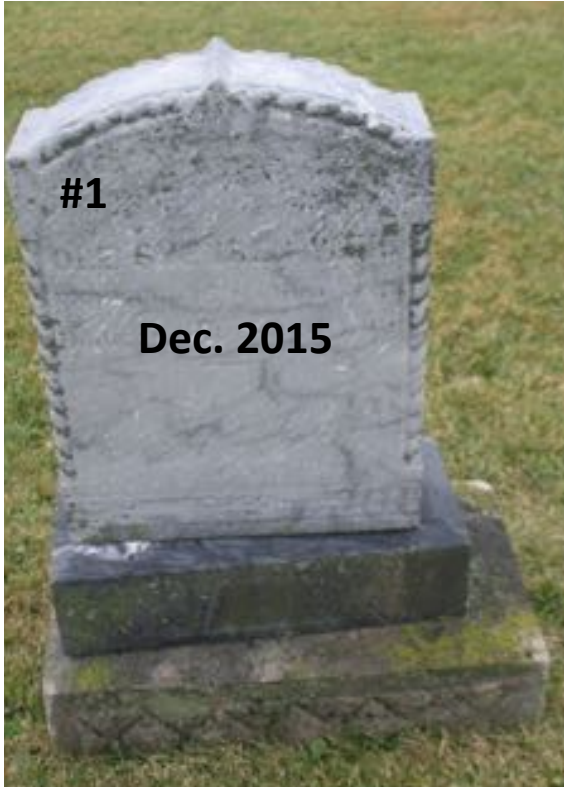
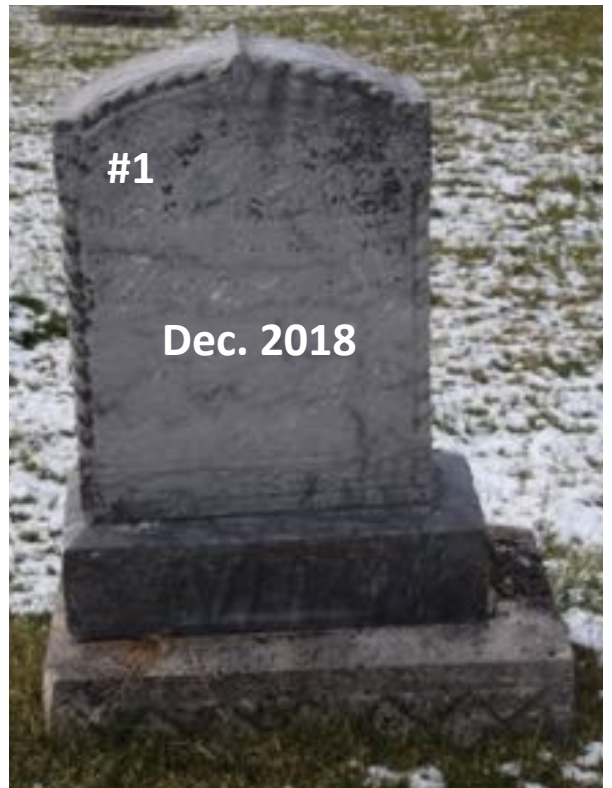
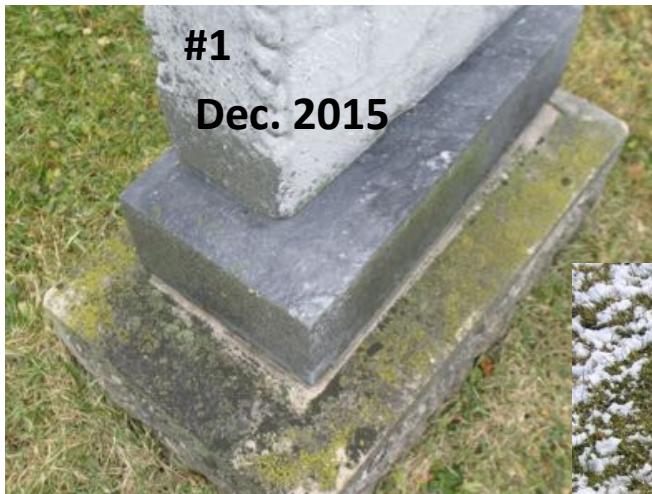
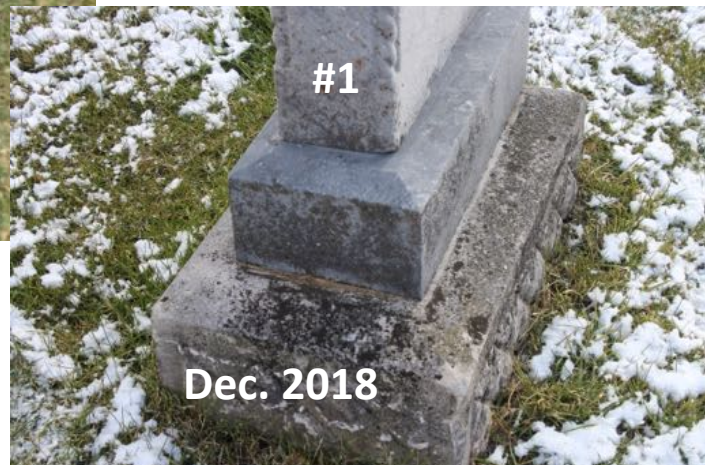
Sample Tombstone #1

Front and side views of Tombstone #1 taken in December of 2015 and then again in December of 2018.

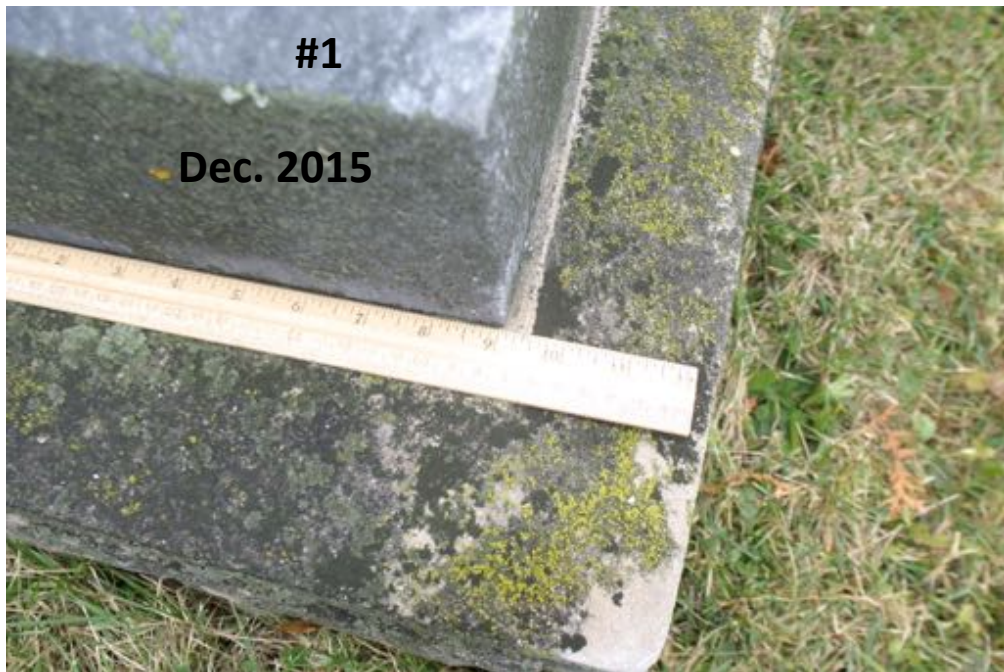
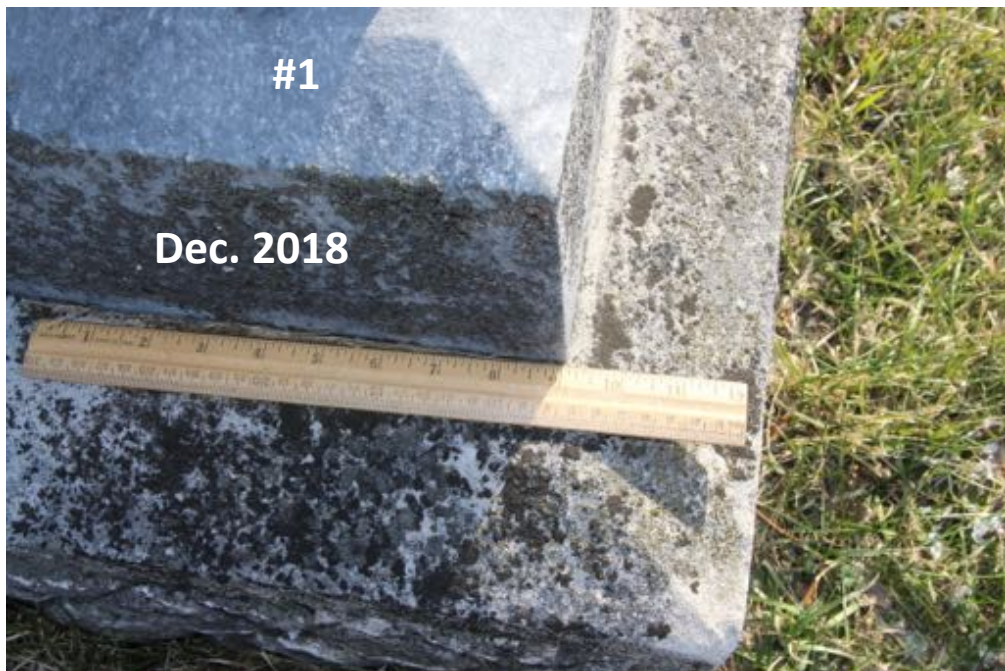
Sample Tombstone #1, cont.

Comparing the photos from 2015 and 2018, the measurement shown here illustrates that Tombstone #1 has not moved since blasting ceased in 2015.

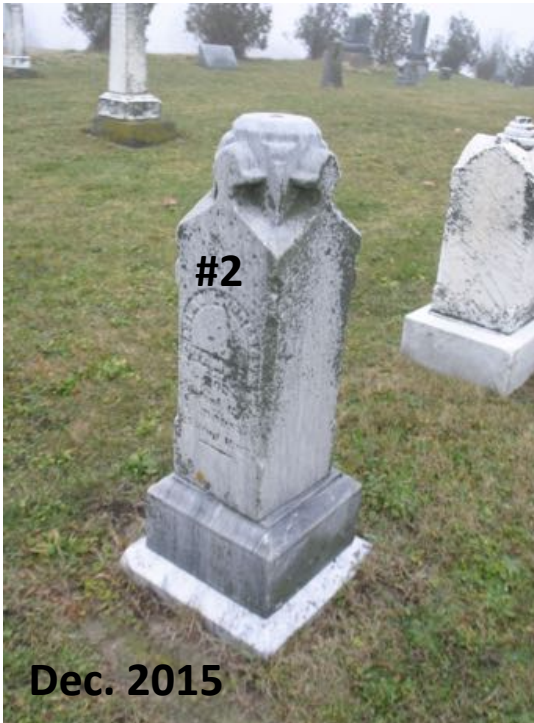
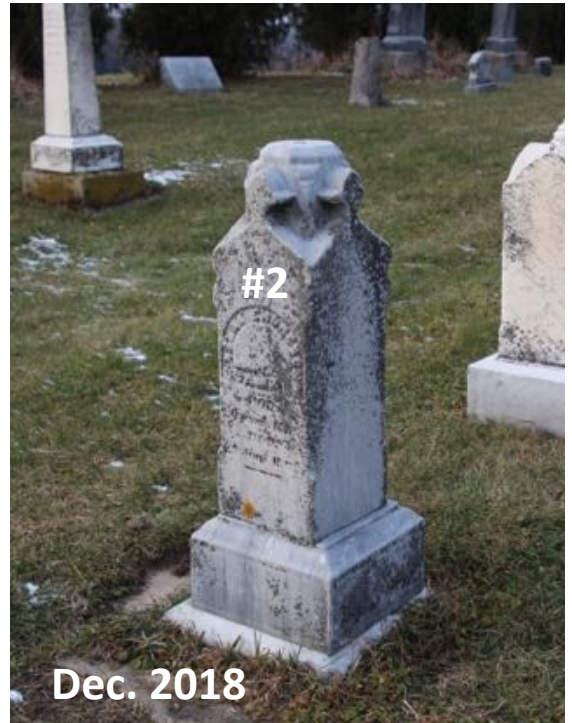
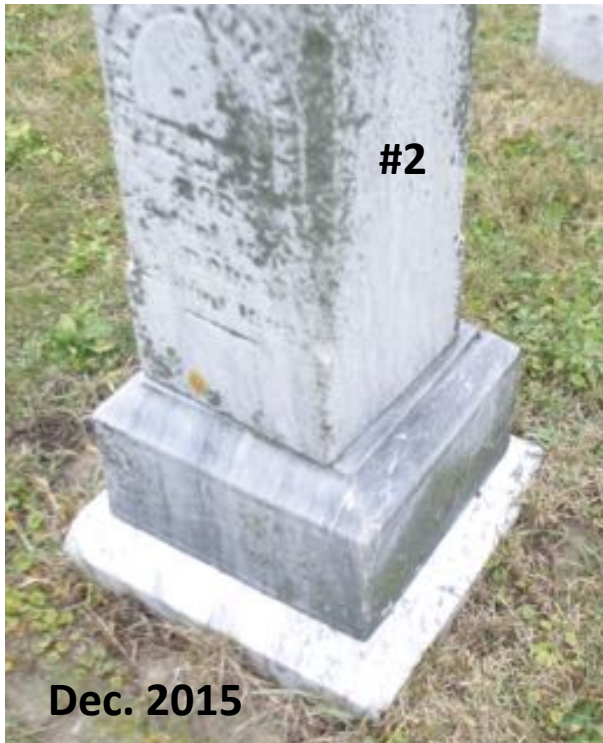
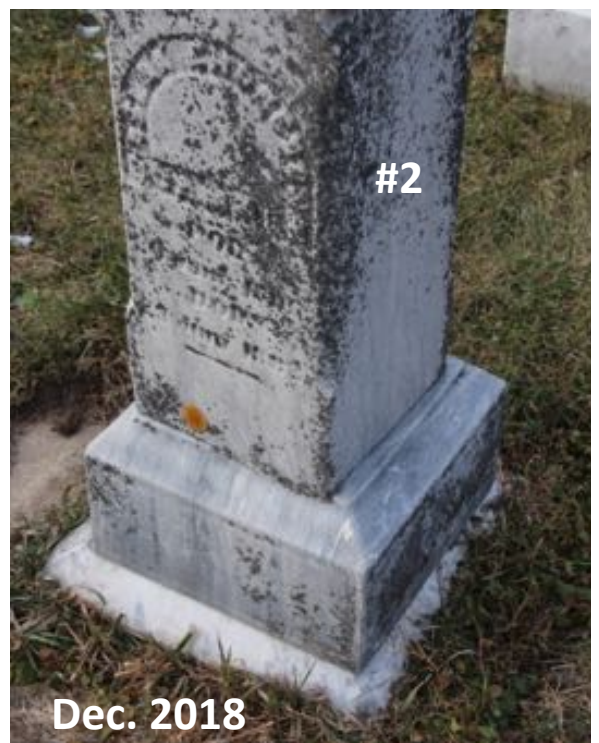
Sample Tombstone #2

Front and side views of Tombstone #2 taken in December of 2015 and then again in December of 2018.

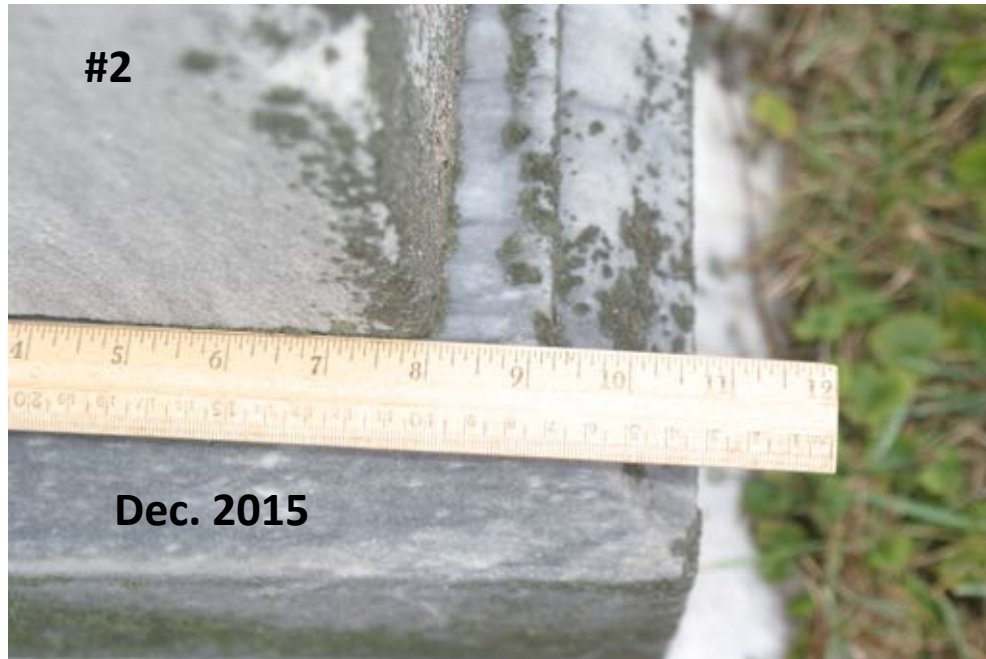
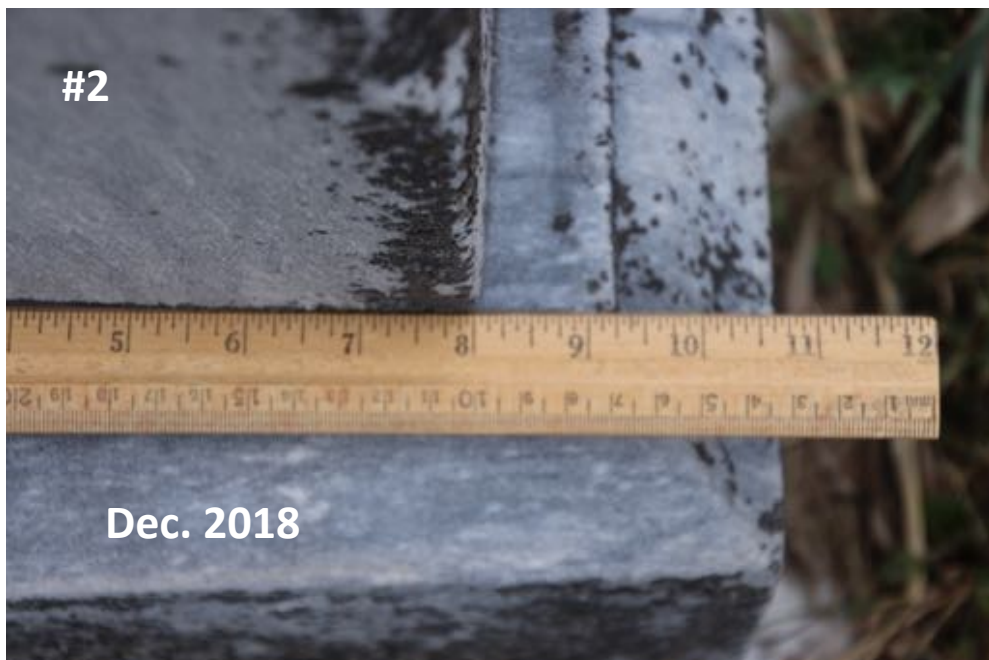
Sample Tombstone #2, cont.

Comparing the photos from 2015 and 2018, the measurement shown here illustrates that Tombstone #2 has not moved since blasting ceased in 2015.

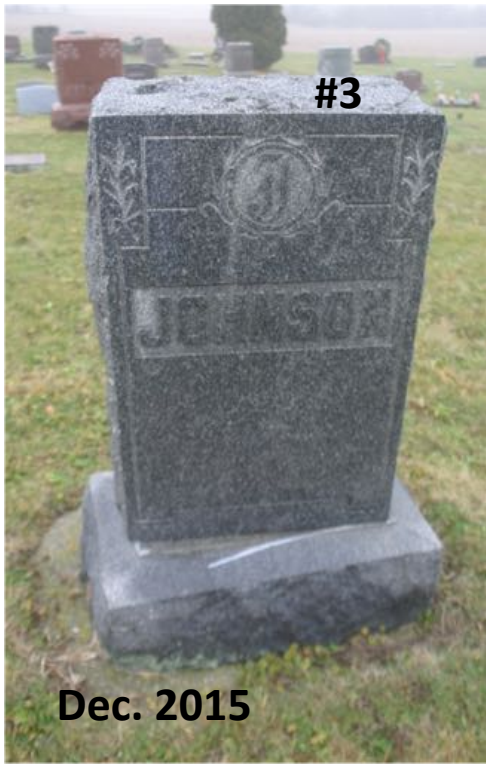
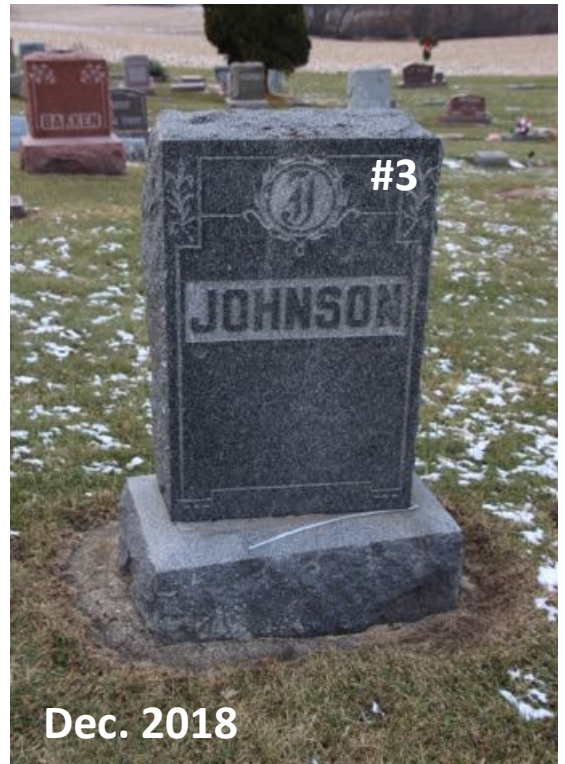
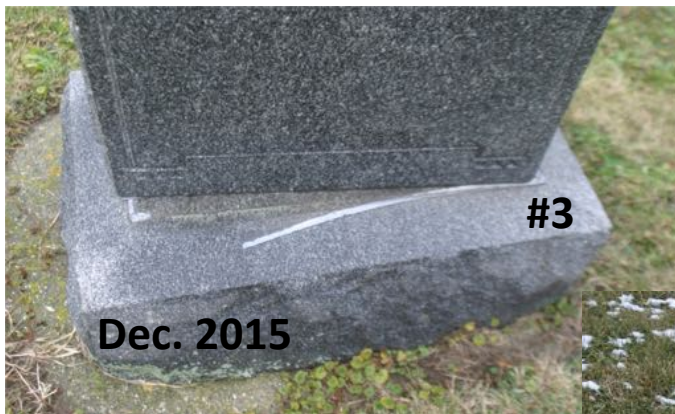
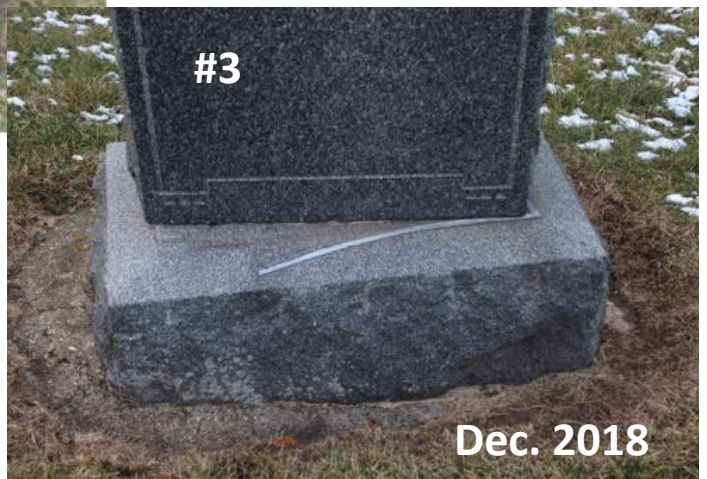
Sample Tombstone #3

Front views of Tombstone #3 taken in December of 2015 and then again in December of 2018.

The upper portion of the headstone weighs approximately 1000 lbs.

The photo taken in 2015 shows that the tombstone had shifted "uphill" from its original position.

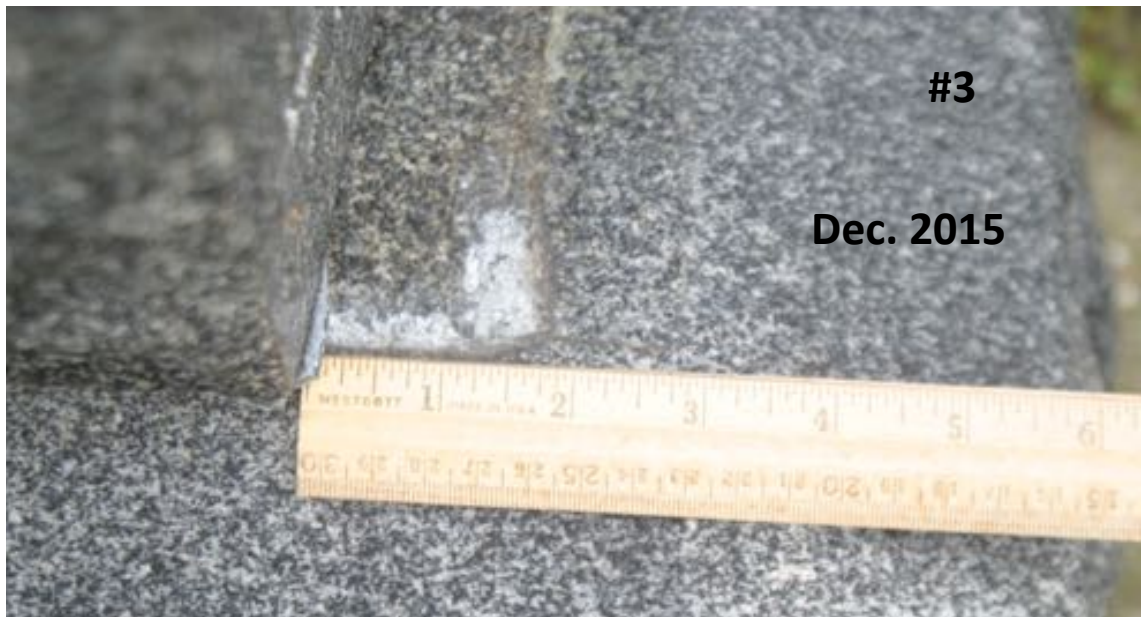
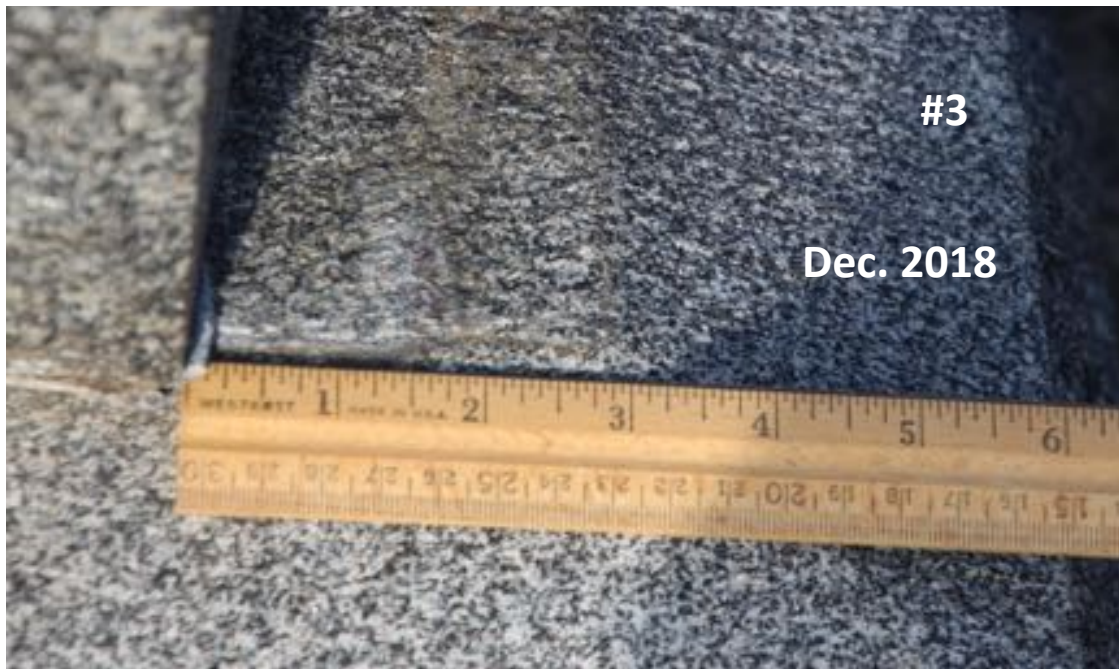
Sample Tombstone #3, cont.

Comparing the photos from 2015 and 2018, the measurement shown here illustrates that Tombstone #3 has not moved since blasting ceased in 2015.

Note that the adhesive marks visible in 2015 have been diminishing over the last three years.

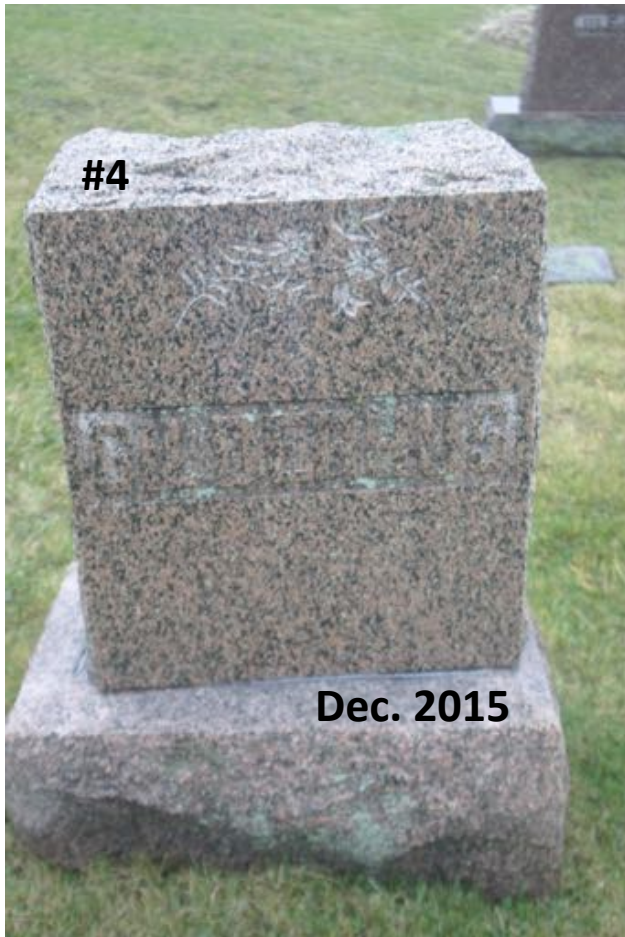
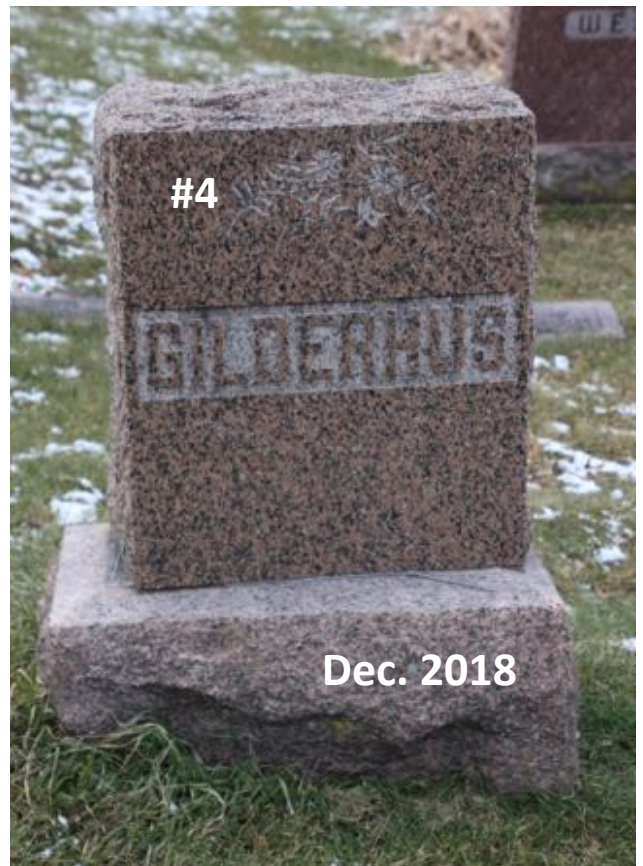
Sample Tombstone #4

Front views of Tombstone #4
(The Gilderhus Stone)
taken in December of 2015 and
then again in December of 2018.

The upper portion of the
headstone weighs
approximately 650 lbs.

The photo taken in 2015
shows that the tombstone
had shifted "uphill" from its
original position.

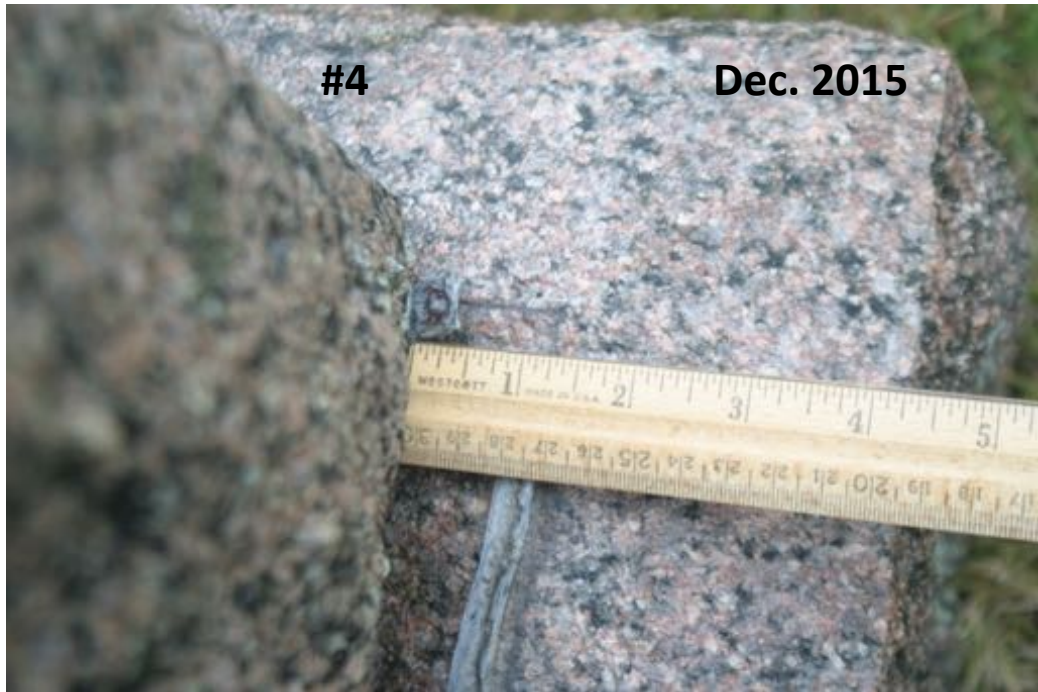
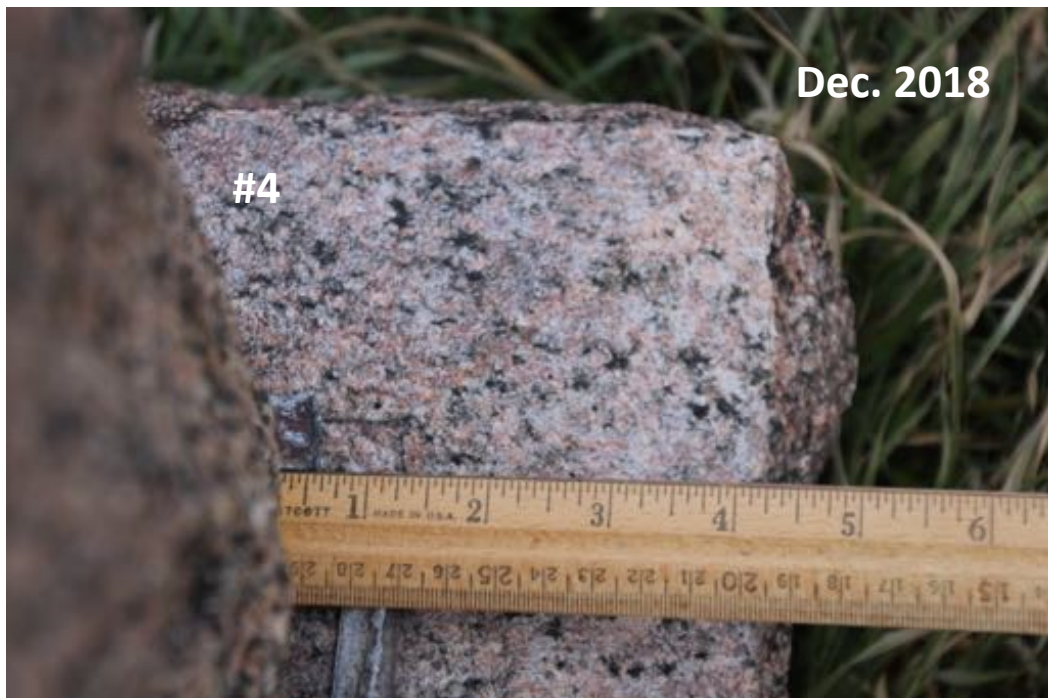
Sample Tombstone #4, cont.

Comparing the photos from 2015 and 2018, the measurement shown here illustrates that Tombstone #4 has not moved since blasting ceased in 2015.

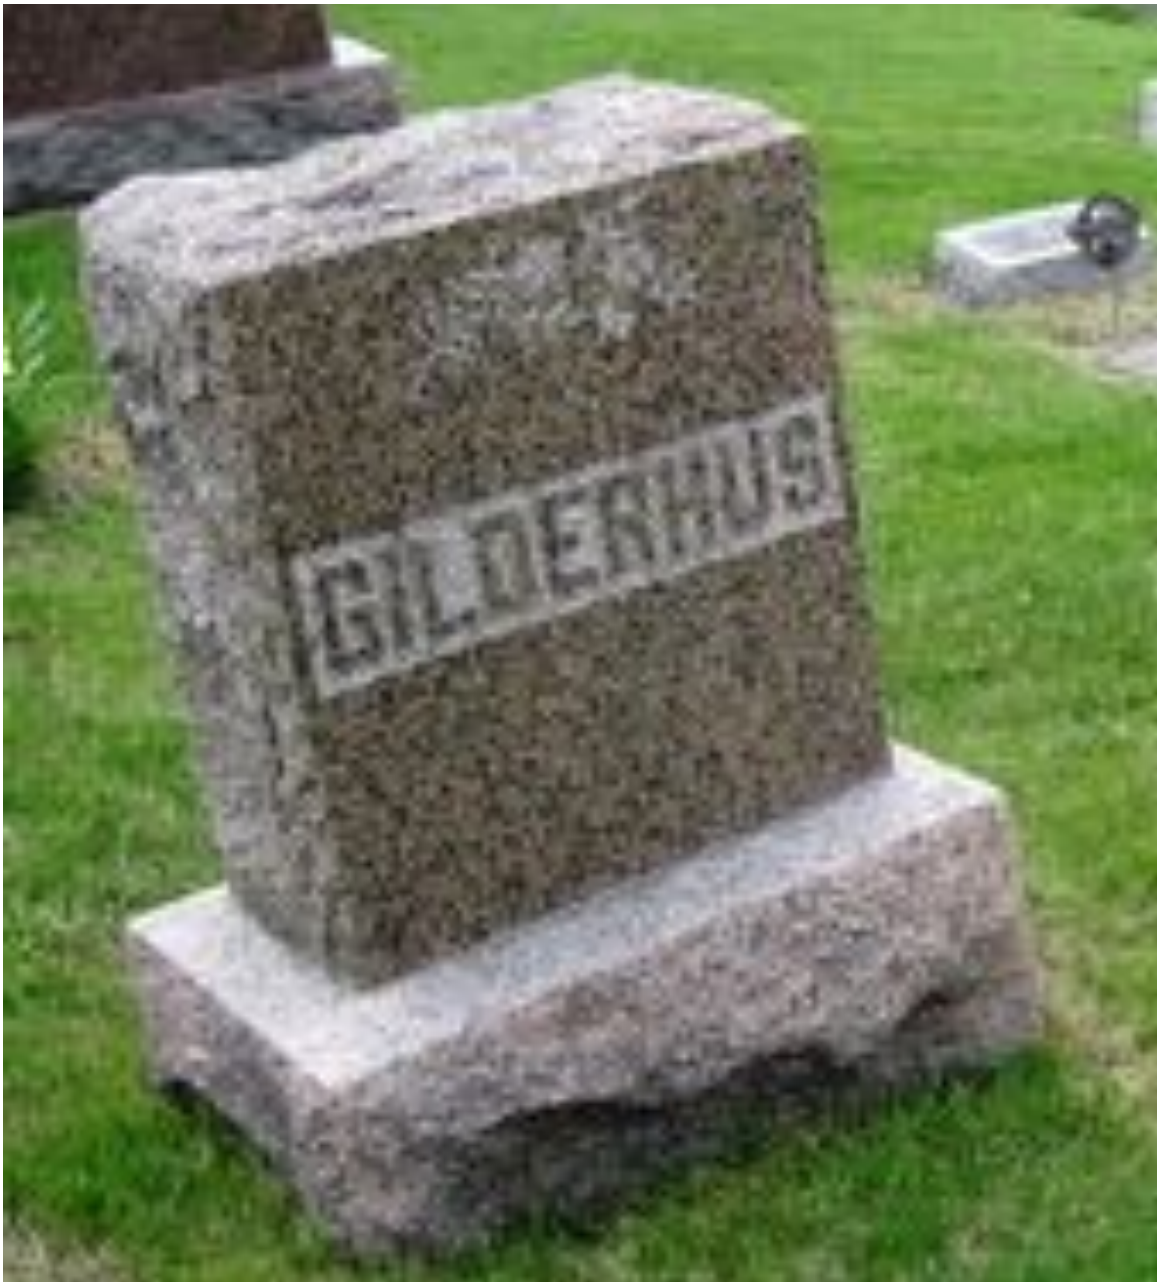
**Close-Up View of the Gilderhus Stone
(photo from “Find a Grave” website)**

The 2011 photo shows that the upper portion of the Gilderhus stone is still in its original position after 80+ years.

Therefore, the “uphill” shifting of the upper portion took place between 2011 and 2015, when blasting was a regular event

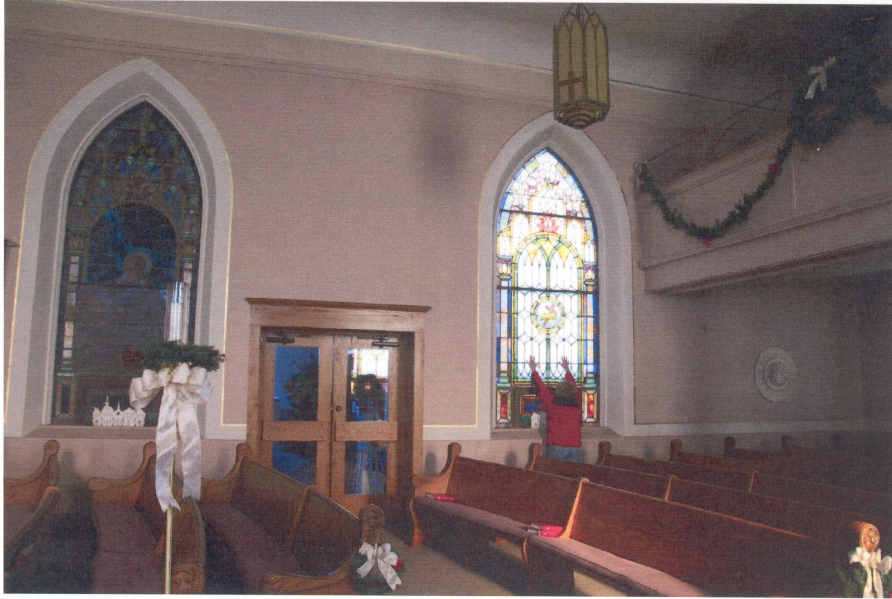
The first time was in late Summer of 2015. I was inside the sanctuary of the church, touching the large stained glass window on the north side in order to sense the response of the window (see Photo 1 attached to this letter). During the blast, I could feel the vibrations of the window, but I also heard cracking of the plaster and/or windows on the south side of the sanctuary.

Photo 1. Engelstad at the large stained glass window on the north side of the sanctuary.

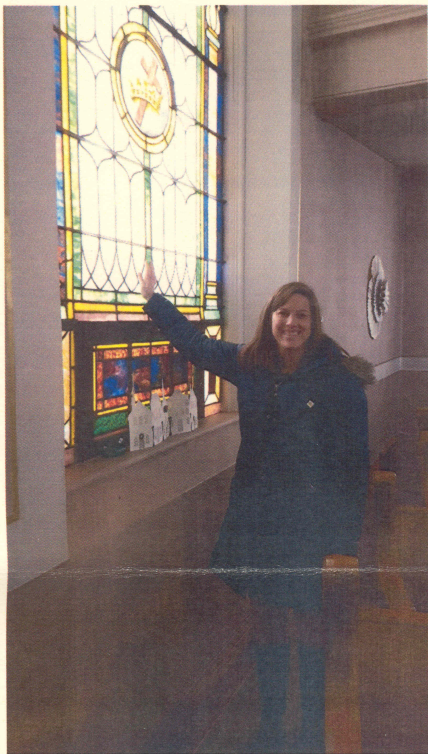
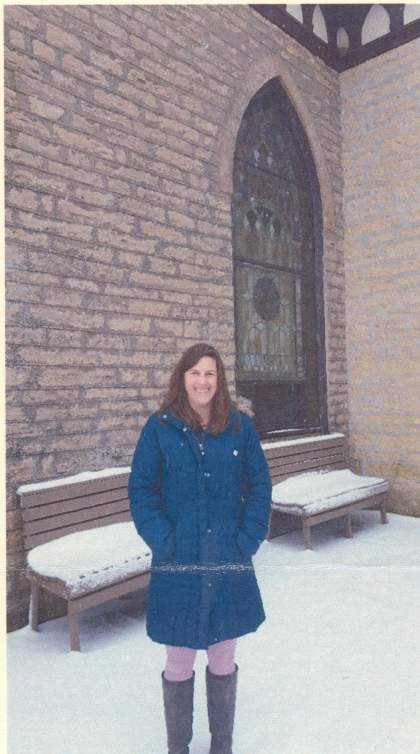
In August 2015, I stood inside the sanctuary touching the stained glass window on the northeast side during a blasting event. When I heard and felt the blast I felt movement in the stained glass and heard cracking in and around the stained glass. I was standing in the same place as the left picture.

Later that week in August 2015, I stood outside the church on the northeast side of the sanctuary. I was in the alcove. During the blasting event I heard and felt the blast and then I felt the overpressure shortly thereafter. I was standing in the same place as the right picture.

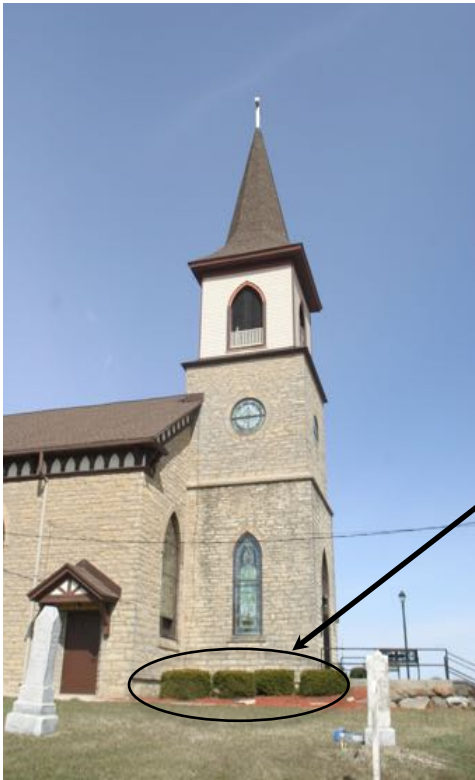
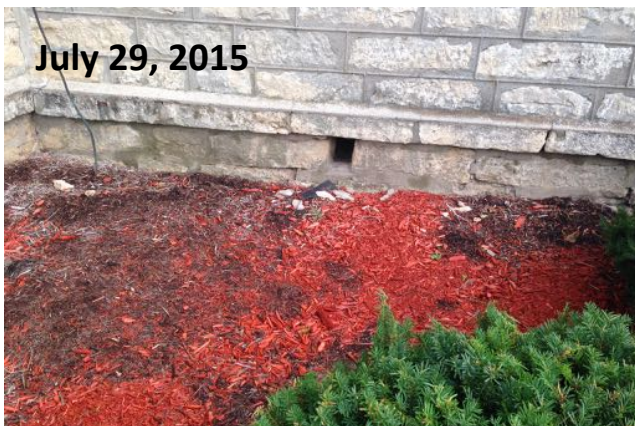
**Photos taken at the base of the Bell
Tower on the south side**

**Early in the Spring of 2015, fresh mulch was
put down around the shrubbery at the base
of the Bell Tower**

**By the end of July, pieces of
stone and mortar that had fallen
from the Bell Tower could be
seen on top of the new mulch**

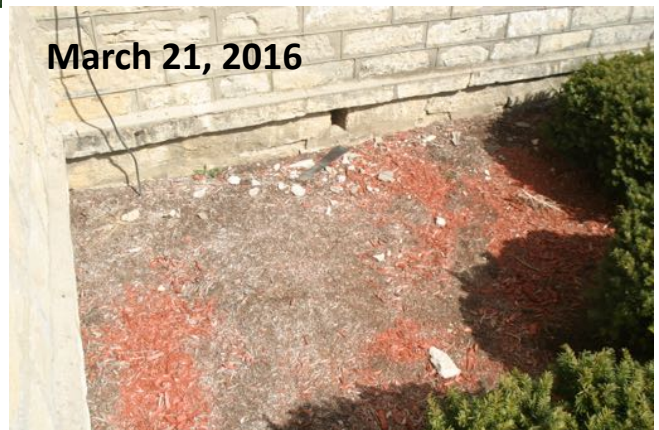
**Blasting continued until December
of 2015, and a second photo was
taken in the early spring showing
that even more stone and mortar
had fallen since July**
