CTH M: Cross County Rd - Prairie Hill Rd
Rare Species Locations

February 22, 2017

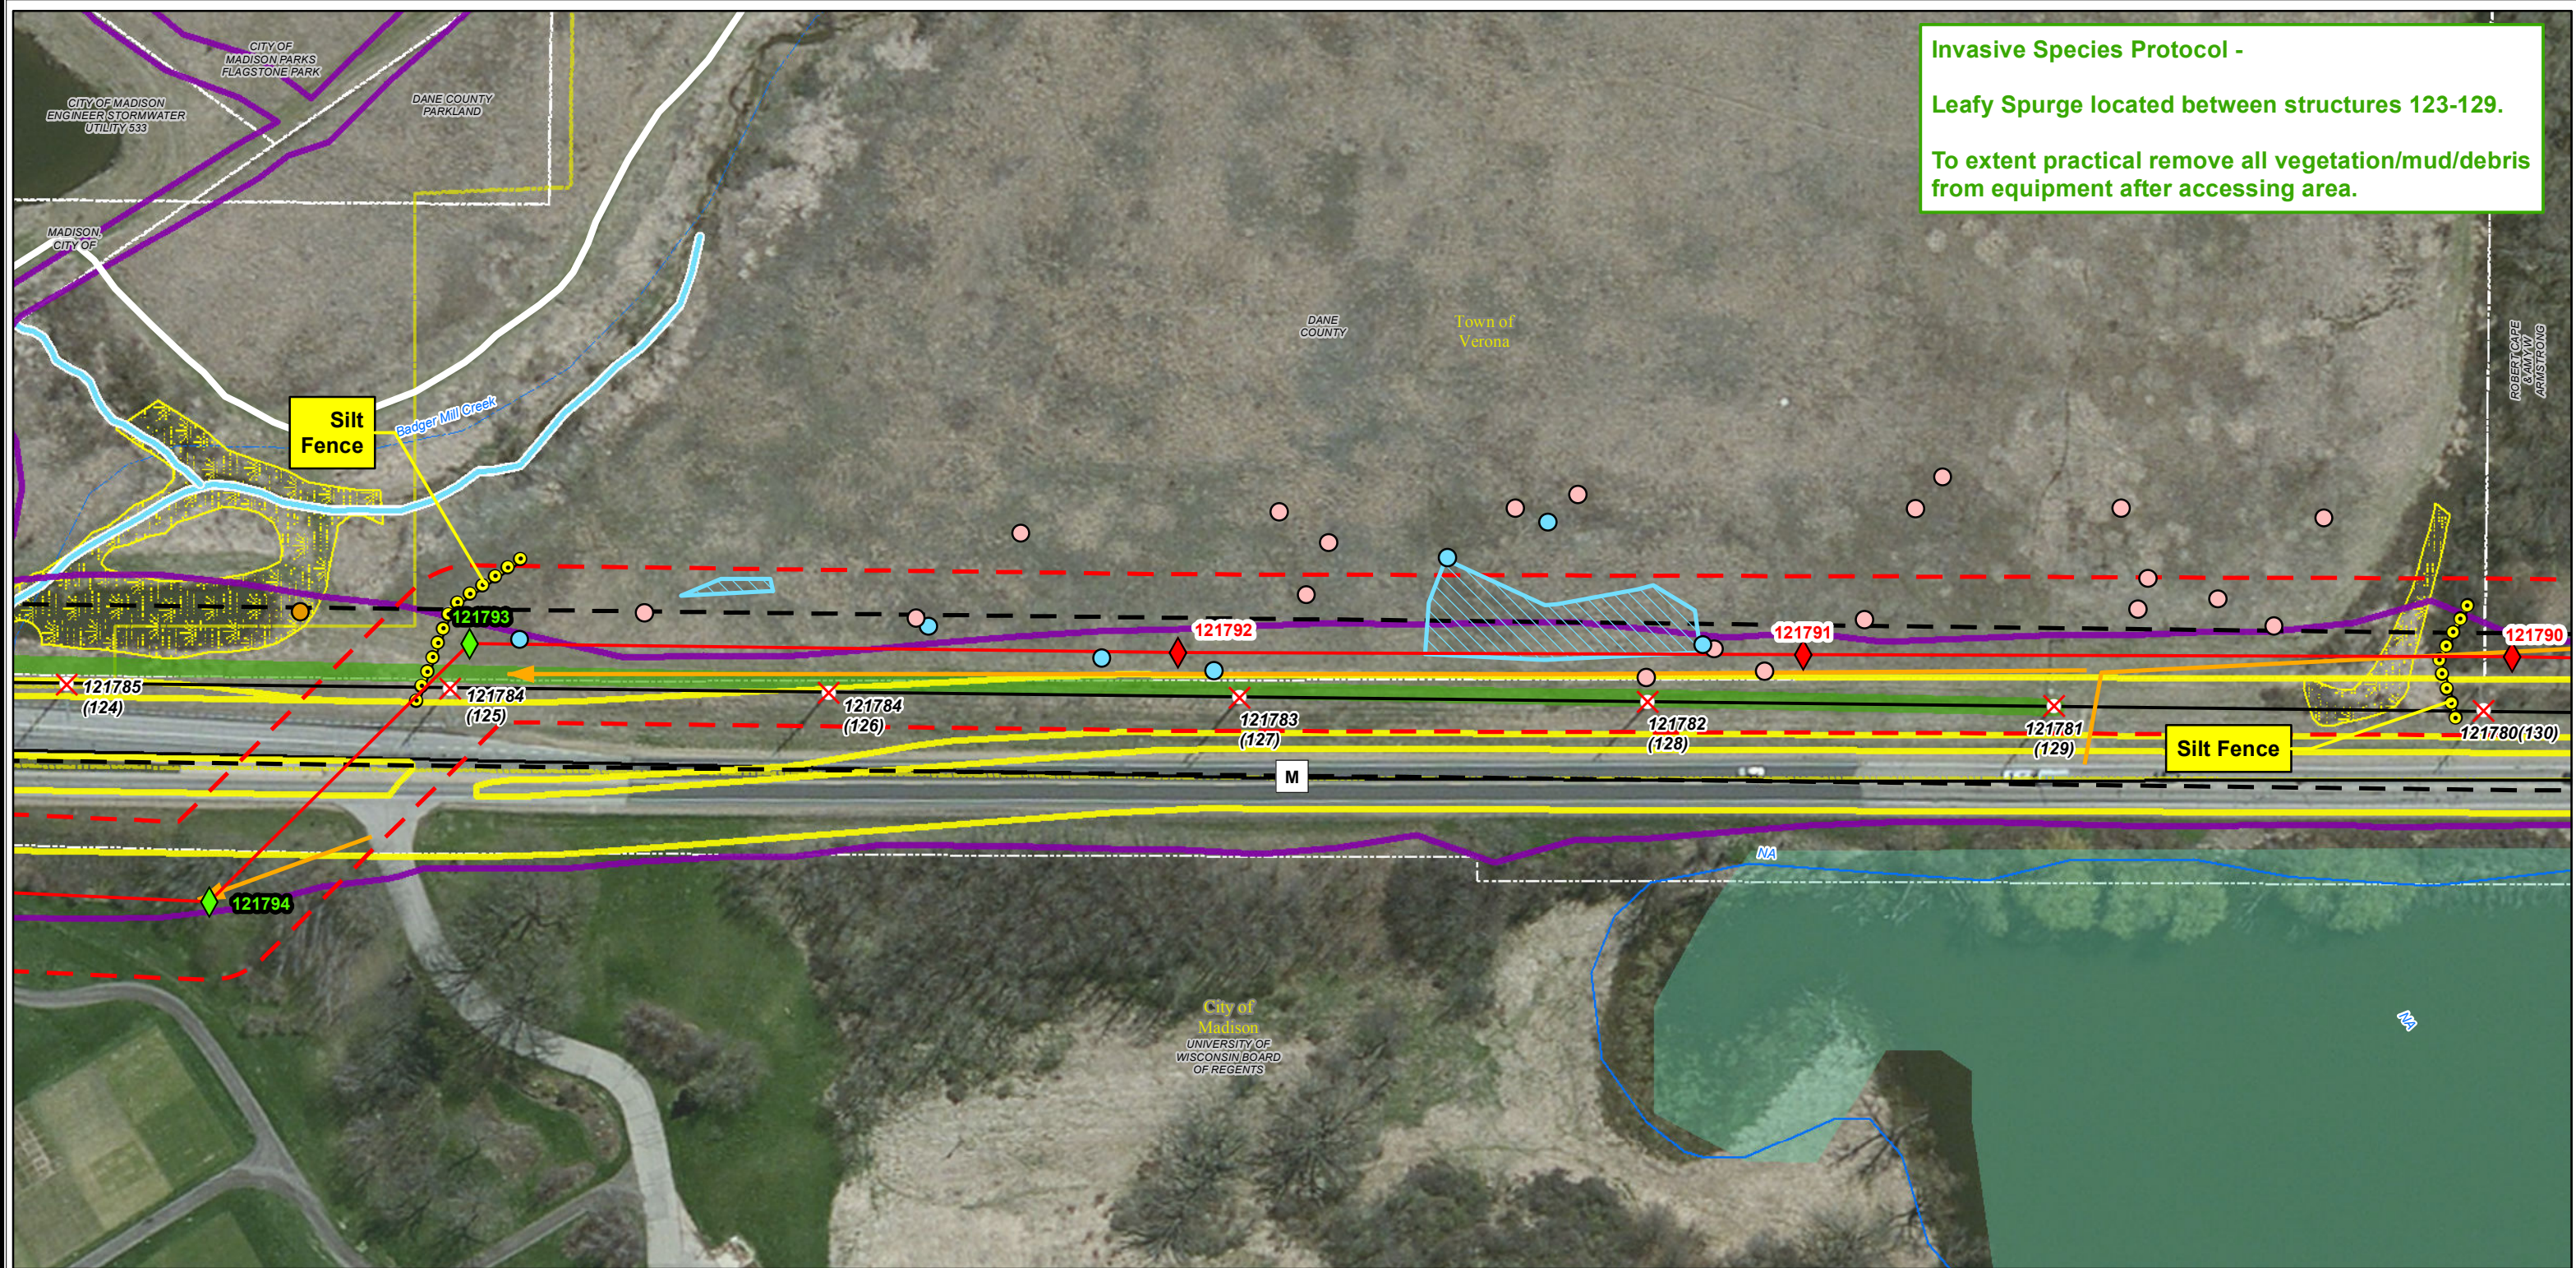
Invasive Species Protocol -
Leafy Spurge located between structures 123-129.
To extent practical remove all vegetation/mud/debris from equipment after accessing area.
