Dane County Rezone & Conditional Use Permit

Wetland Delineation Report

Icke Property

Town of Dunn, Dane County
Wisconsin

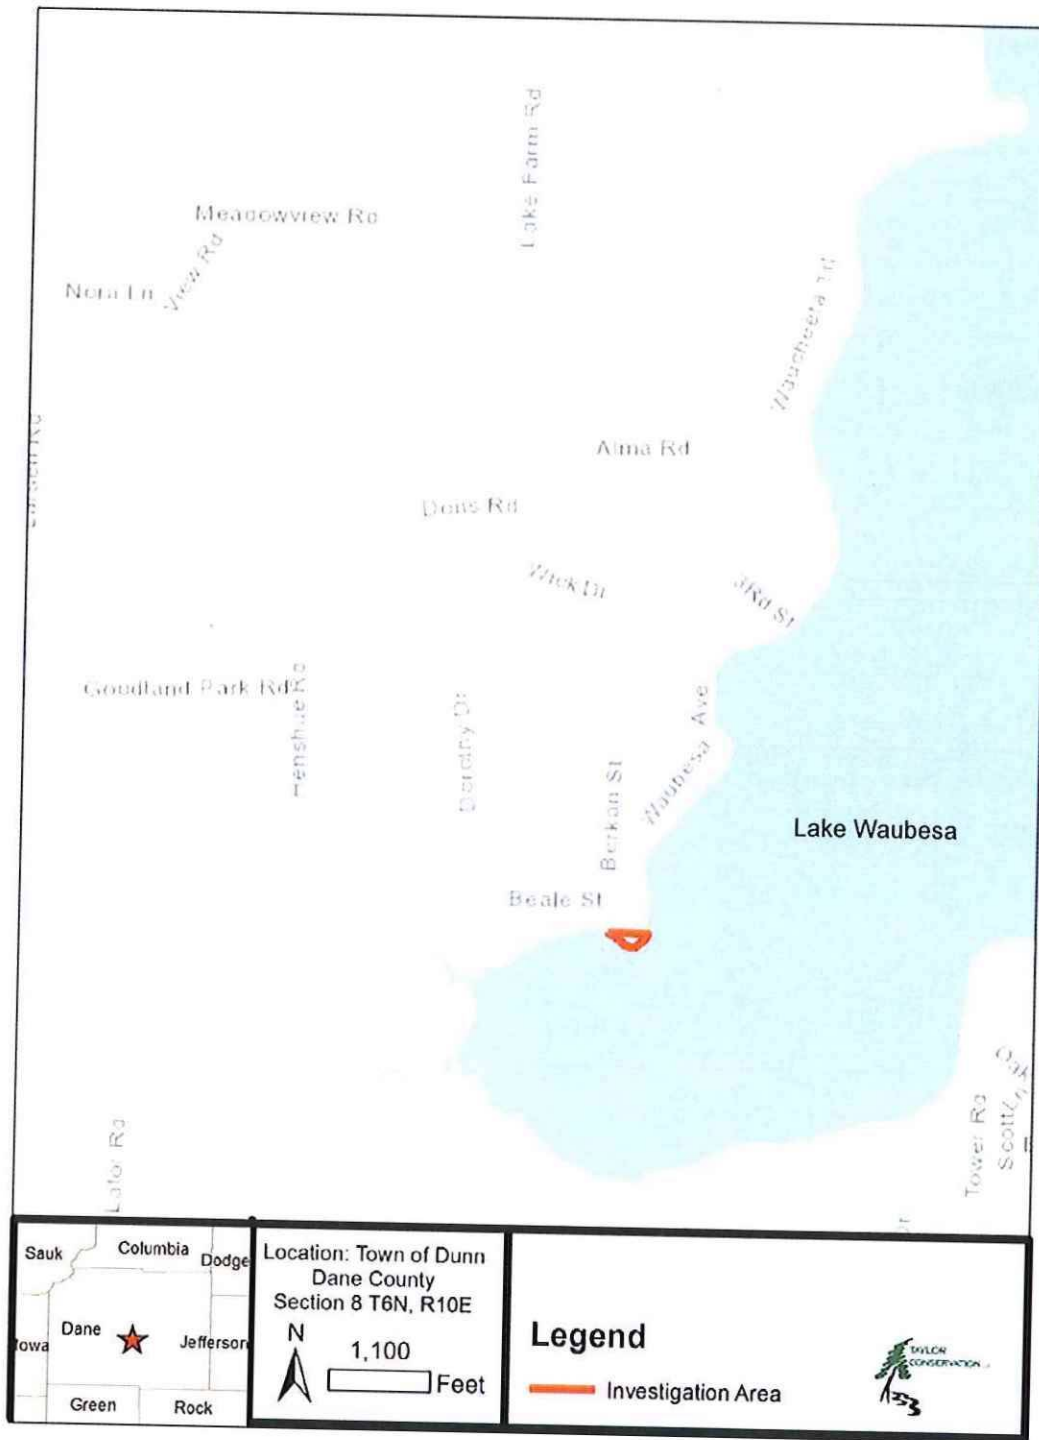
Figure 1: Landscape Overview Map.

On August 11th of 2014, Scott Taylor of Taylor Conservation, LLC performed a wetland determination and delineation on the Icke property in the Town of Dunn, Dane County, Wisconsin (Figure 1). The property, which was a vacant residential parcel of approximately 1 acre on the shores of Lake Waubesa, consisted primarily of mowed turf and scattered trees. However there were areas of thick brush within two depressions and along the shoreline. The depressions and a narrow fringe of low-lying land on the shoreline were found to be wetlands (Figure 2).
