# Wetland Delineation Report

Quality West Construction:  
Netherwood Road Wetland  
Delineation

Cardno Project Number: J178357800

August 11, 2017

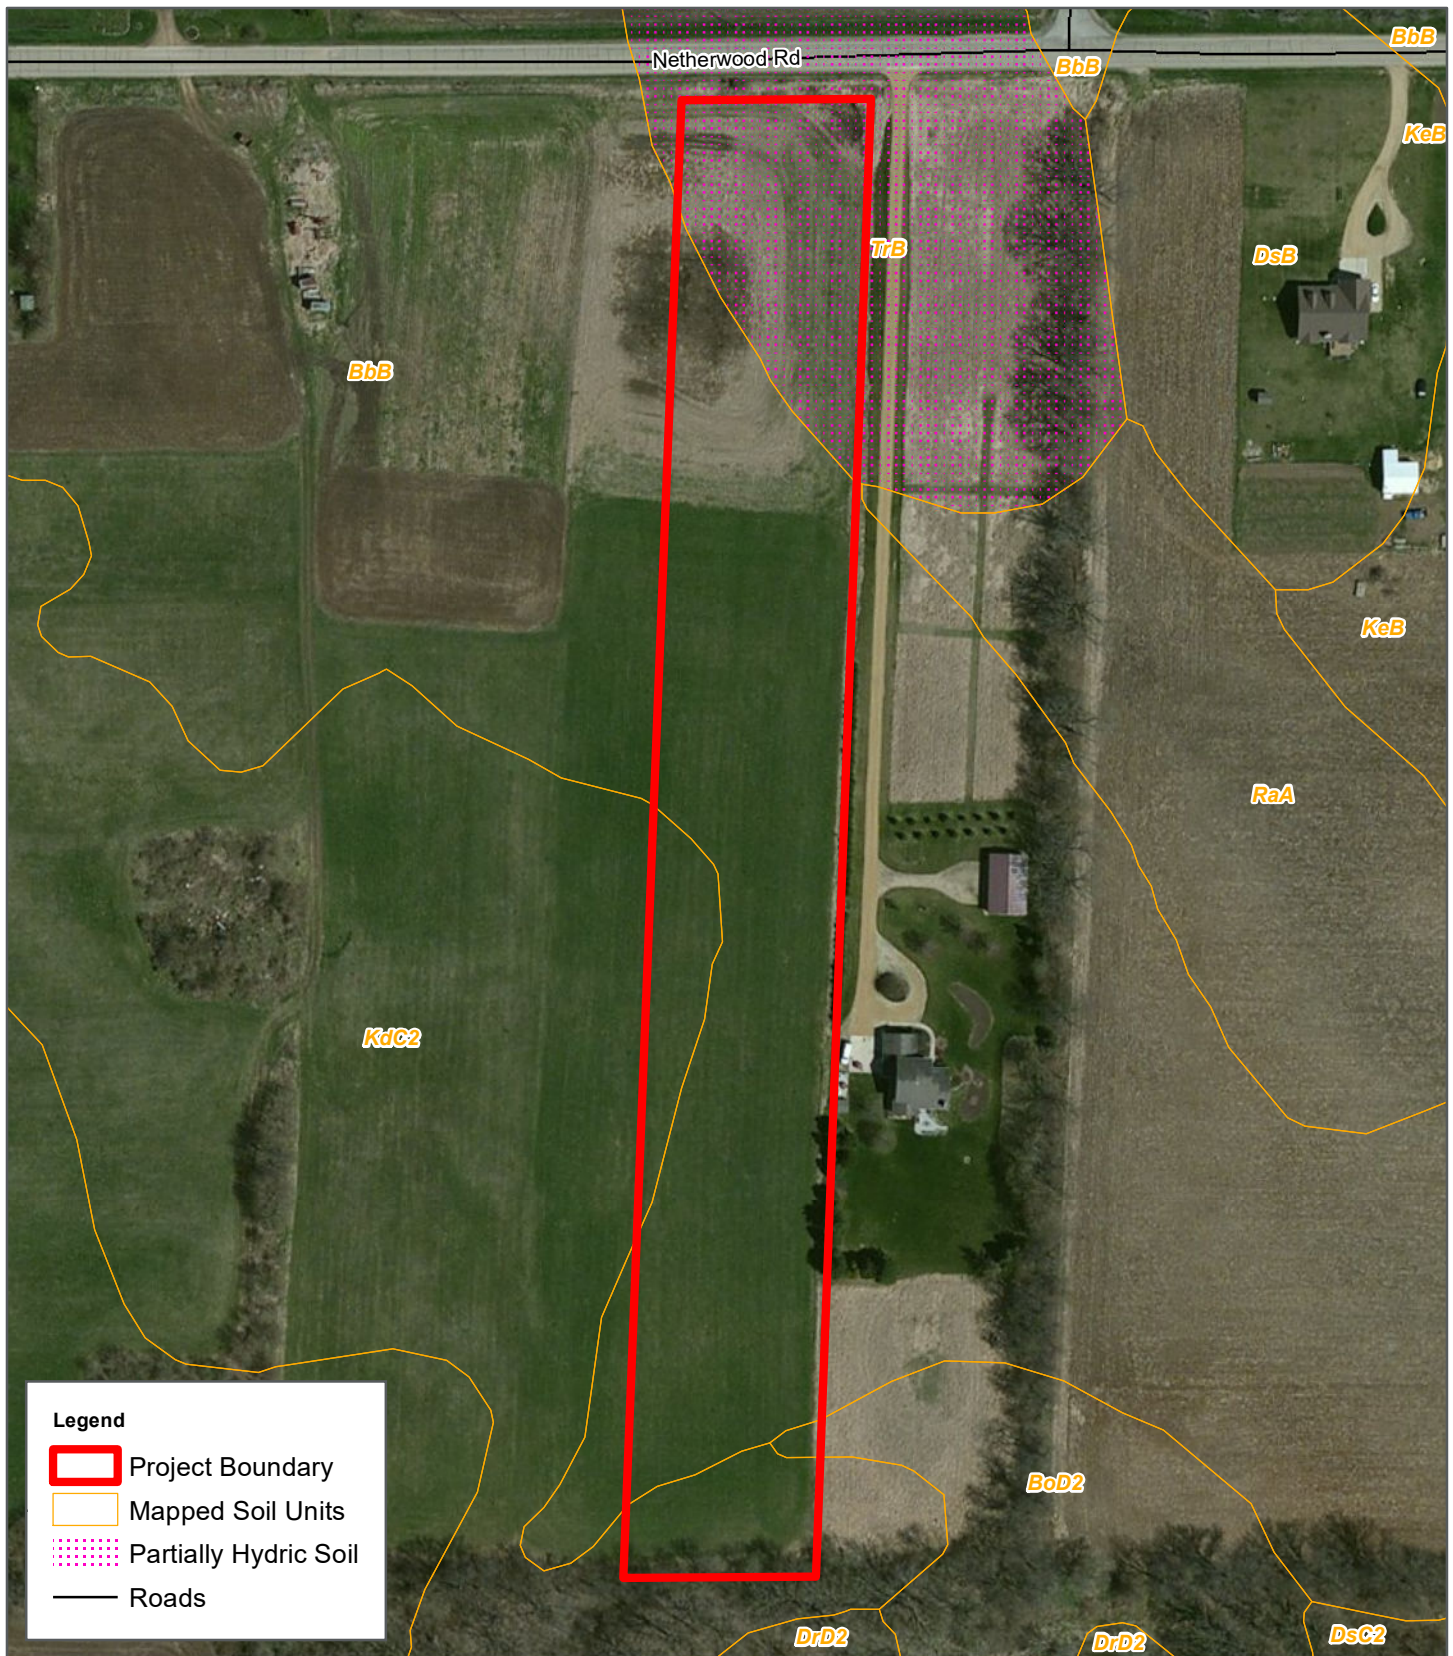
The NRCS soil map of the project area (Figure 3) identified the four soil types outlined in Table 2-1, below. In total, approximately 0.87 (17%) of the 4.92 acre project area contains mapped hydric soil units. Hydric soil units are restricted to the northeastern half of the project area and are correlated with the topographic break noted in Section 2.1.1.

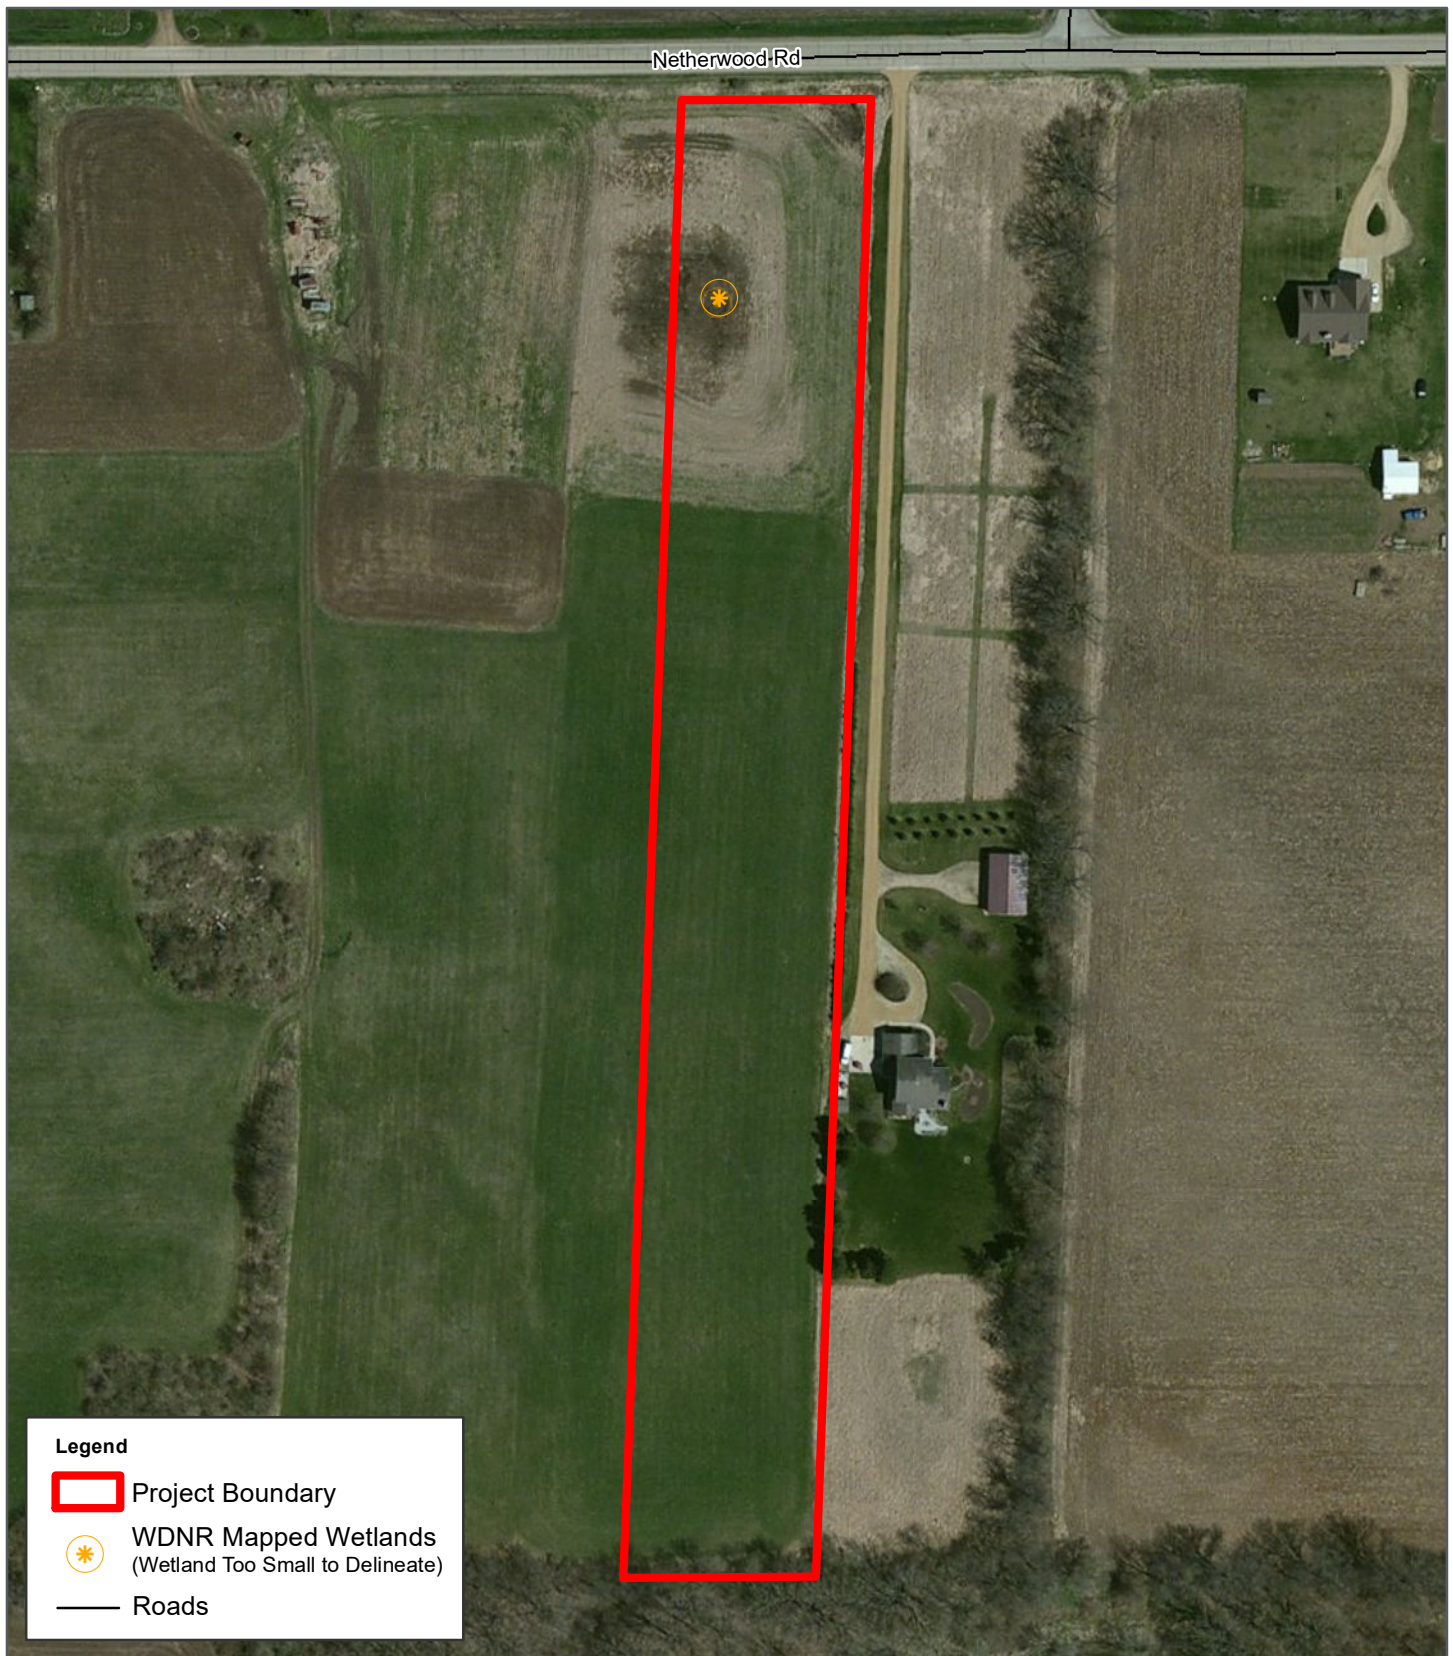
The Wisconsin Wetland Inventory (WWI) map of the project area (Figure 4) identified an area of wetland that was too small to delineate. The mapped wetland is depicted on the northern end of the site.

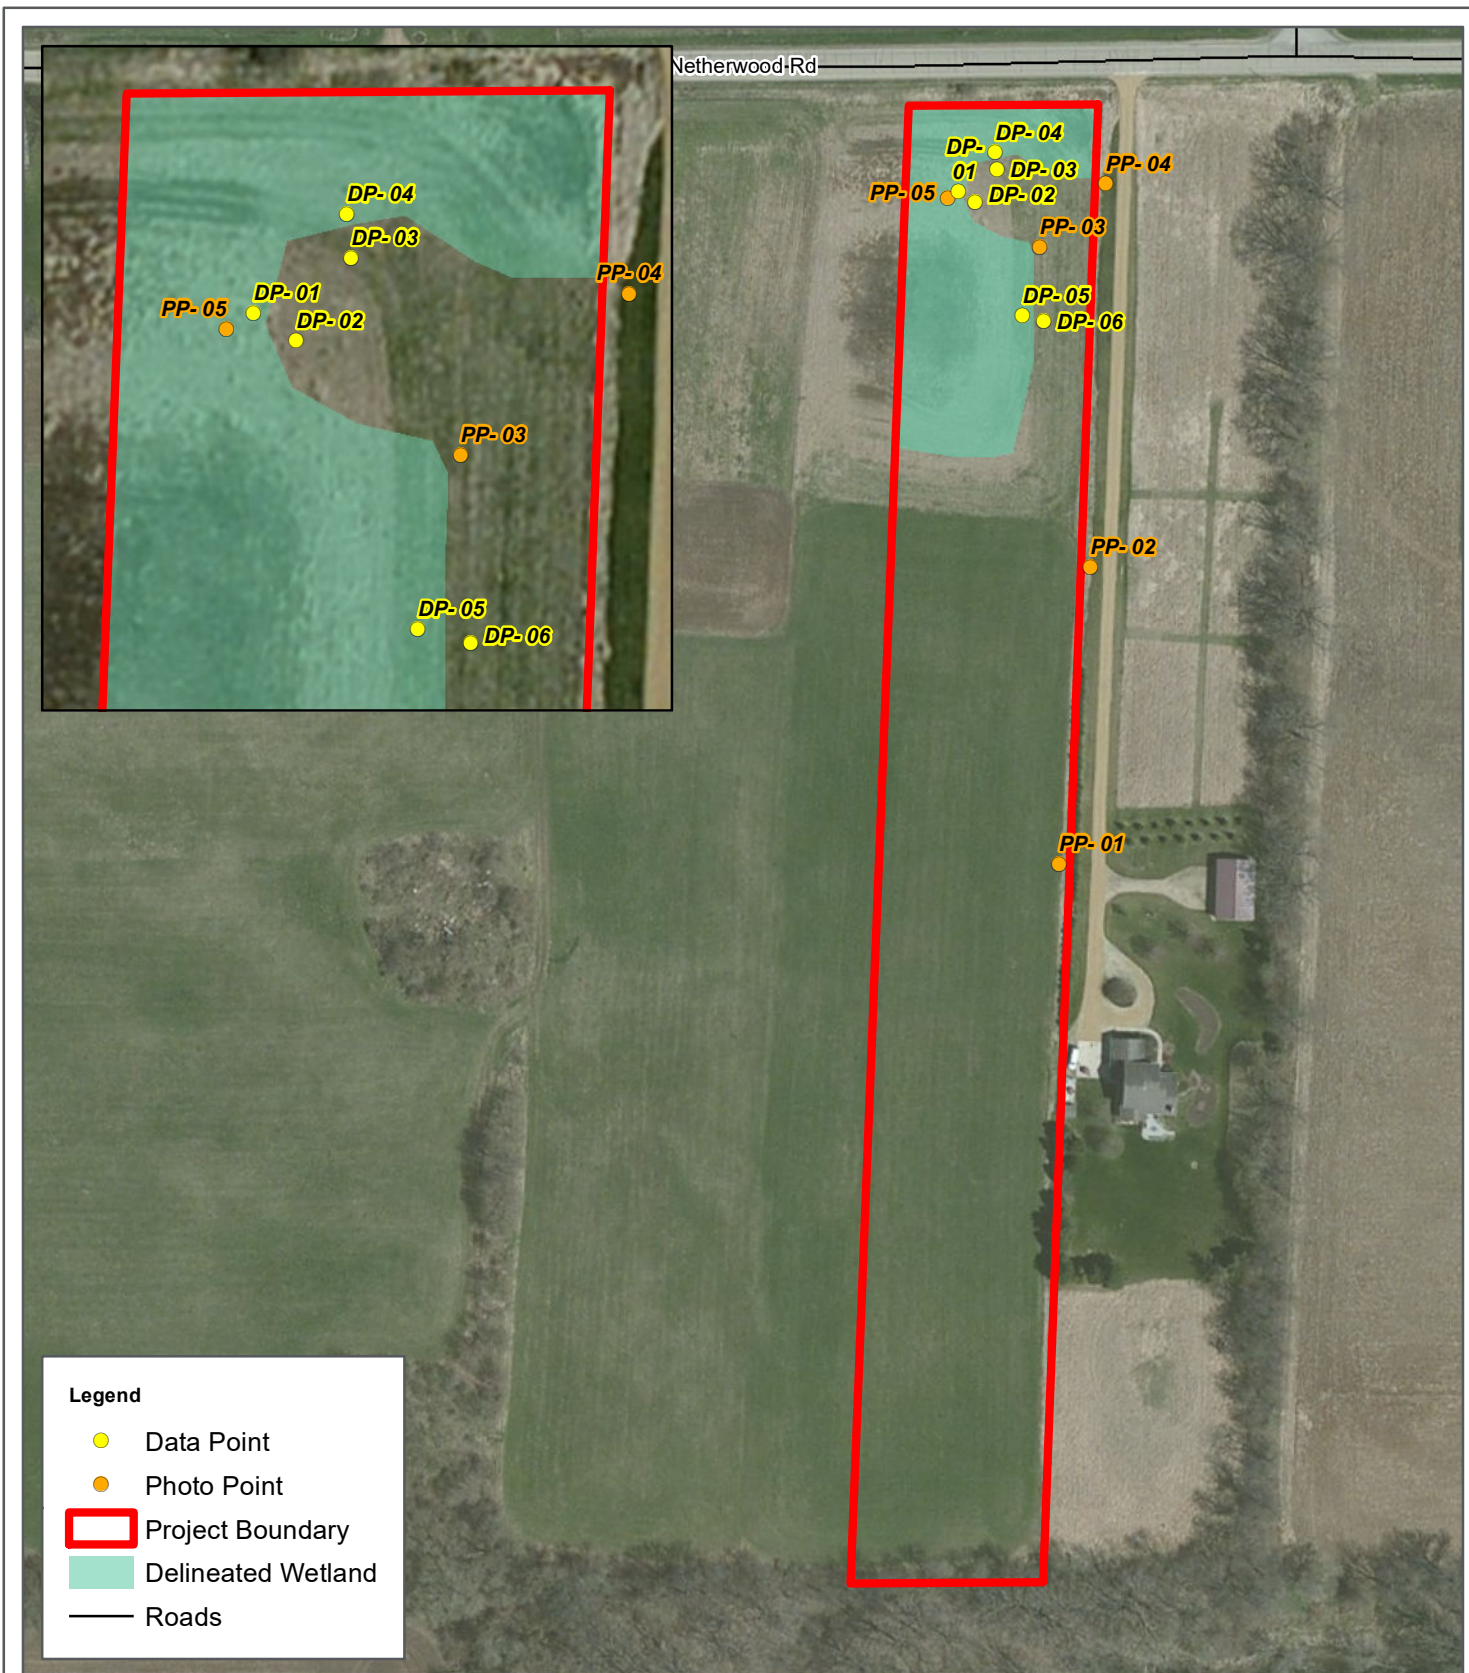
Across the entire project area, a total of one wetland complex was identified that contained fresh (wet) meadow. Total delineated wetland area within the project area is approximately 0.77 acres (15% of the entire project area). The completed wetland delineation data forms are included as Appendix B. Figure 5 depicts the wetland boundaries.

The wetland boundary occurs along the foot slope of the upland/wetland transition area located at the northern end of the project area where topography becomes flat and depressed below the surrounding landscape. The wetland boundary was delineated primarily by areas where the local relief transitions from a convex to a concave position. Although not present immediately along the wetland boundary at data point locations, it is evident that a shallow aquitard (D3) of tightly packed clay soils perch the water table for extended periods of time following rainfall events in these wetland areas. Soil investigations identified no saturation or water table below the surface to a depth of 24-inches. Other indicators of hydrology within this wetland area includes geomorphic position (D2) and passing of the FAC-neutral test (D5). The dominant hydrophytic vegetation within this wetland complex includes reed canary grass (*Phalaris arundinacea*), straw-color flat sedge (*Cyperus strigosus*), and large barnyard grass (*Echinochloa crus-galli*). While vegetation was always dominated by wetland species in these areas, the presence of the upland species creeping wild rye (*Elymus repens*) was also dominant in portions of the wetland area.

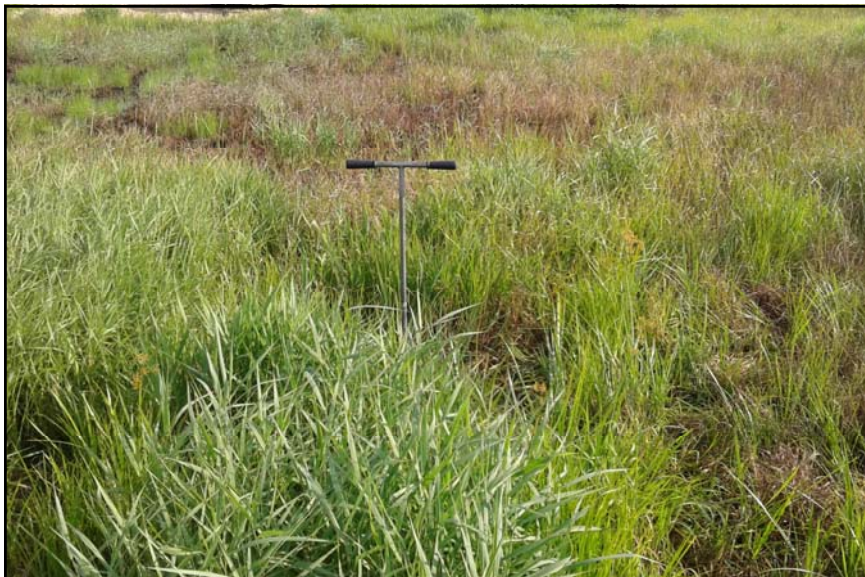
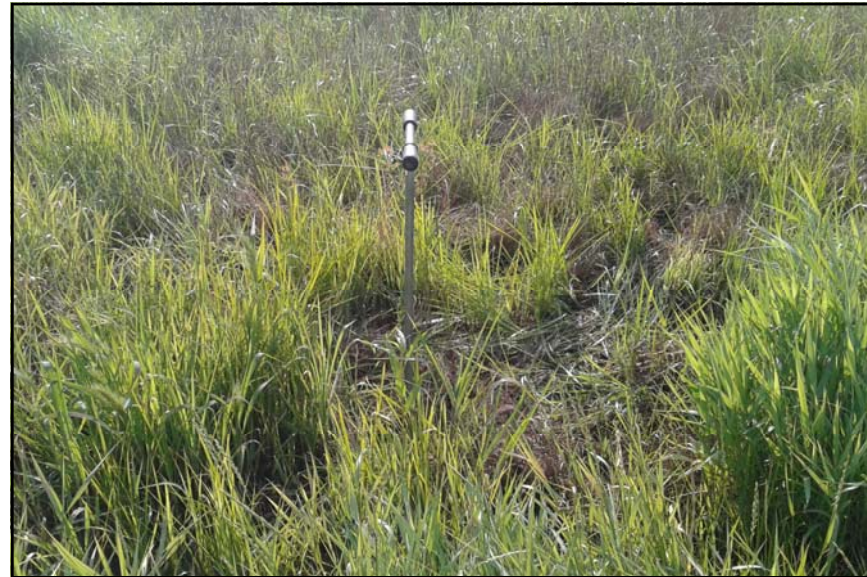
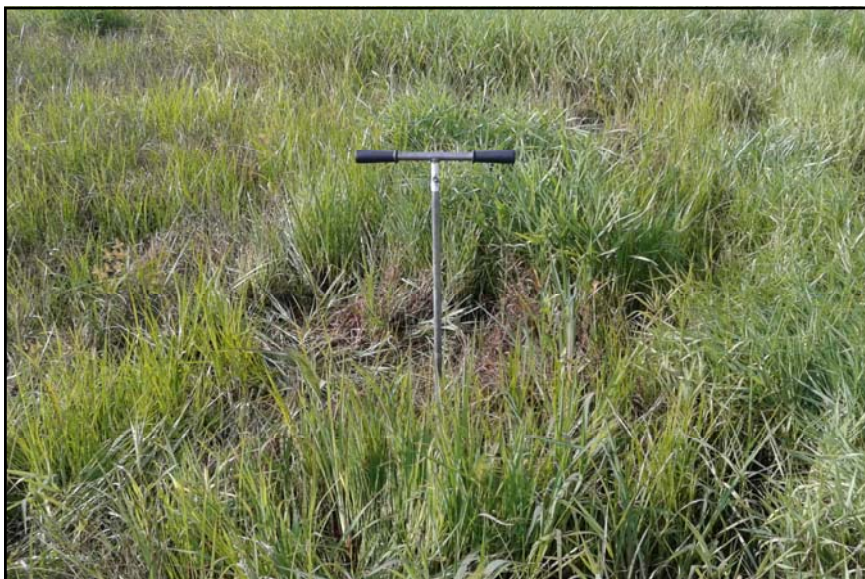
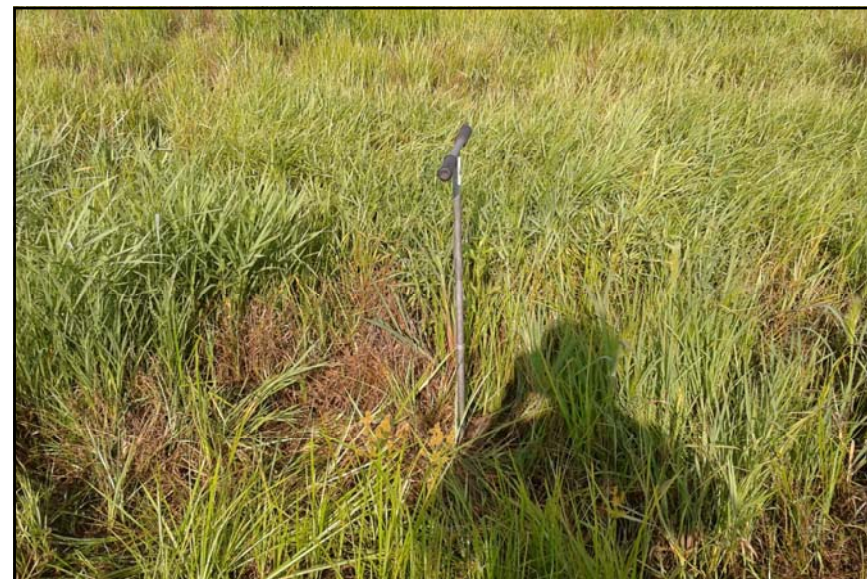
DP-01, view north

DP-01, view east

DP-01, view south

DP-01, view west

Hydrophytic Vegetation Present?	Yes <u>X</u> No <u>    </u>	<b>Is the Sampled Area within a Wetland?</b> Yes <u>X</u> No <u>    </u> If yes, optional Wetland Site ID: <u>    </u>
Hydric Soil Present?	Yes <u>X</u> No <u>    </u>	
Wetland Hydrology Present?	Yes <u>X</u> No <u>    </u>	
Remarks: (Explain alternative procedures here or in a separate report.) A WETS Table Analysis was completed for the project area. Comparison of recent precipitation data to that of historic rainfalls in the area (from 1971 - 2017) revealed climatic conditions on site were atypical for this time of year. This analysis revealed site conditions at the time of delineation were wetter than normal.

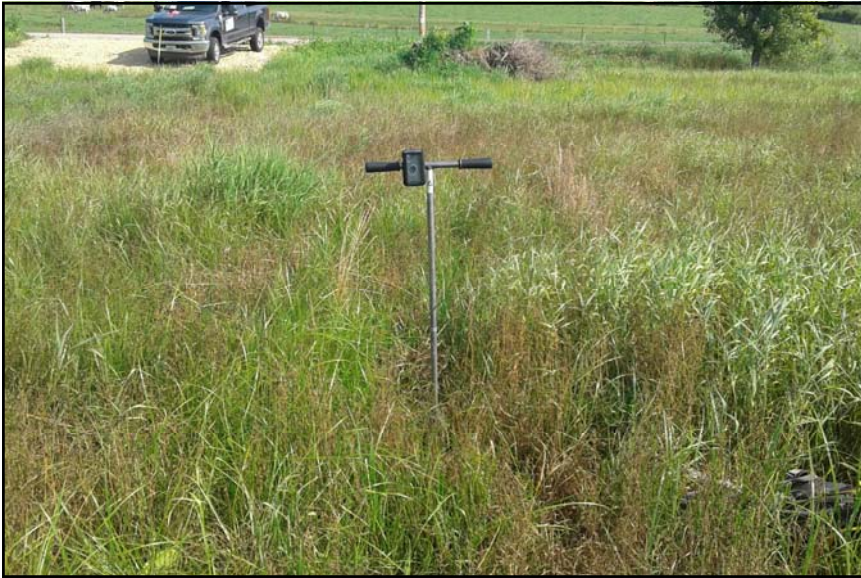
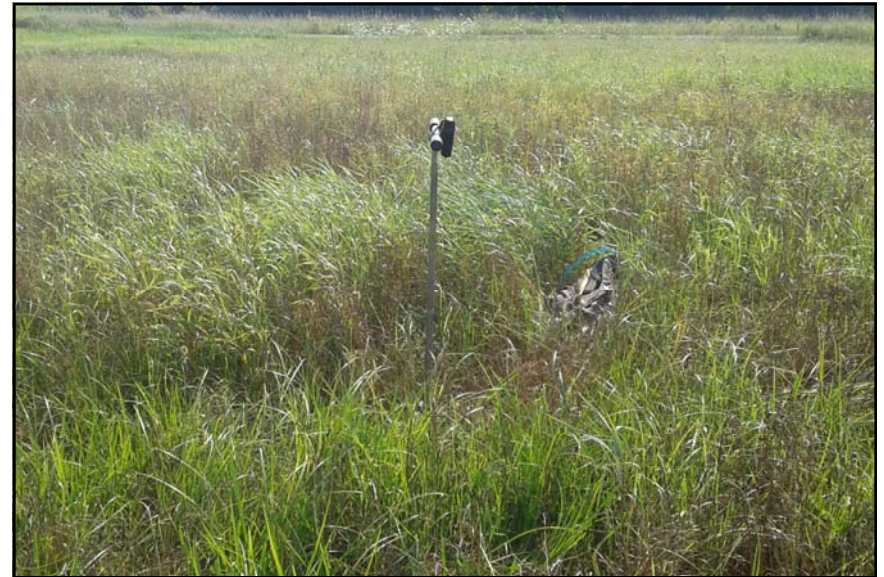
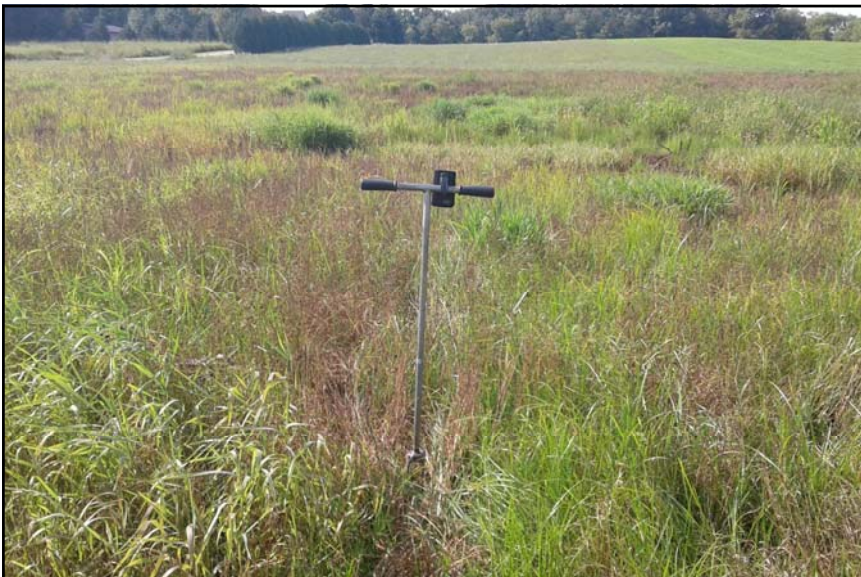
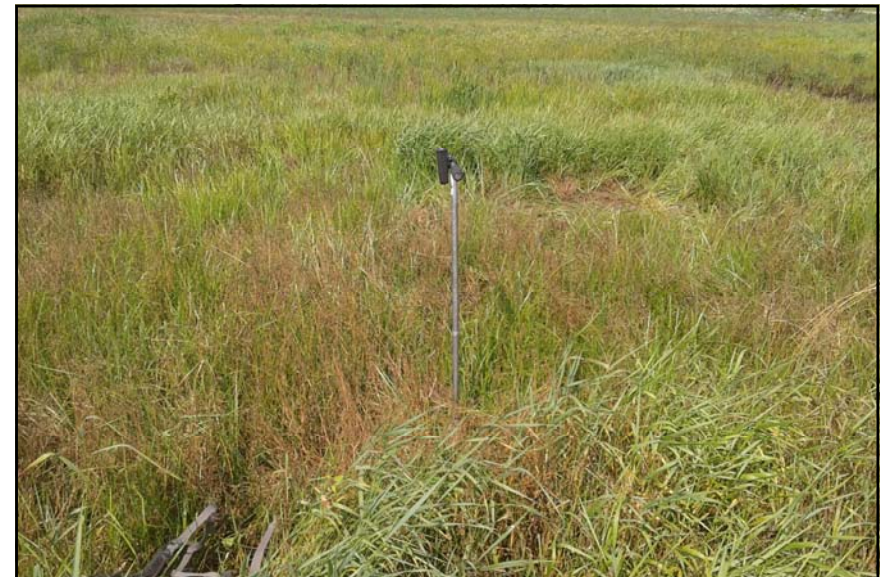
DP-02, view north

DP-02, view east

DP-02, view south

DP-02, view west

Hydrophytic Vegetation Present?	Yes _____	No <u>X</u>	<b>Is the Sampled Area within a Wetland?</b> Yes _____ No <u>X</u> If yes, optional Wetland Site ID: _____
Hydric Soil Present?	Yes <u>X</u>	No _____	
Wetland Hydrology Present?	Yes _____	No <u>X</u>	
Remarks: (Explain alternative procedures here or in a separate report.) A WETS Table Analysis was completed for the project area. Comparison of recent precipitation data to that of historic rainfalls in the area (from 1971 - 2017) revealed climatic conditions on site were atypical for this time of year. This analysis revealed site conditions at the time of delineation were wetter than normal.

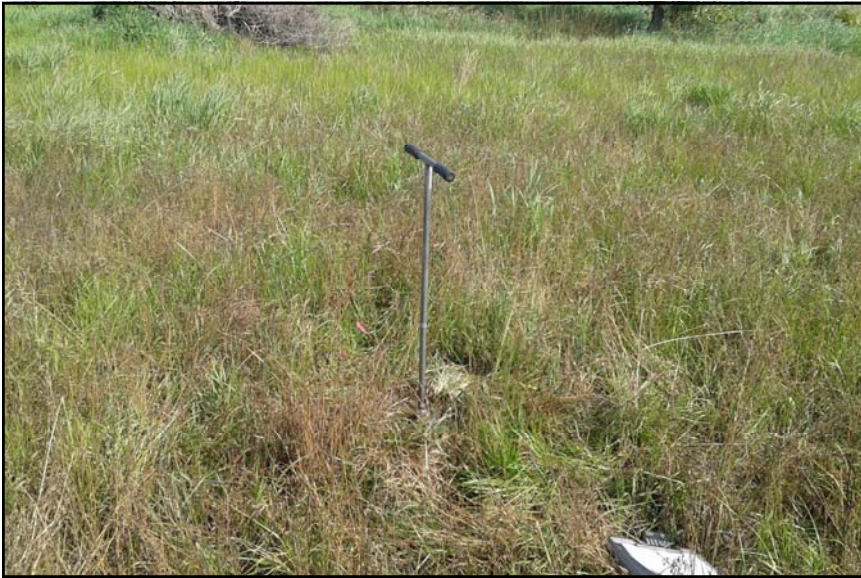
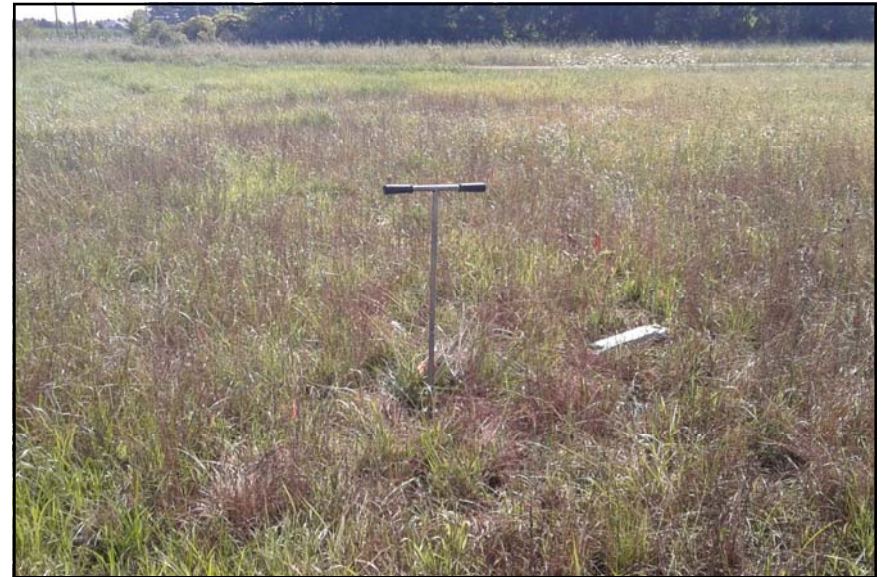
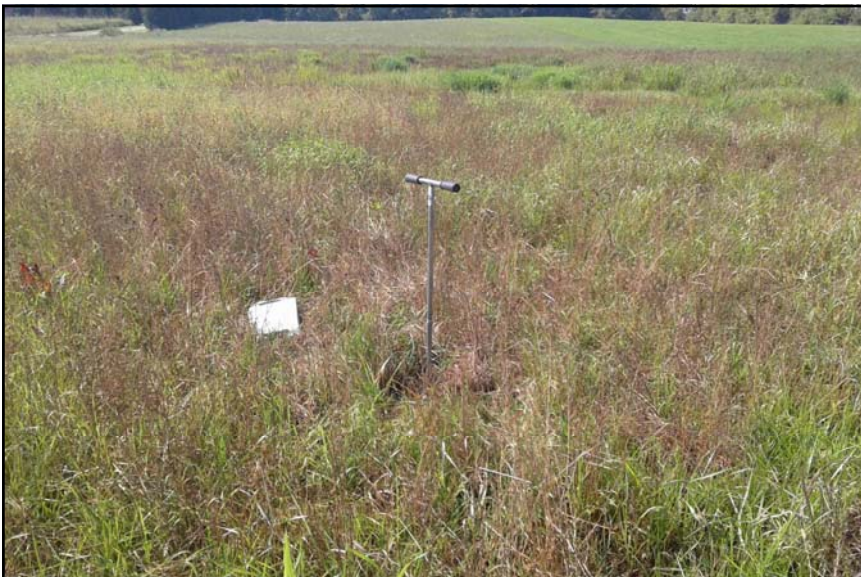
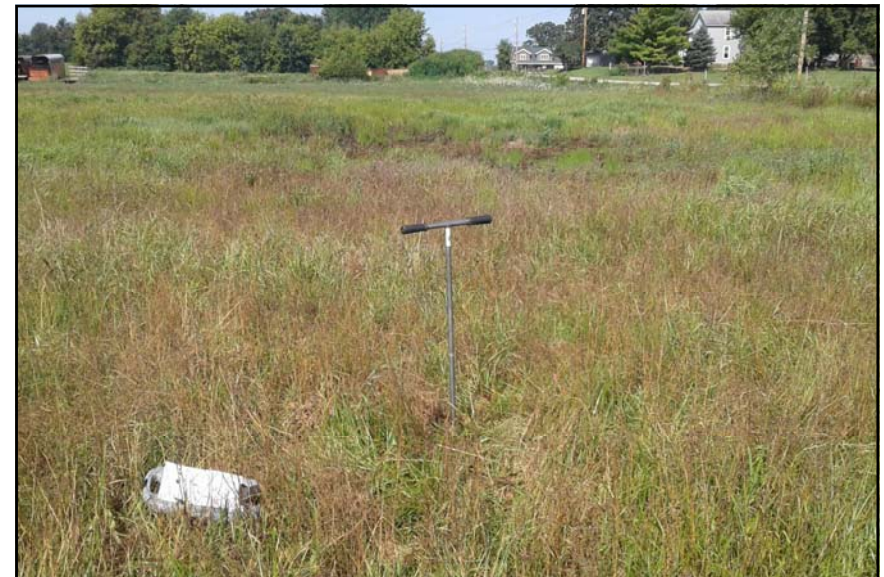
DP-03, view north

DP-03, view east

DP-03, view south

DP-03, view west

Hydrophytic Vegetation Present?	Yes _____ No <u>X</u>	Is the Sampled Area within a Wetland? Yes _____ No <u>X</u> If yes, optional Wetland Site ID: _____
Hydric Soil Present?	Yes <u>X</u> No _____	
Wetland Hydrology Present?	Yes _____ No <u>X</u>	
Remarks: (Explain alternative procedures here or in a separate report.) A WETS Table Analysis was completed for the project area. Comparison of recent precipitation data to that of historic rainfalls in the area (from 1971 - 2017) revealed climatic conditions on site were atypical for this time of year. This analysis revealed site conditions at the time of delineation were wetter than normal.

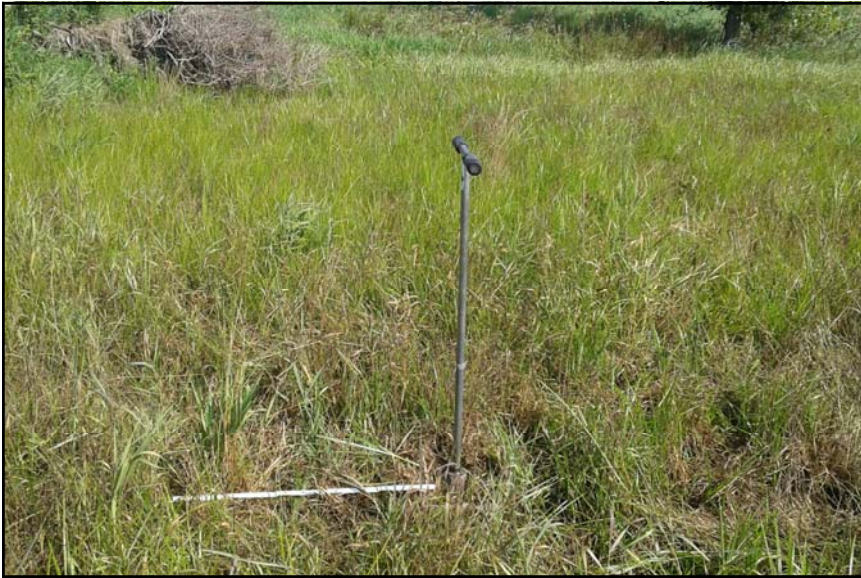
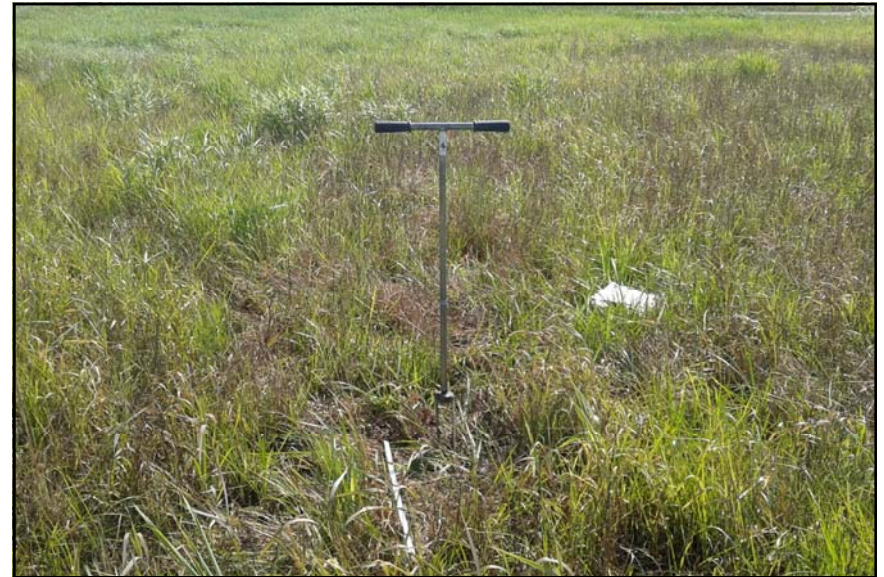
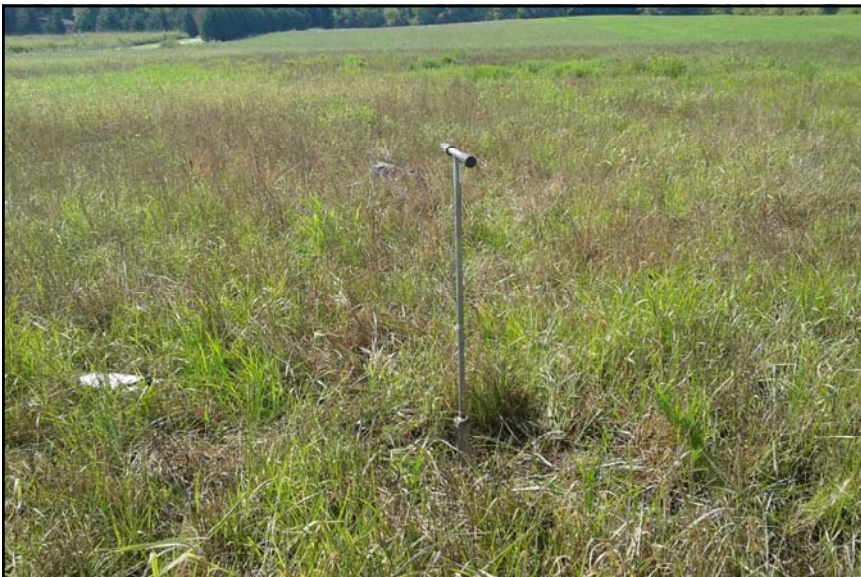
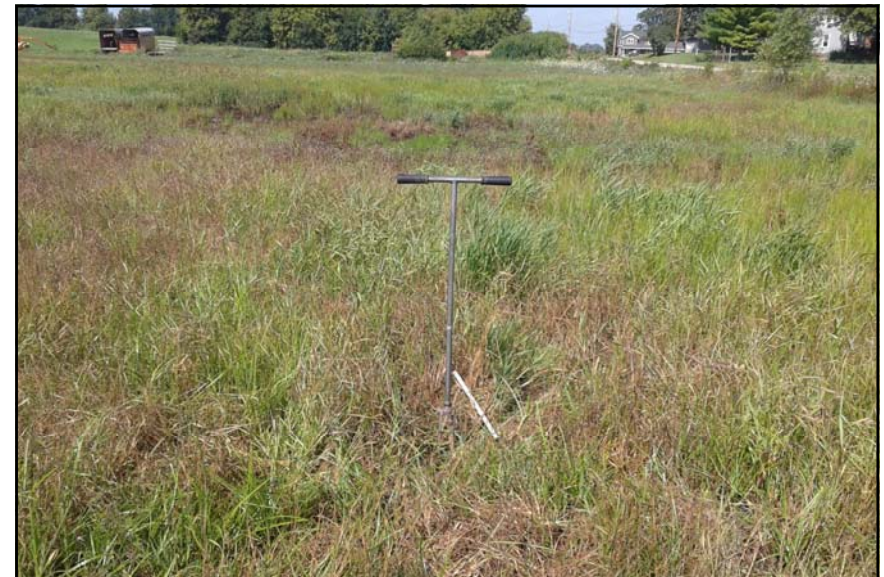
DP-04, view north

DP-04, view east

DP-04, view south

DP-04, view west

Hydrophytic Vegetation Present?	Yes <u>X</u> No <u>    </u>	<b>Is the Sampled Area within a Wetland?</b> Yes <u>X</u> No <u>    </u> If yes, optional Wetland Site ID: <u>    </u>
Hydric Soil Present?	Yes <u>X</u> No <u>    </u>	
Wetland Hydrology Present?	Yes <u>X</u> No <u>    </u>	
Remarks: (Explain alternative procedures here or in a separate report.) A WETS Table Analysis was completed for the project area. Comparison of recent precipitation data to that of historic rainfalls in the area (from 1971 - 2017) revealed climatic conditions on site were atypical for this time of year. This analysis revealed site conditions at the time of delineation were wetter than normal.

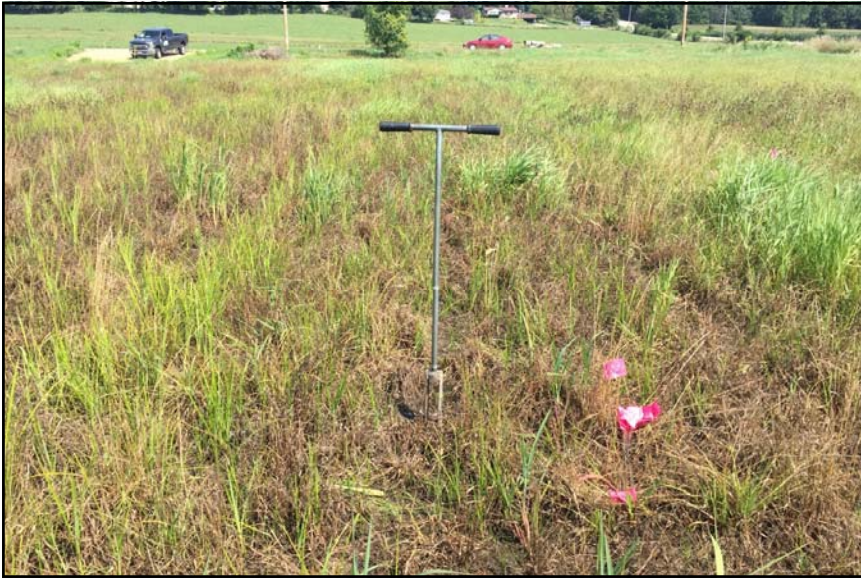
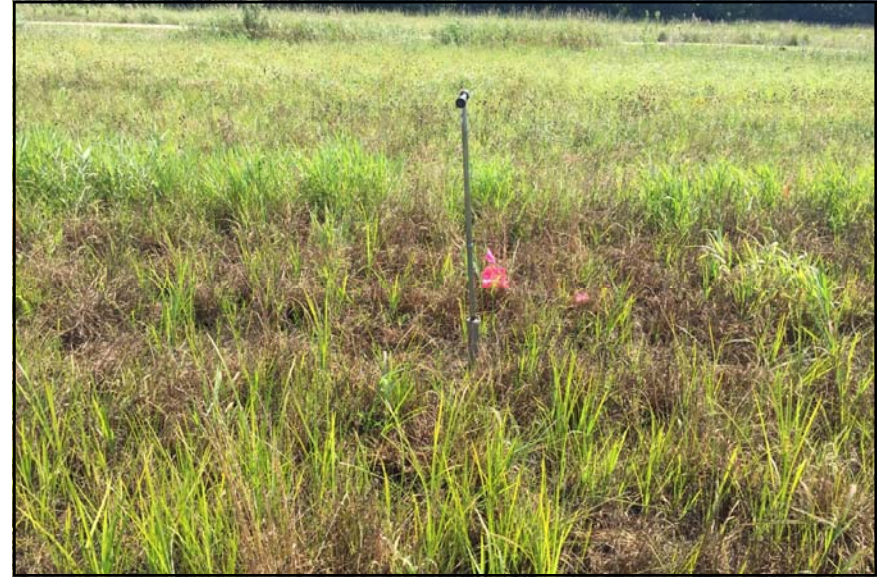
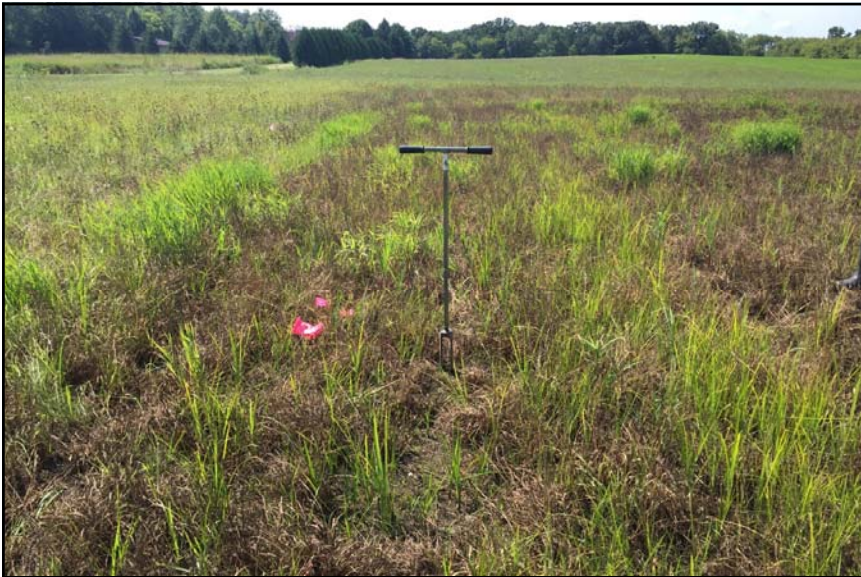
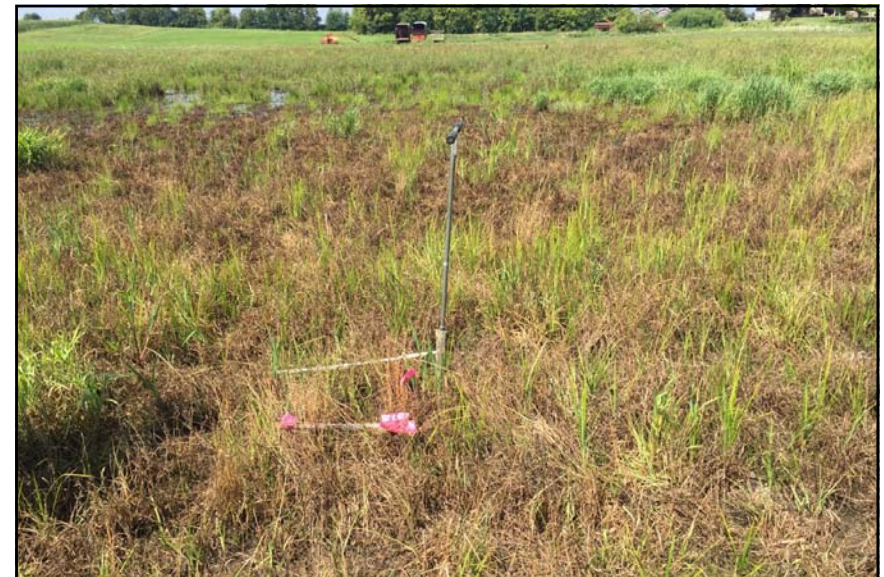
DP-05, view north

DP-05, view east

DP-05, view south

DP-05, view west

Hydrophytic Vegetation Present?	Yes <u>X</u> No <u>    </u>	<b>Is the Sampled Area within a Wetland?</b> Yes <u>X</u> No <u>    </u> If yes, optional Wetland Site ID: <u>    </u>
Hydric Soil Present?	Yes <u>X</u> No <u>    </u>	
Wetland Hydrology Present?	Yes <u>X</u> No <u>    </u>	
Remarks: (Explain alternative procedures here or in a separate report.) A WETS Table Analysis was completed for the project area. Comparison of recent precipitation data to that of historic rainfalls in the area (from 1971 - 2017) revealed climatic conditions on site were atypical for this time of year. This analysis revealed site conditions at the time of delineation were wetter than normal.

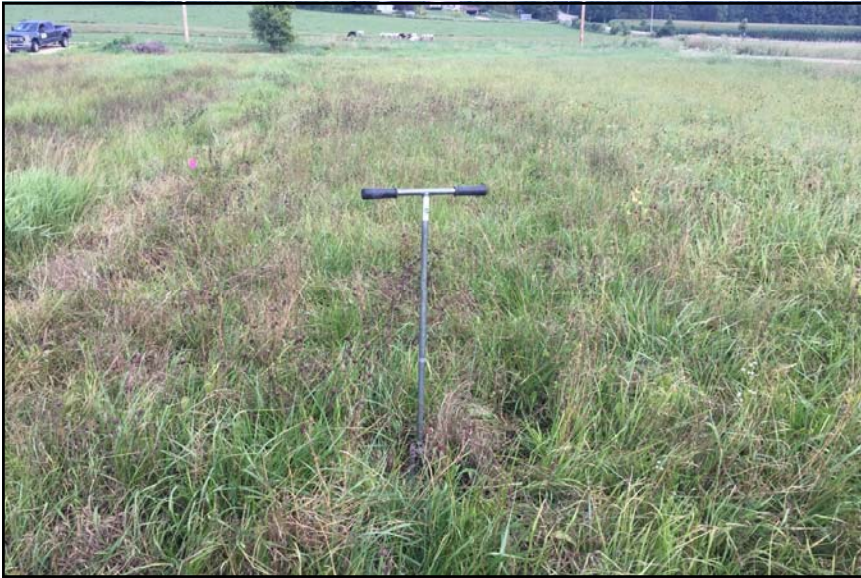
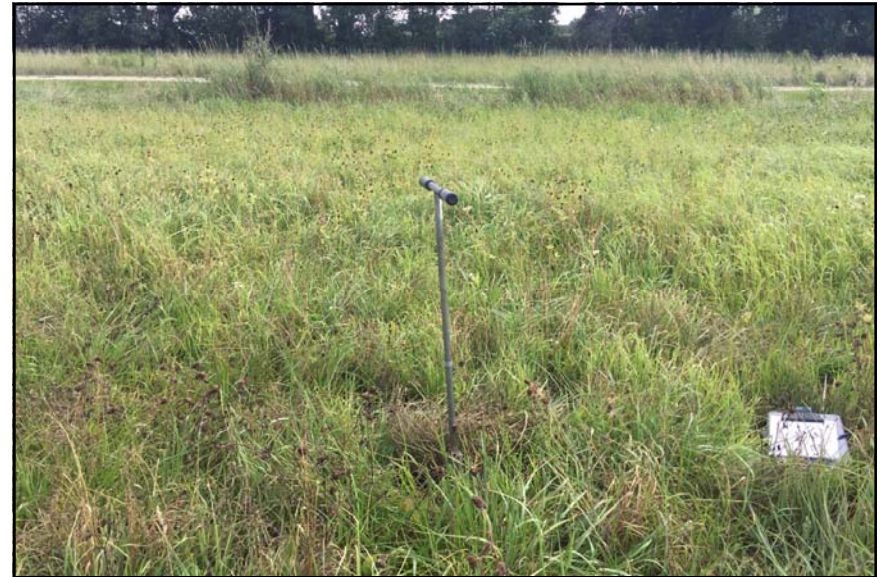
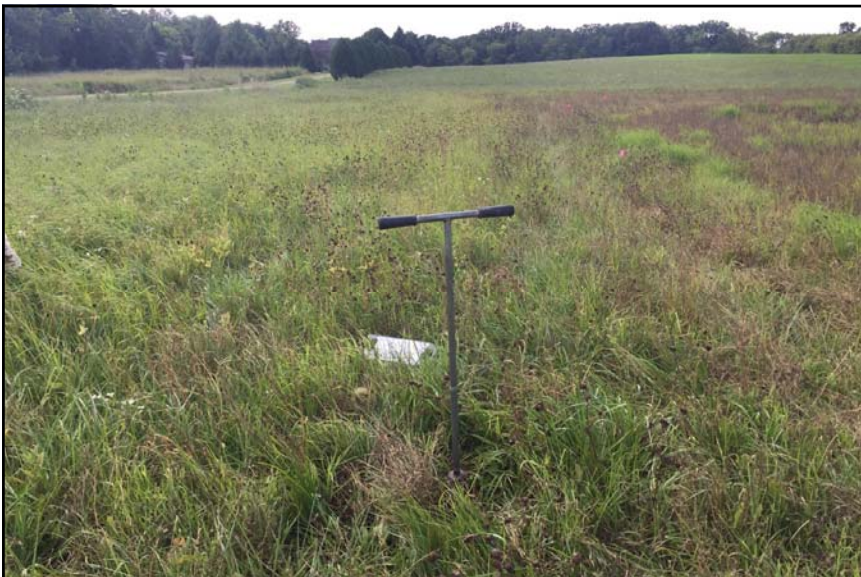
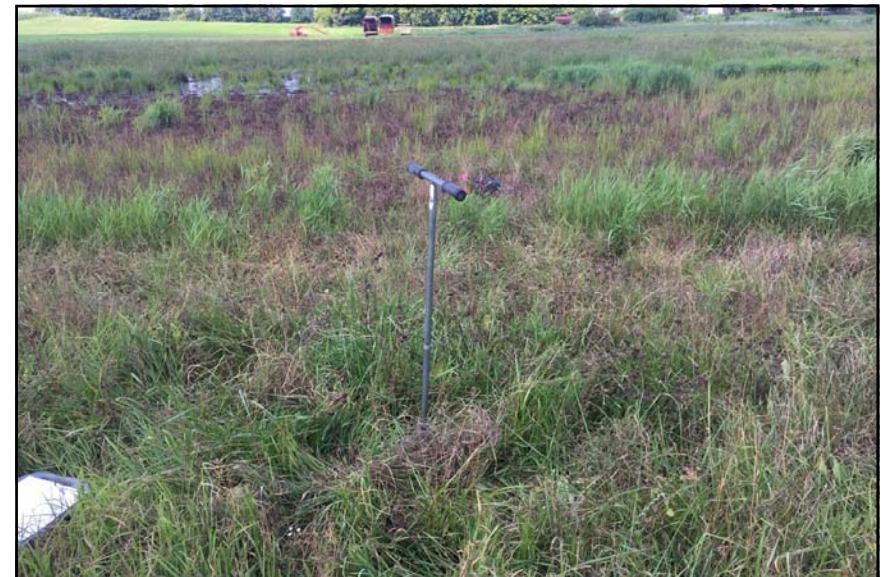
DP-06, view north

DP-06, view east

DP-06, view south

DP-06, view west

Hydrophytic Vegetation Present?	Yes _____	No <u>X</u>	<b>Is the Sampled Area within a Wetland?</b> Yes _____ No <u>X</u> If yes, optional Wetland Site ID: _____
Hydric Soil Present?	Yes <u>X</u>	No _____	
Wetland Hydrology Present?	Yes _____	No <u>X</u>	
Remarks: (Explain alternative procedures here or in a separate report.) A WETS Table Analysis was completed for the project area. Comparison of recent precipitation data to that of historic rainfalls in the area (from 1971 - 2017) revealed climatic conditions on site were atypical for this time of year. This analysis revealed site conditions at the time of delineation were wetter than normal.
