Hydraulic Impacts of Quarries and Gravel Pits

J.A. Green, J.A. Pavlish, R.G. Merritt, and J.L. Leete
Minnesota Department of Natural Resources,
Division of Waters

2005

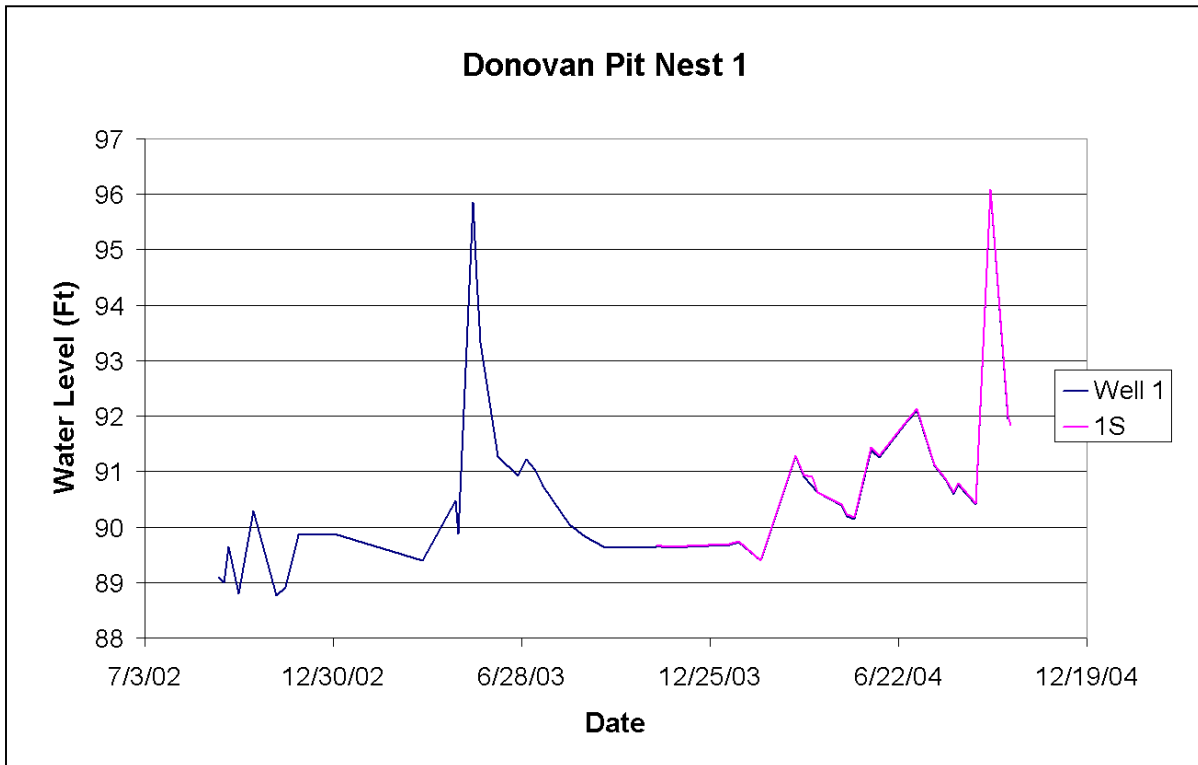
Figure 6. Water level measurements, well nest 1, Donovan Pit.

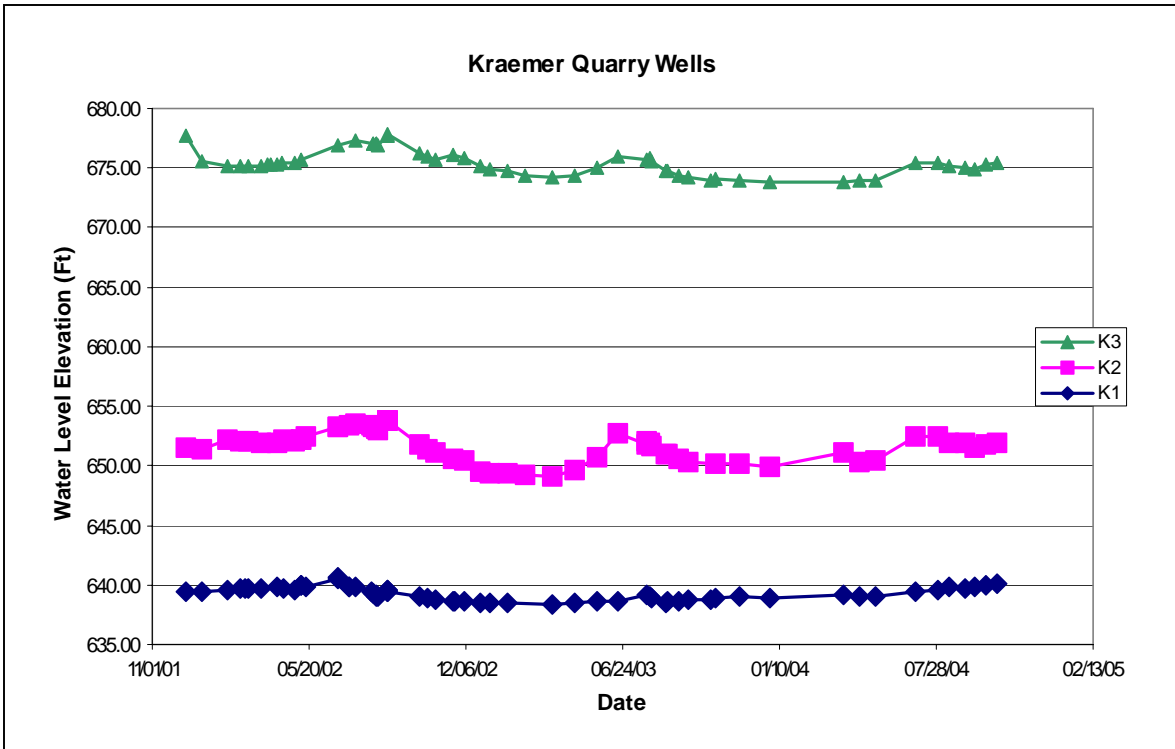
Figure 3.2. Seasonal variation of water levels in Kraemer quarry wells.

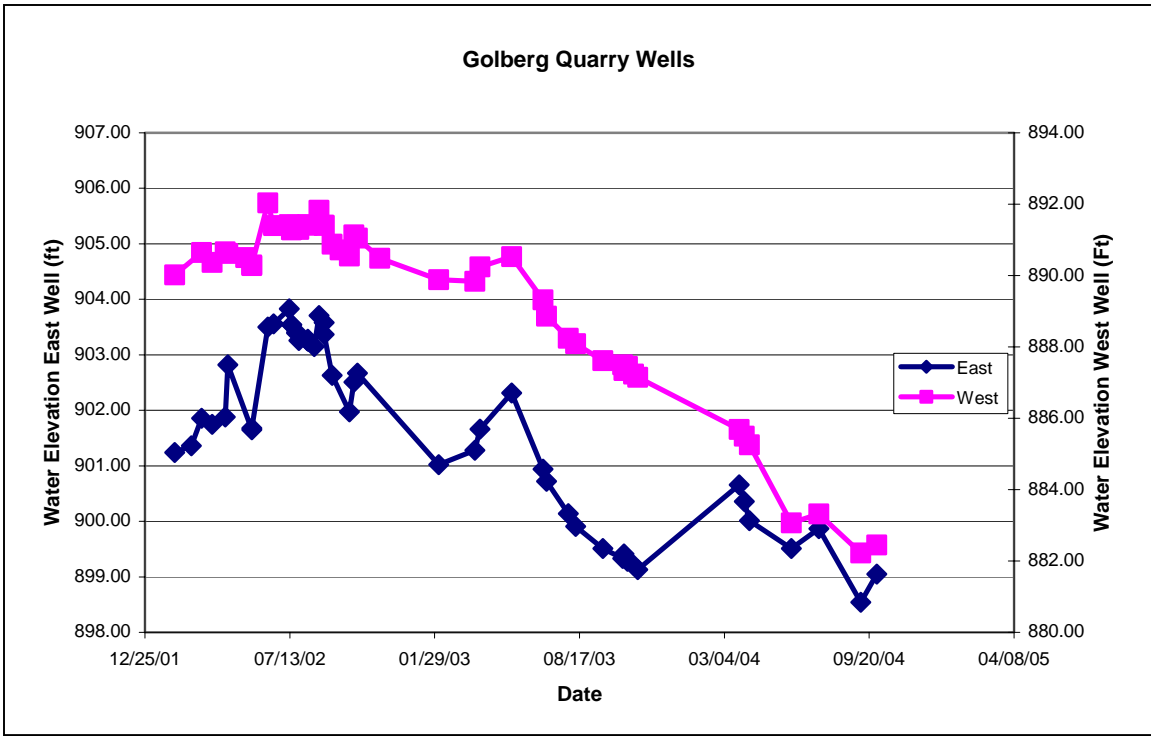
Figure 4.2. Seasonal variation of water levels in Golberg quarry wells.

The two drilled wells on the quarry site (Figure 4.1) were measured several times per month during quarrying activities, and pressure transducers measured water levels at 15-minute intervals. The quarry company does not turn off the pumps during winter, and the quarry expansion toward the wells has removed rock, which has caused ground-water levels to decline. Ground-water levels usually rise seasonally during late spring or early summer from snowmelt (Figure 4.2).

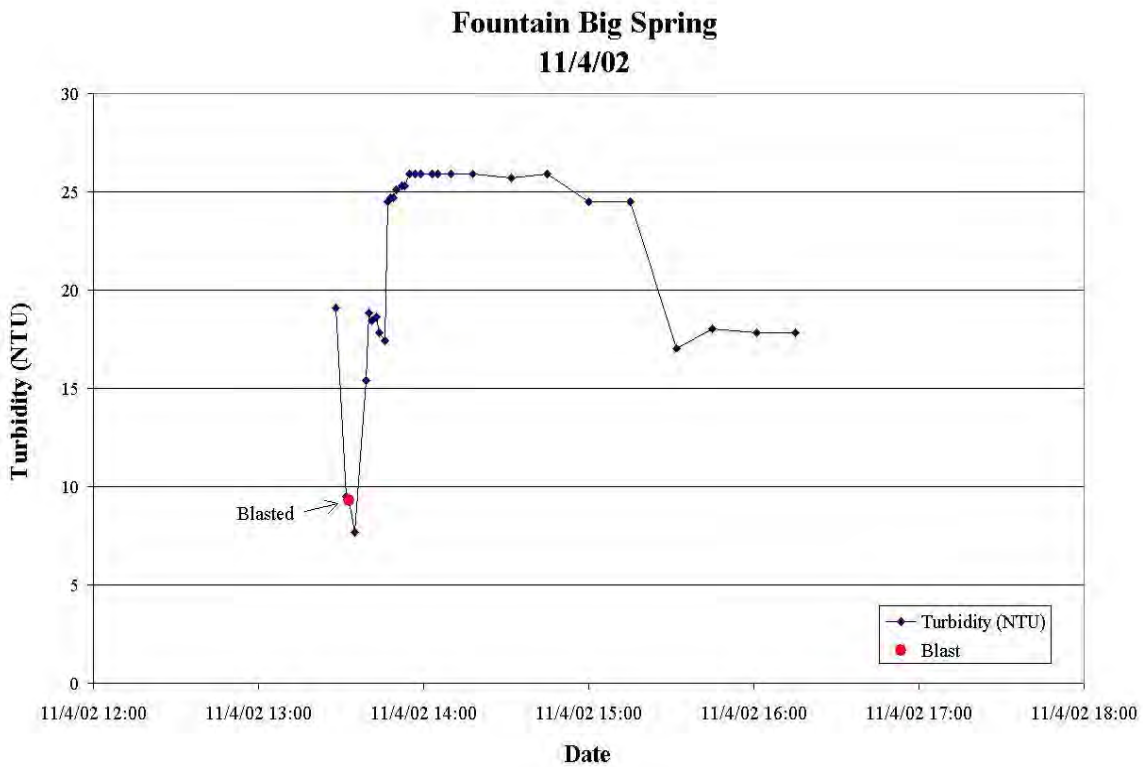
On November 4, 2002, Milestone Materials Division of Mathy Construction blasted rock on the west end of the Fountain Quarry. DNR staff at the Big Spring using a handheld turbidity meter made measurements prior to the blast, for approximately 2.5 hours after the blast, and the next day. Results in Figure 6.3 indicate that the turbidity level in the spring increased rapidly after the

Figure 6.3. Fountain Big Spring turbidity after November 4, 2002 blast.

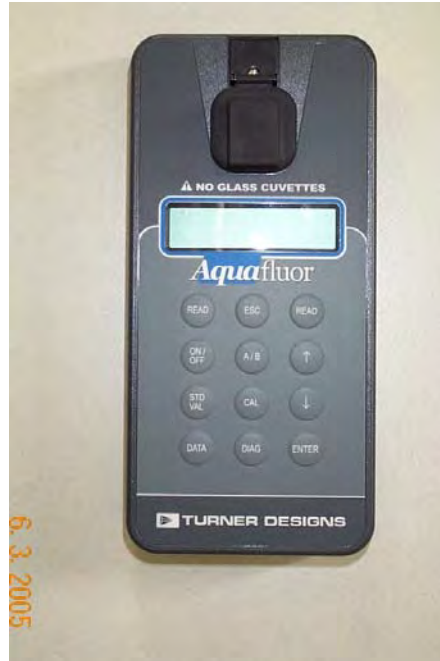
Figure 8.9. Handheld fluorometer.

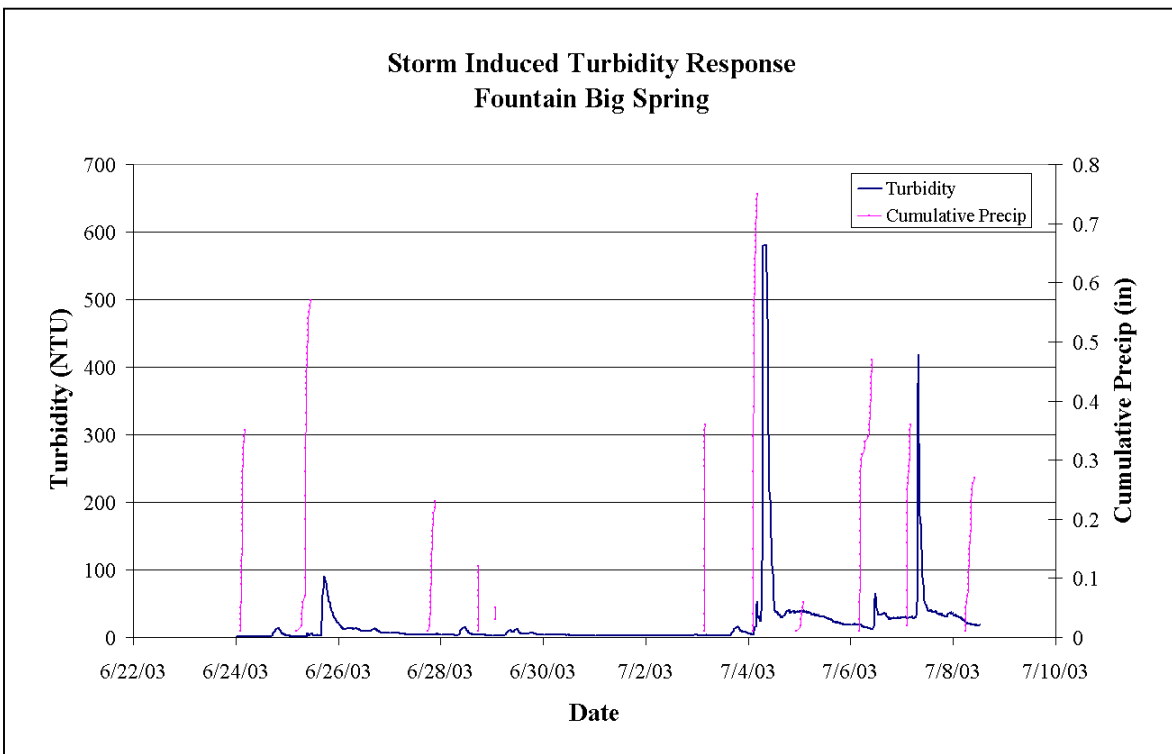
Figure 10. Storm induced turbidity response (2003).
