Wetland Delineation Report

Babcock Park

**Town of Dunn, Dane County
Wisconsin**

September 26th, 2022

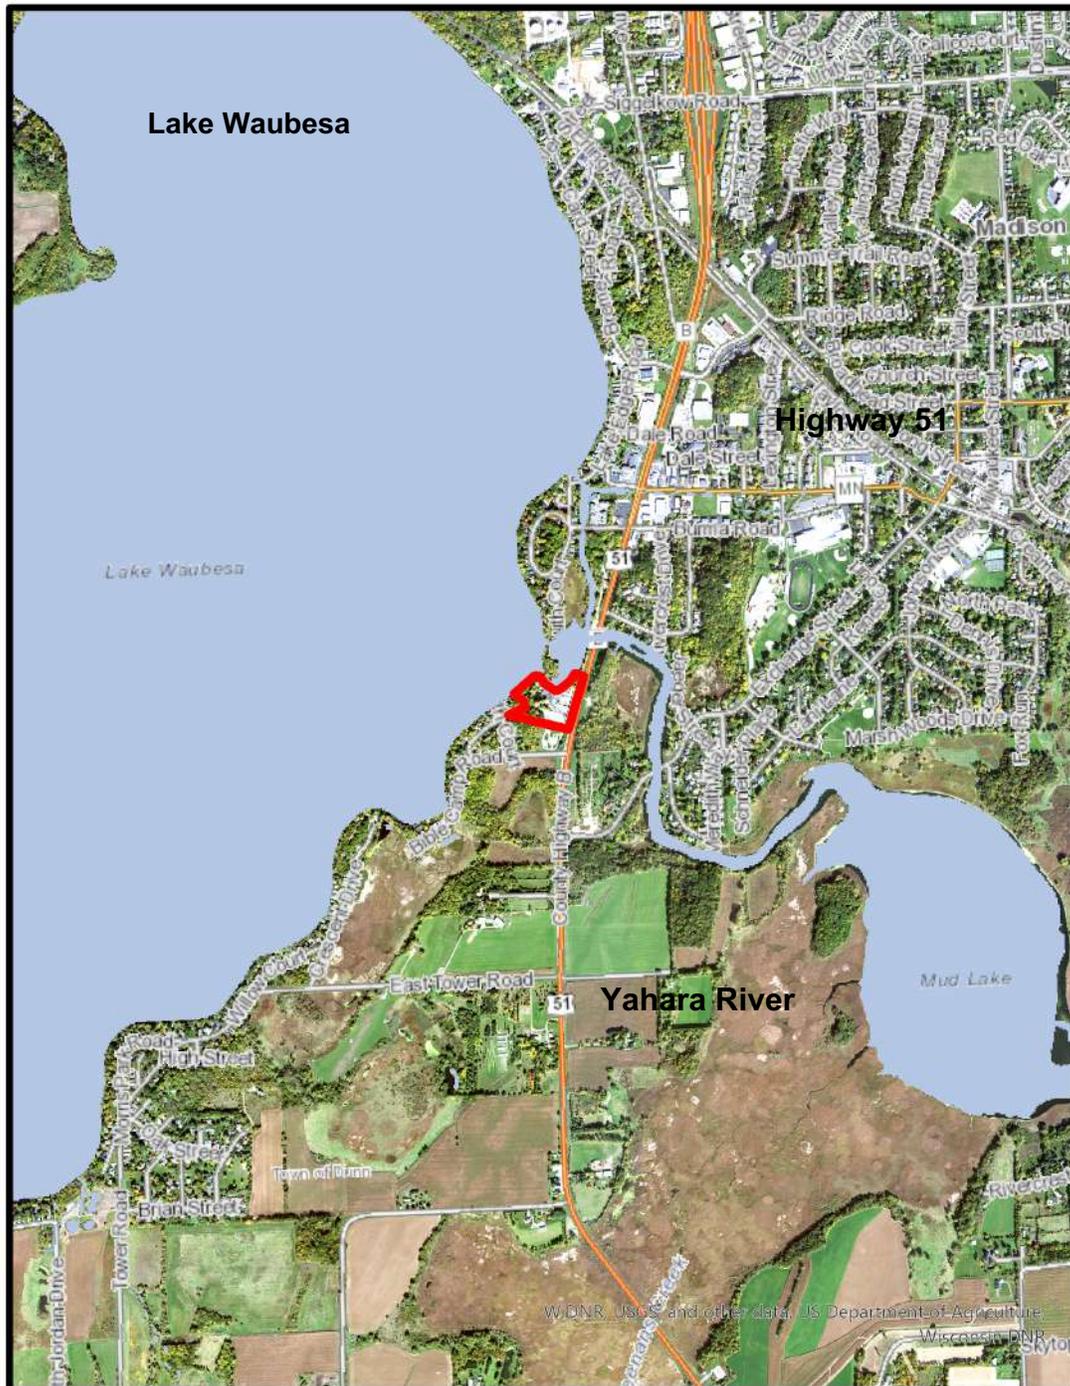
Figure 1: Landscape Overview.

The wetland investigation area covered 7.4 acres (Figures 1 & 2). It was in the Town of Dunn, Dane County, Wisconsin, SWSW, Section 3, and SESE, Section 4, T06N, R10E. It was situated on the west side of Highway 51, 2.9 miles south of the intersection with Highway 12/18 (the beltline highway).

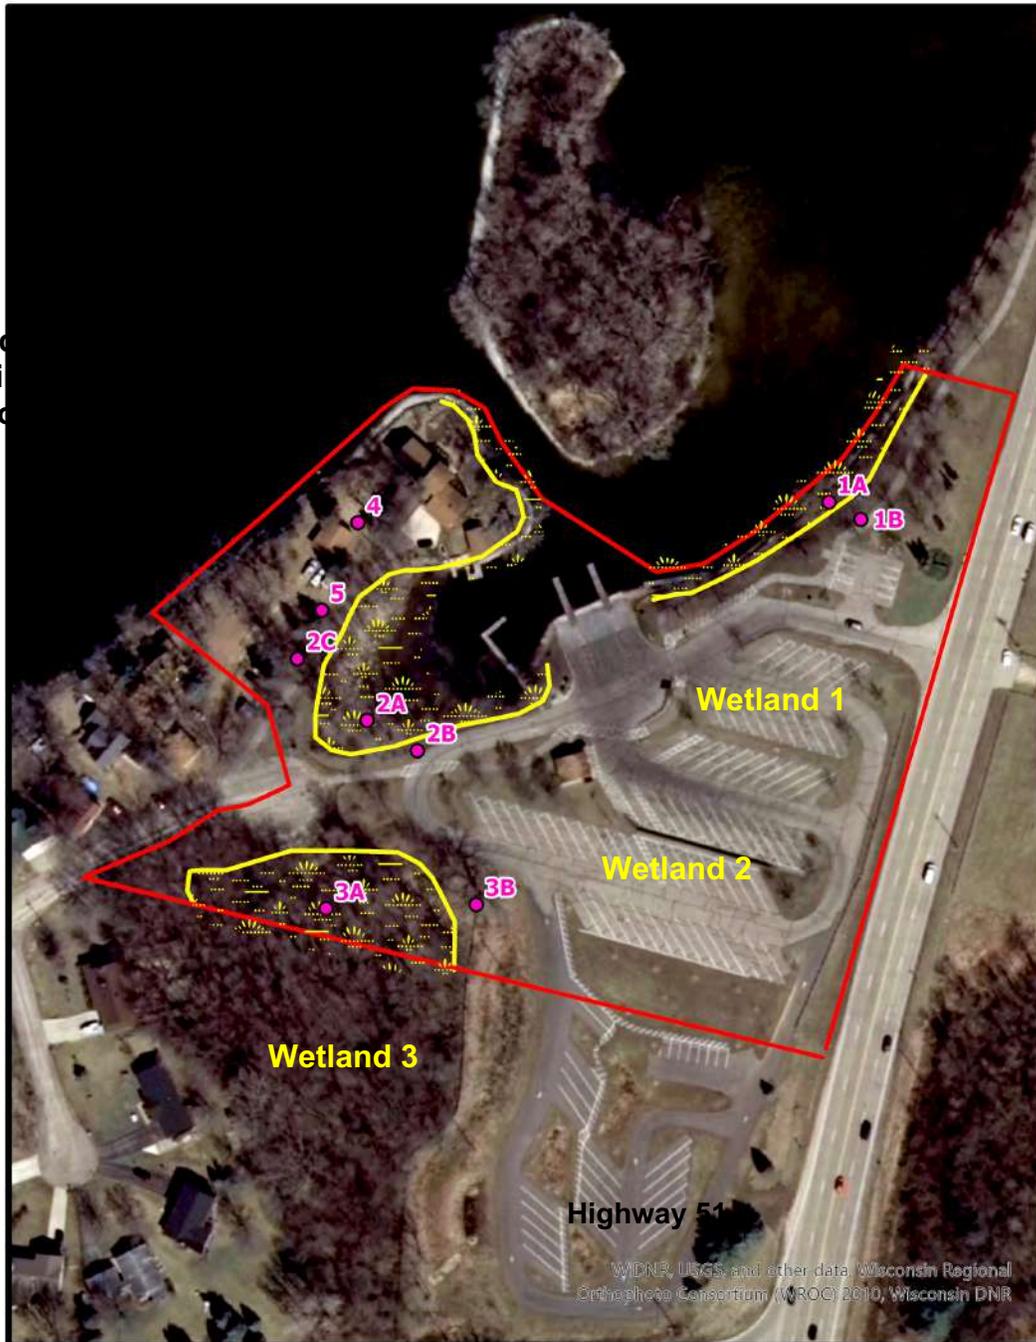
Figure 2: Investigation Area, Wetlands & Sample Plots.

The lower banks and shallow lagoon fringes were found to be wetlands. A wooded depression was a wetland as well (Figure 2).

If the sample plot data suggested that the location was inside of a wetland, a second plot was placed in an upslope location with a different plant community. If data collected at this plot suggested that the location was inside of the upland, no further plots were sampled. Otherwise, the process was repeated. A total of 9 plots were sampled, 3 inside of wetlands and 6 on the uplands (Figure 2).

Wetland 3 was a hardwood swamp with many recently dead green ashes (*Fraxinus pennsylvanica*-FacW) that were probably victims of the Emerald Ash Borer insect (Figure 2).

The uplands (non-wetlands) were the (1) upper lagoon banks and wetland basin side-slopes that supported woody and/or unmowed herbaceous vegetation; (2) high lying areas that were regularly mowed; and (3) paved parking and boat launch areas (Figure 2).

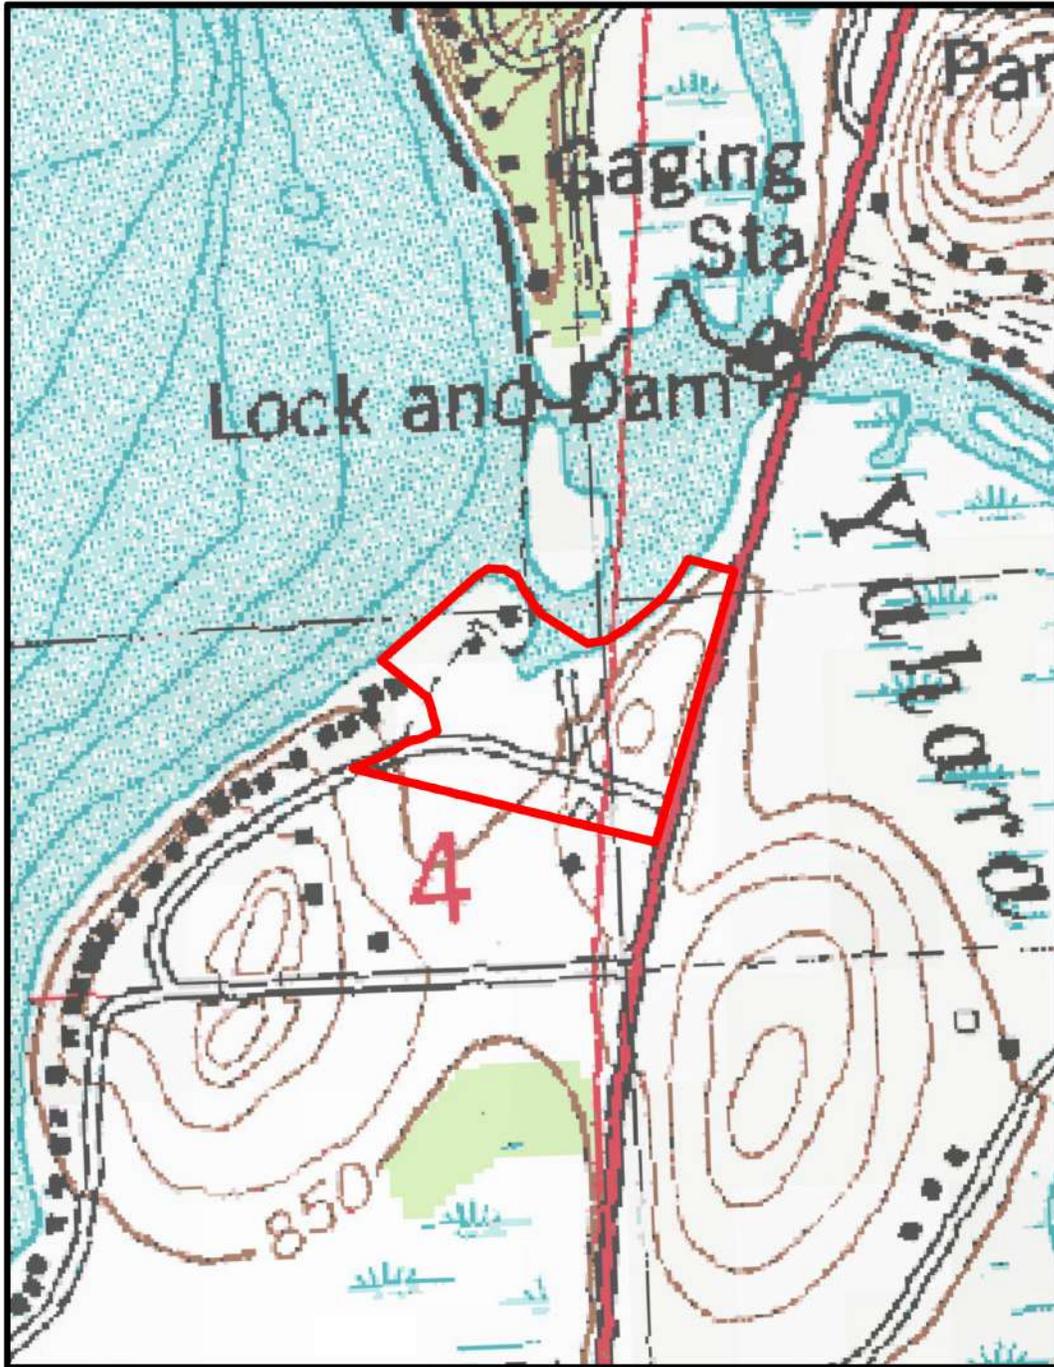
Figure 4: Topography – United States Geological Survey Map.
Source: U.S. Geological Survey 7.5-Minute Quadrangle Map.

The investigation area occupied the east shore of Lake Waubesa and the banks of a lagoon that forms the outlet of the lake before it empties into the Yahara River (Figure 4).

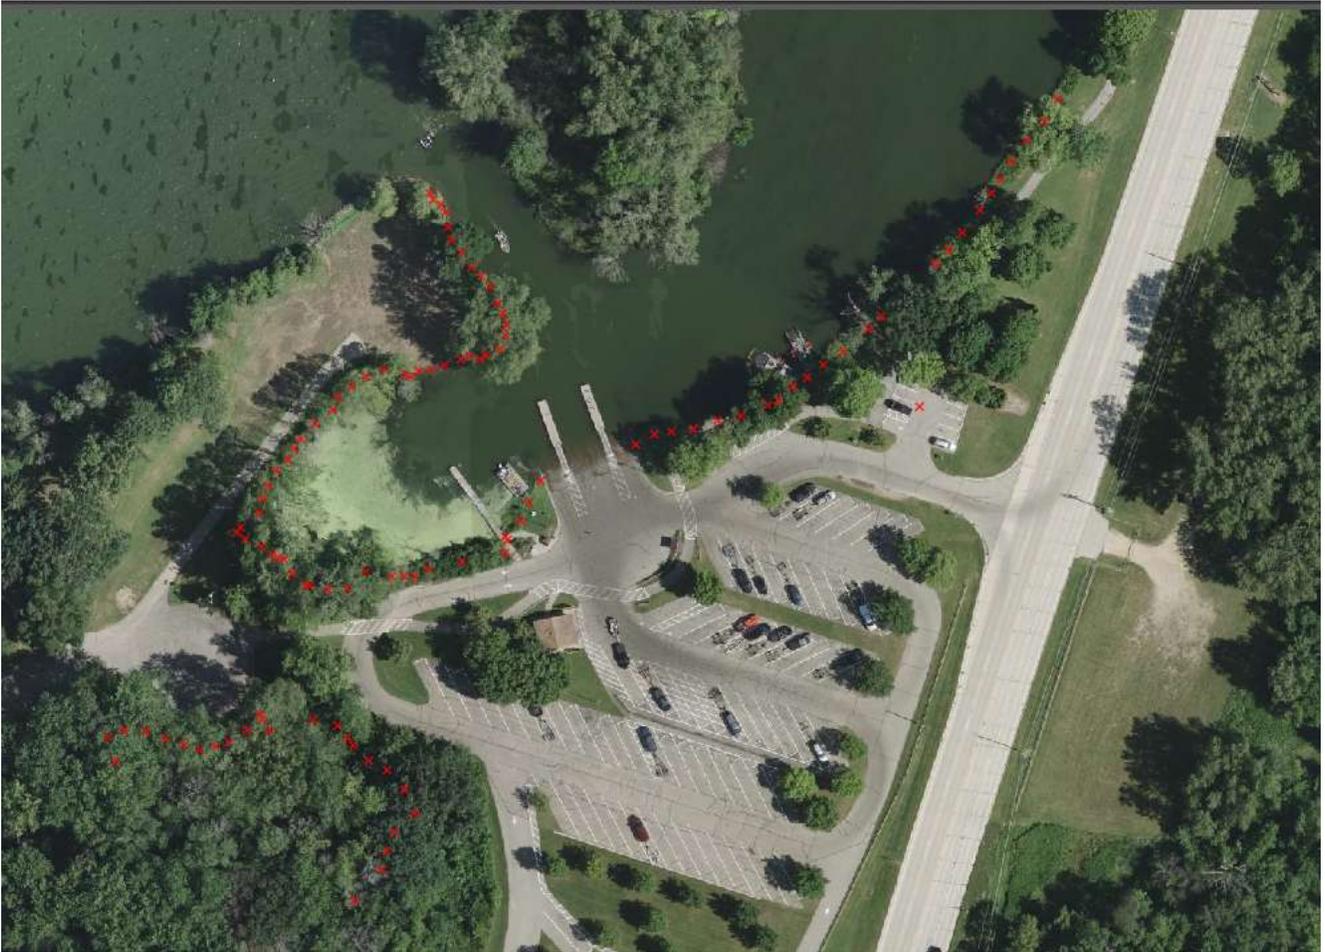
Appendix I: Survey Map of Wetland Boundary.

The wetland boundary marked in the field is the best estimate of the location of the boundary based on the available vegetation, hydrology and soil evidence on August 18th of 2022. Wetland boundaries can change over time with changes in vegetation, precipitation, or regional hydrology. The wetlands identified for this report may be subject to federal regulation under the jurisdiction of the U.S. Army Corp of Engineers, state regulation under the jurisdiction of Wisconsin Department of Natural Resources, and local jurisdiction under your local county, town, city or village. The U.S. Army Corps of Engineers and/or the Wisconsin DNR have authority to make the final decision regarding the wetland boundary. Personnel from these agencies may adjust the boundary upon field inspection.

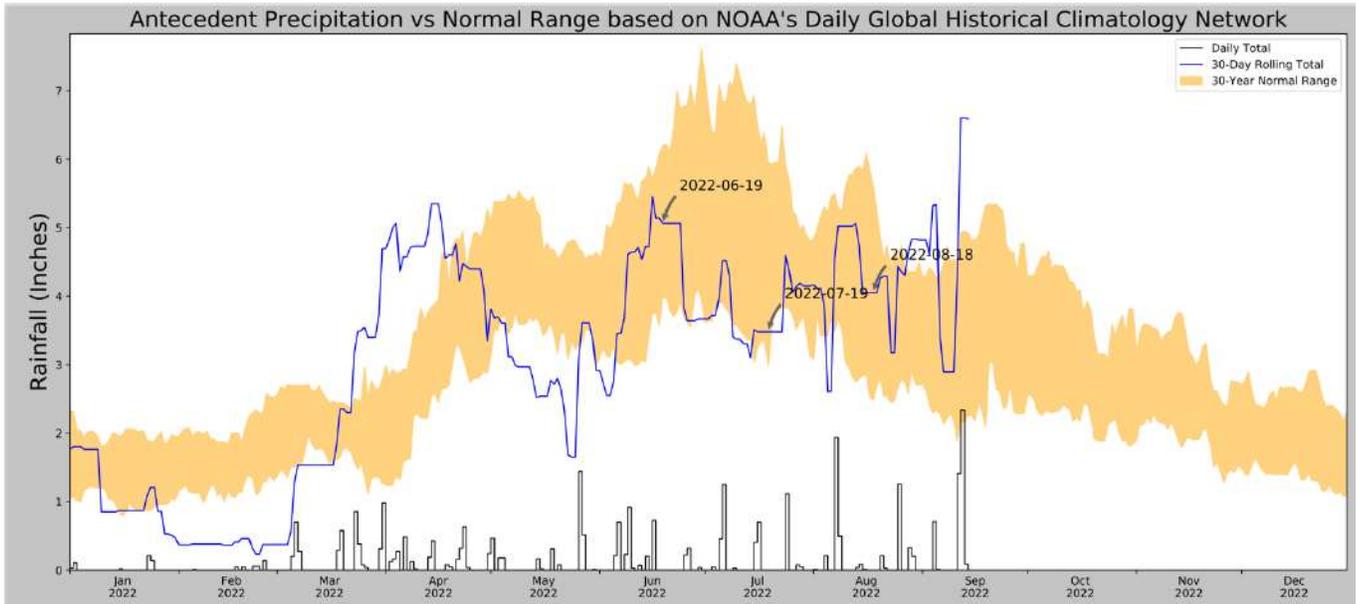
Appendix II: Antecedent Precipitation Data

The following are the results of analysis of recent and historic precipitation data from the weather stations nearest the wetland investigation area using the Antecedent Precipitation Tool (Army Corps of Engineers). See Appendix II for precipitation data graph.

The results indicate that on the date of the field investigation, **wetland moisture levels should be normal.**

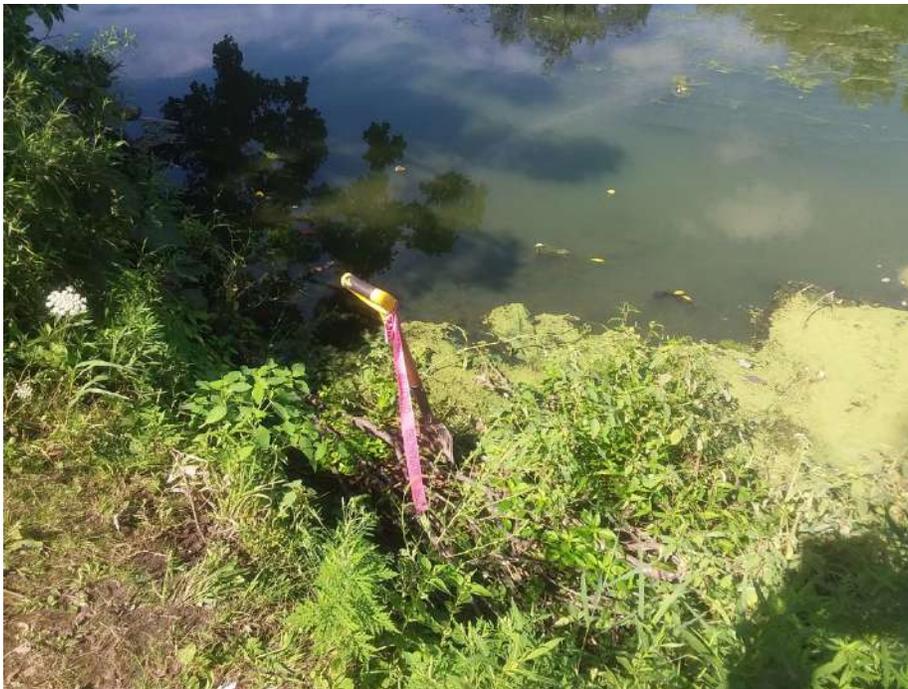
Wetland - Plot 1A

One wetland sample plot (1A) possessed standing water and vegetation dominated by FacW-rated species, therefore no soil pit was dug, and the soil was assumed hydric without direct examination.

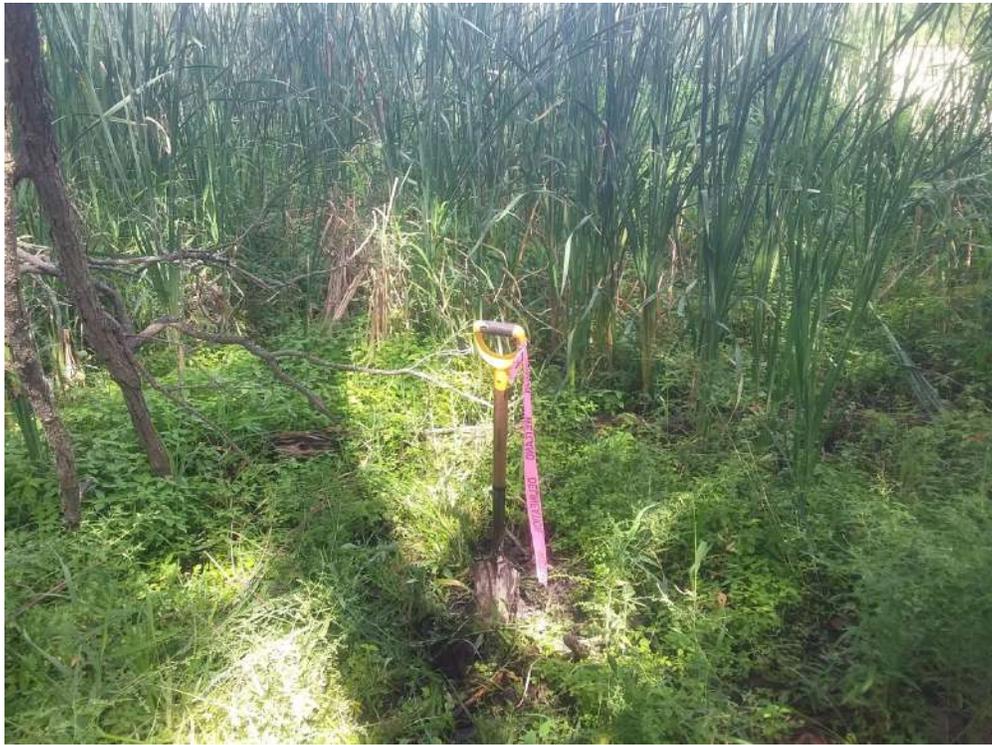
Wetland - Plot 2A

One wetland plot (2A) did not show a hydric soil indicator, but professional judgment was used to assume the soil was hydric based on the presence of hydrophytic vegetation

and wetland hydrology indicators, and the plot location in a low landscape position, following guidance in Chapter 5 of the Regional Supplement to the Corps of Engineers Wetland Delineation Manual.

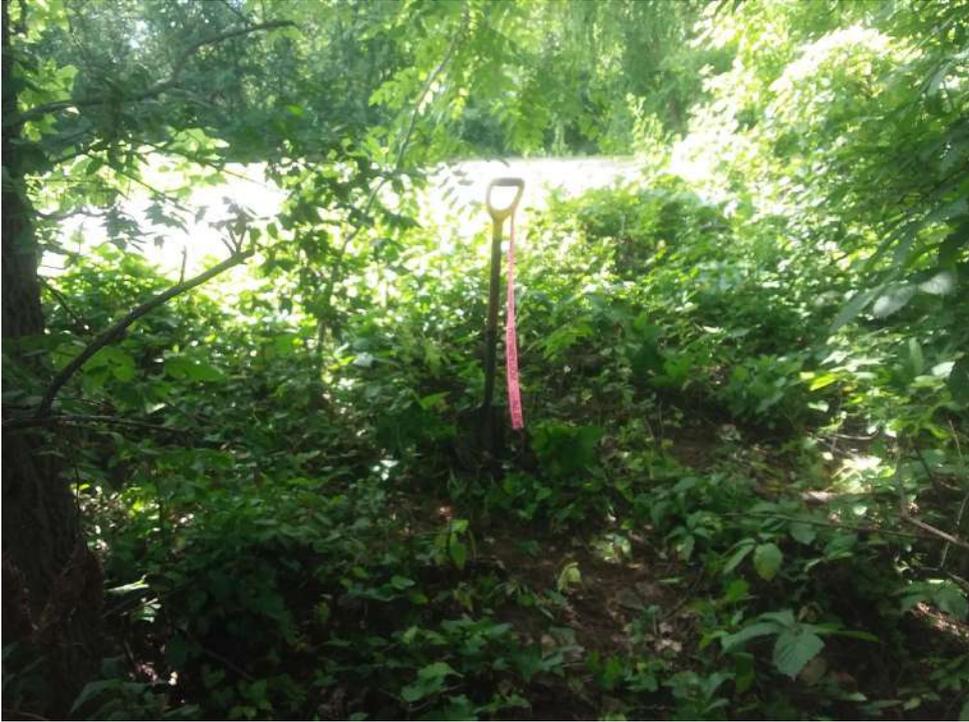
Wetland - Plot 3A

Soils	
Hydric indicators	Redox Dark Surface-F6 (plot 3A). Plot 1A possessed standing water, so soil was assumed hydric, see notes below.
Hydric Indicators Missing?	Plot 2A. Investigator used professional judgment, see notes below.
Surface Horizon Colors & Textures	10 YR 2/1, 2/2; silt loam
Subsoil Horizon Colors & Textures	10 YR 3/2, 3/2; silt loam

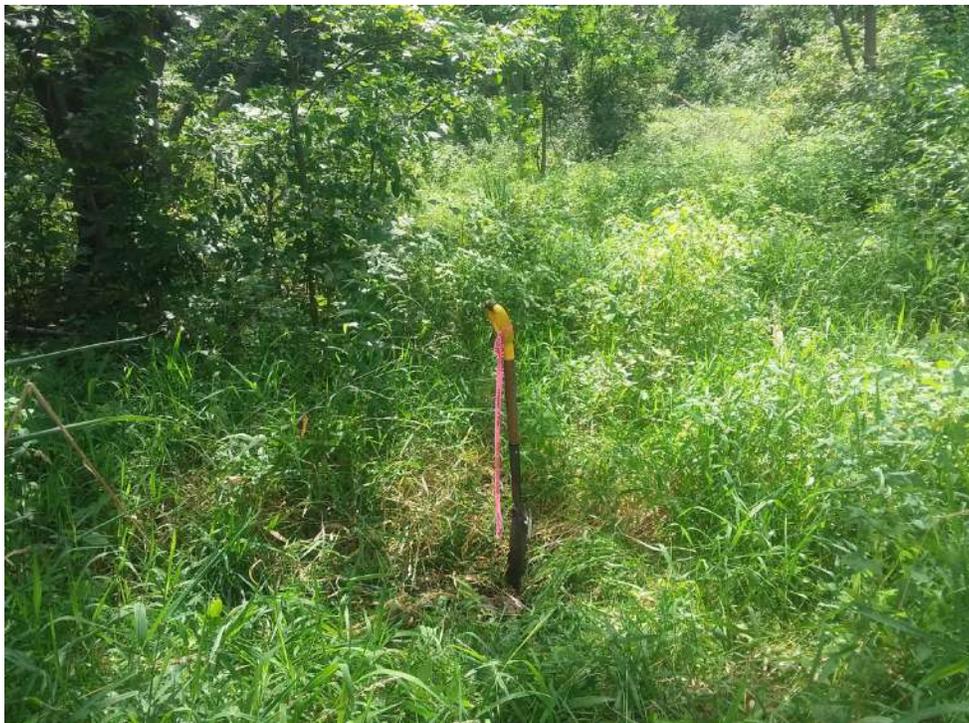
Upland – Plot 3B

<i>Vegetation</i>	
<i>Dominant Species:</i>	
Herb-layer	Canada goldenrod (<i>Solidago canadensis</i> -FacU), white avens (<i>Geum canadense</i> -Fac), frost aster (<i>Symphyotricum pilosum</i> -FacU), enchanter's nightshade (<i>Circaea canadensis</i> -FacU), Kentucky blue grass (<i>Poa pratensis</i> -FacU)
Saplings & Shrubs	Honeysuckle (<i>Lonicera X bella</i> -FacU), buckthorn (<i>Rhamnus cathartica</i> -Fac), high bush cranberry (<i>Viburnum opulus</i> -FacW)
Trees	Bur oak (<i>Quercus macrocarpa</i> -Fac), hackberry (<i>Celtis occidentalis</i> -Fac)
<i>Hydrophytic Indicators:</i>	
Plots Meeting Dominance Test?	Plot 3B. See notes below.
Plots Meeting Prevalence Index?	None

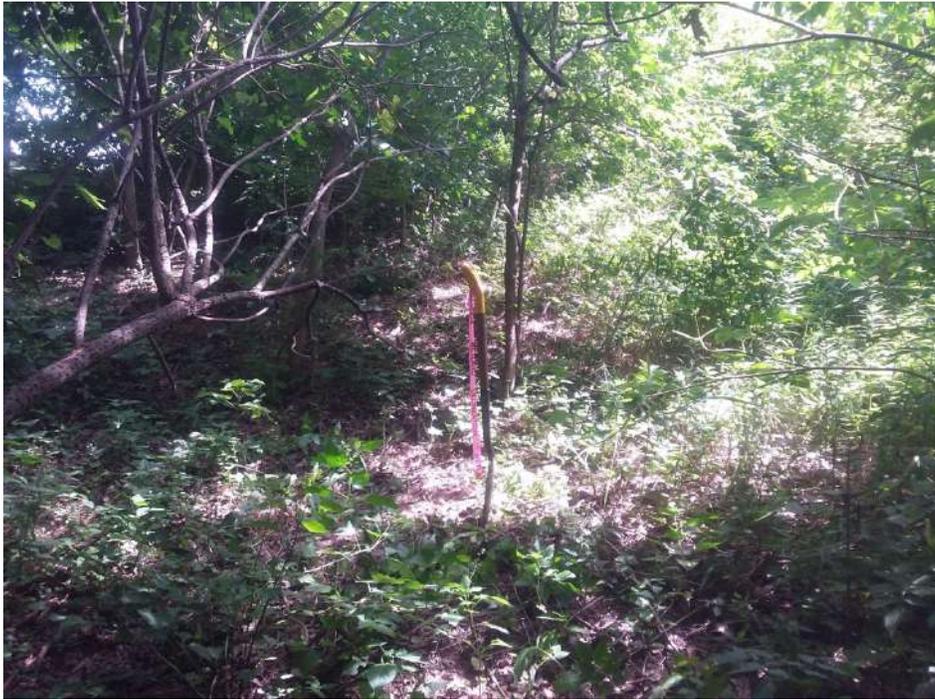
One of 6 upland sample plots (plot 3B) showed dominance by hydrophytic vegetation. However, the absence of hydric soil and wetland hydrology indicators at this site strongly suggested it could support a predominantly non-hydrophytic plant community.

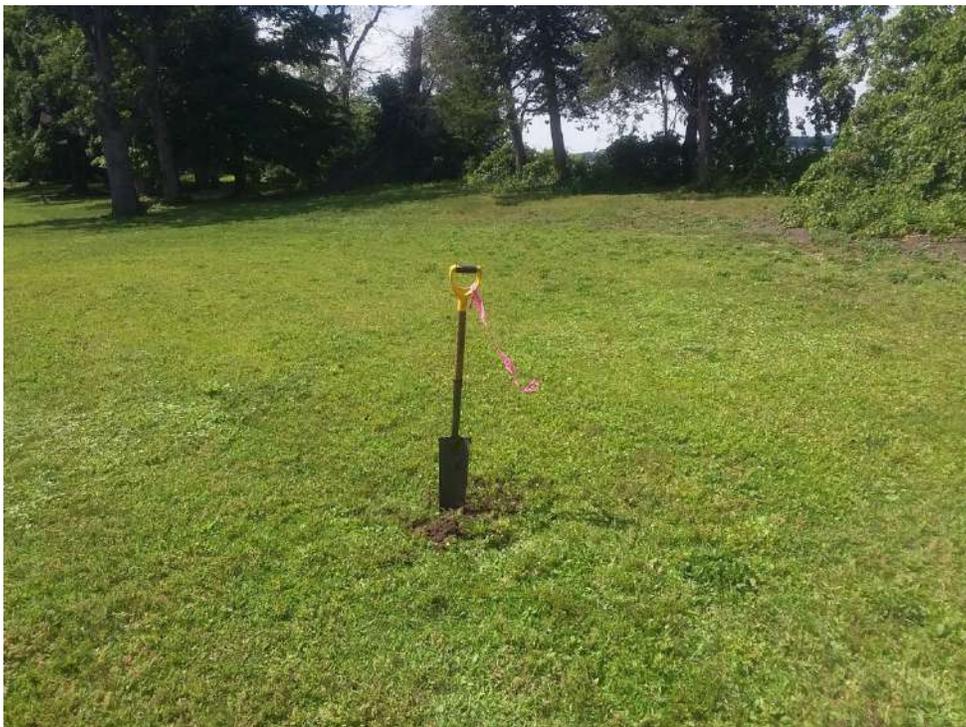
Upland - Plot 4

Although upland sample plot 4 showed a hydric indicator, the absence of hydrophytic vegetation and wetland hydrology indicators at this site strongly suggested it was not a wetland.
