Memo of Findings

Discussion with Commission/Director Mandli re: Potential PW Class II Emergency

12/3/2021

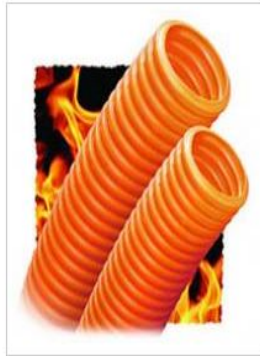
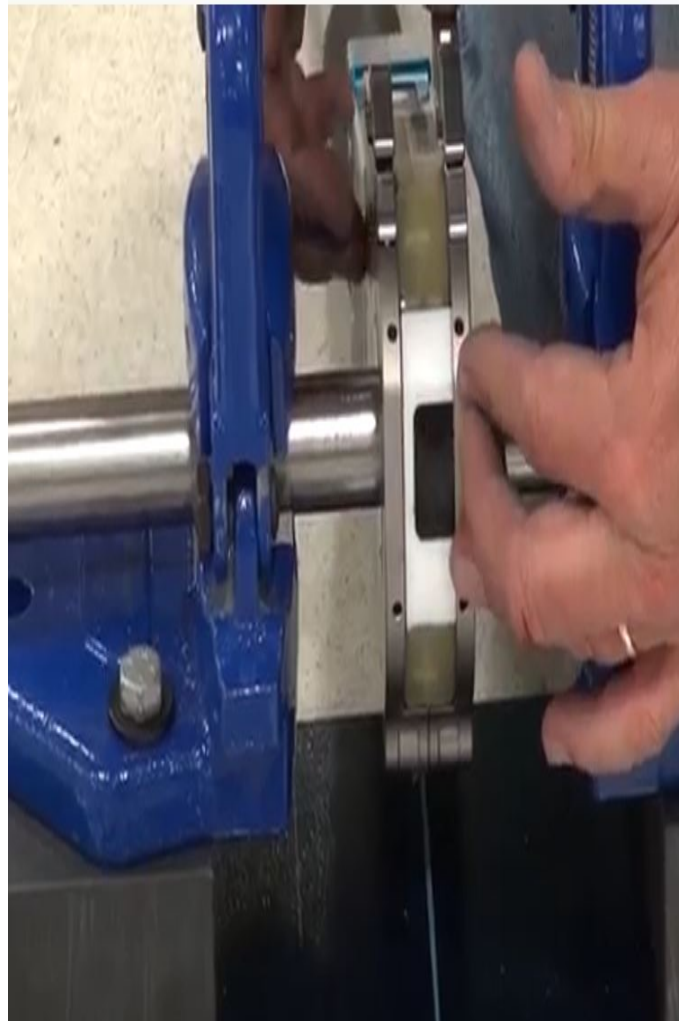
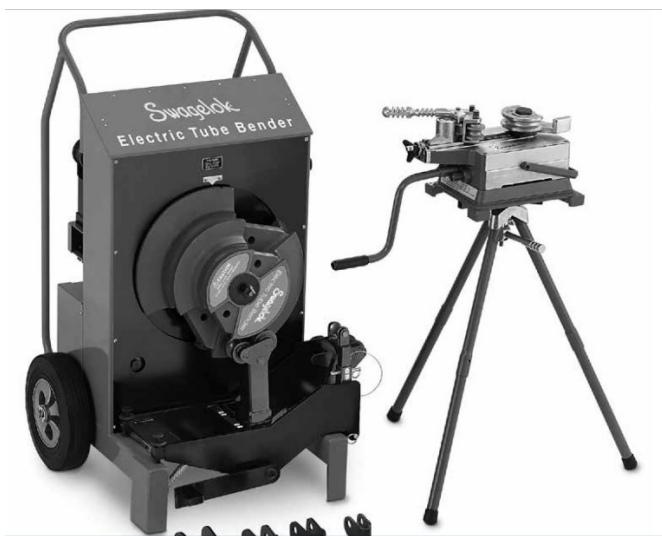
Upper Left –Continuous Carrier pipe Upper Right- Orbital Weld Bottom Left- Pipe Bender

-There now is a protective carrier casing that makes installation faster and easier that wasn't included in initial estimate.

1100' of new 1" SS tubing @ \$20/ft =	\$22,000.00
Xray inspection of welds	\$ 6,000.00
Additional Labor (removal of old Tube, bend & install new)	\$ 6,000.00
Materials and Equipment	
(New cont. tube sleeve, tube bender rent, dispose existing ¾")	\$11,000.00
