Memo of Findings

Discussion with Commission/Director Mandli re: Potential PW Class II Emergency

12/3/2021

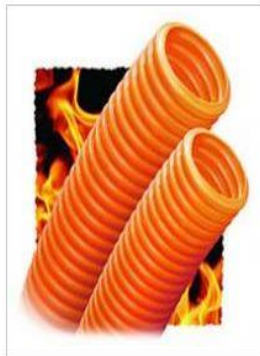
Corrugated HDPE Coils

Our riser is ideally suited for use as a nonmetallic flexible raceway for protecting and organizing optical fibers in riser applications. Our riser is listed by Underwriters Laboratory (UL) for use with riser or general purpose optical fiber cables per National Electric Code (NEC) article 770 or communication cables per article 800.

-There now is a protective carrier casing that makes installation faster and easier that wasn't included in initial estimate.

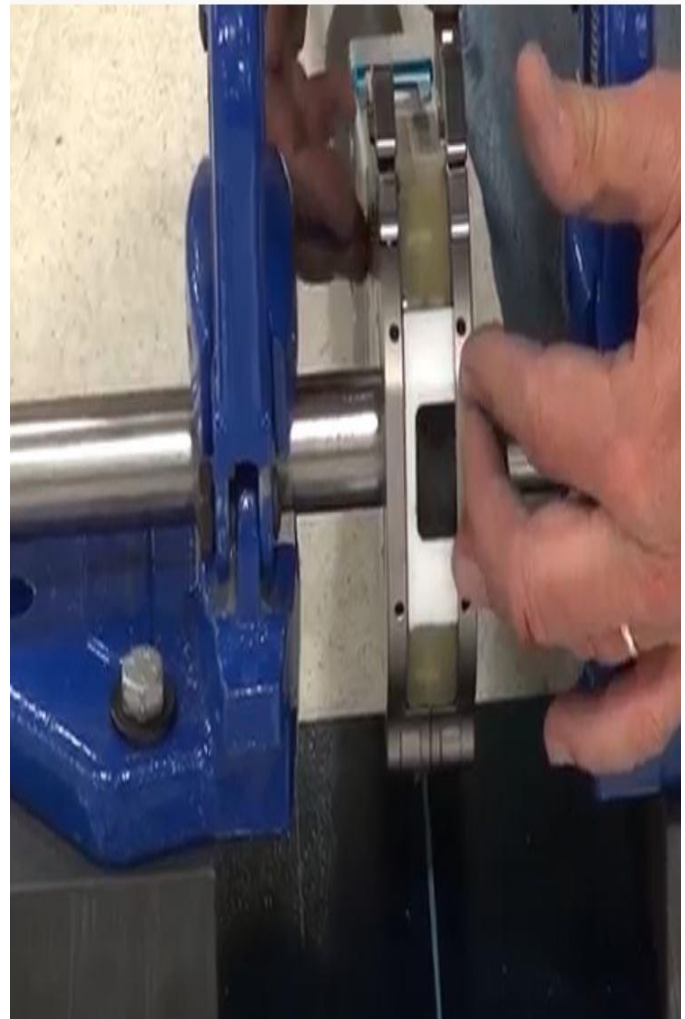
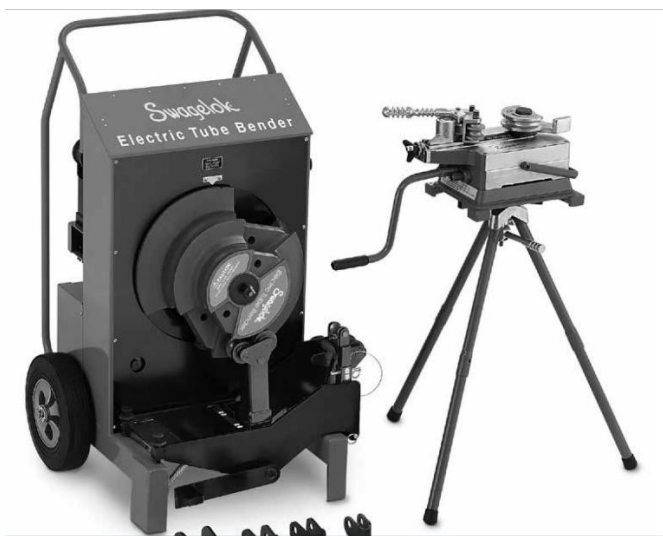
Upper Left –Continuous Carrier pipe Upper Right- Orbital Weld Bottom Left- Pipe Bender

1100' of new 1" SS tubing @ \$20/ft. =	\$22,000.00
Xray inspection of welds	\$ 6,000.00
Additional Labor (removal of old Tube, bend & install new)	\$ 6,000.00
Materials and Equipment	
(New cont. tube sleeve, tube bender rent, dispose existing ¾")	\$11,000.00
