All WC Determinations Map

Figure 3. NRCS
Hydric Soils
Maier Farm
Project #20200322
T9N, R9E, S21
T Vienna, Dane Co

Maier Farm
Project #20200322
T9N, R9E, S21
T Vienna, Dane Co

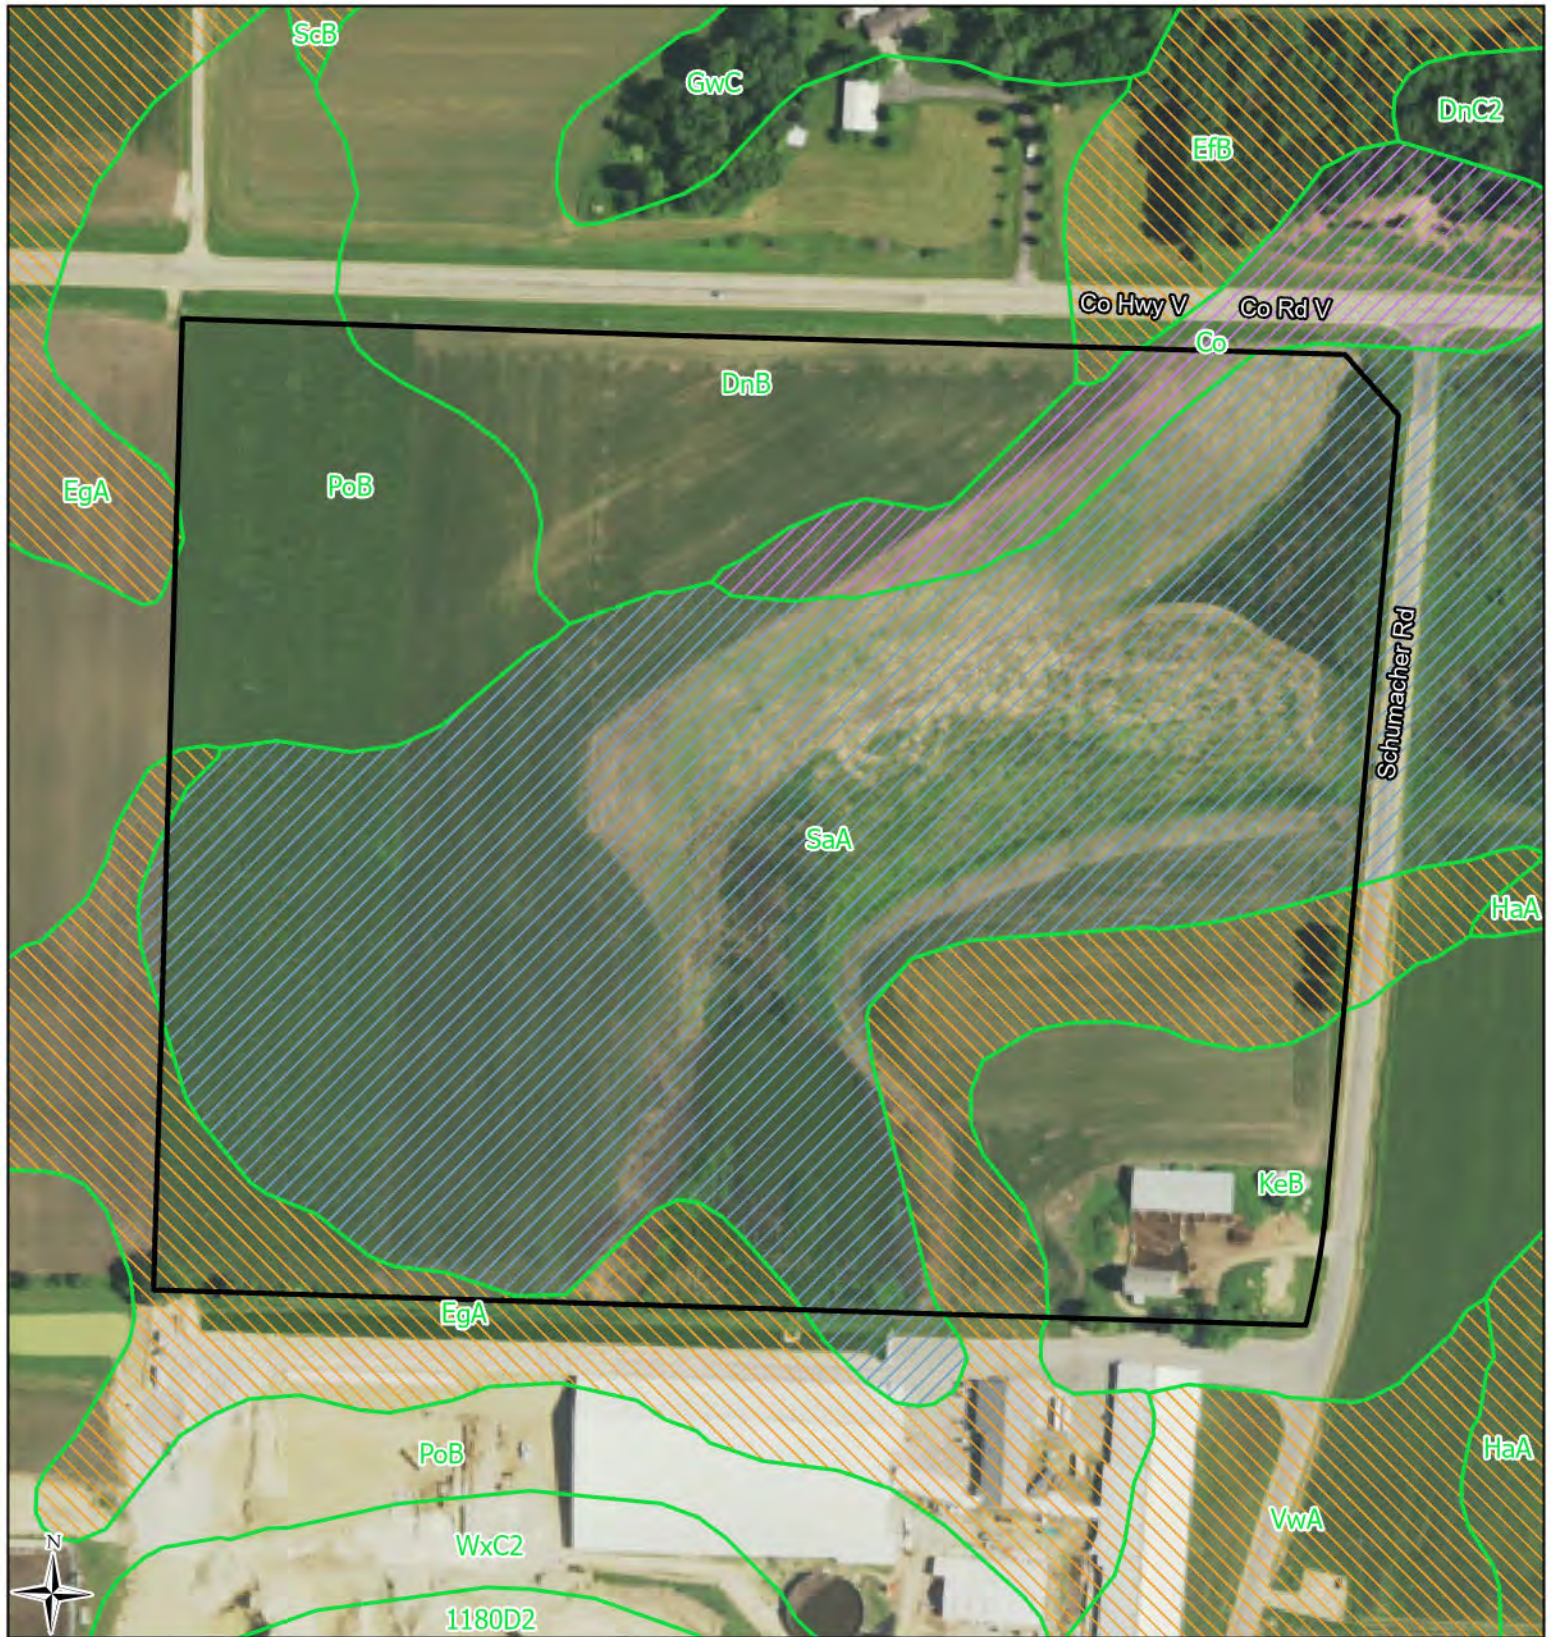
This map shows all completed WC determinations for the site. It is the responsibility of all program participants to not convert obvious wetlands regardless of map interpretation. Newly completed and previously certified areas are shown on this map. Other areas are marked as, "Not Evaluated."

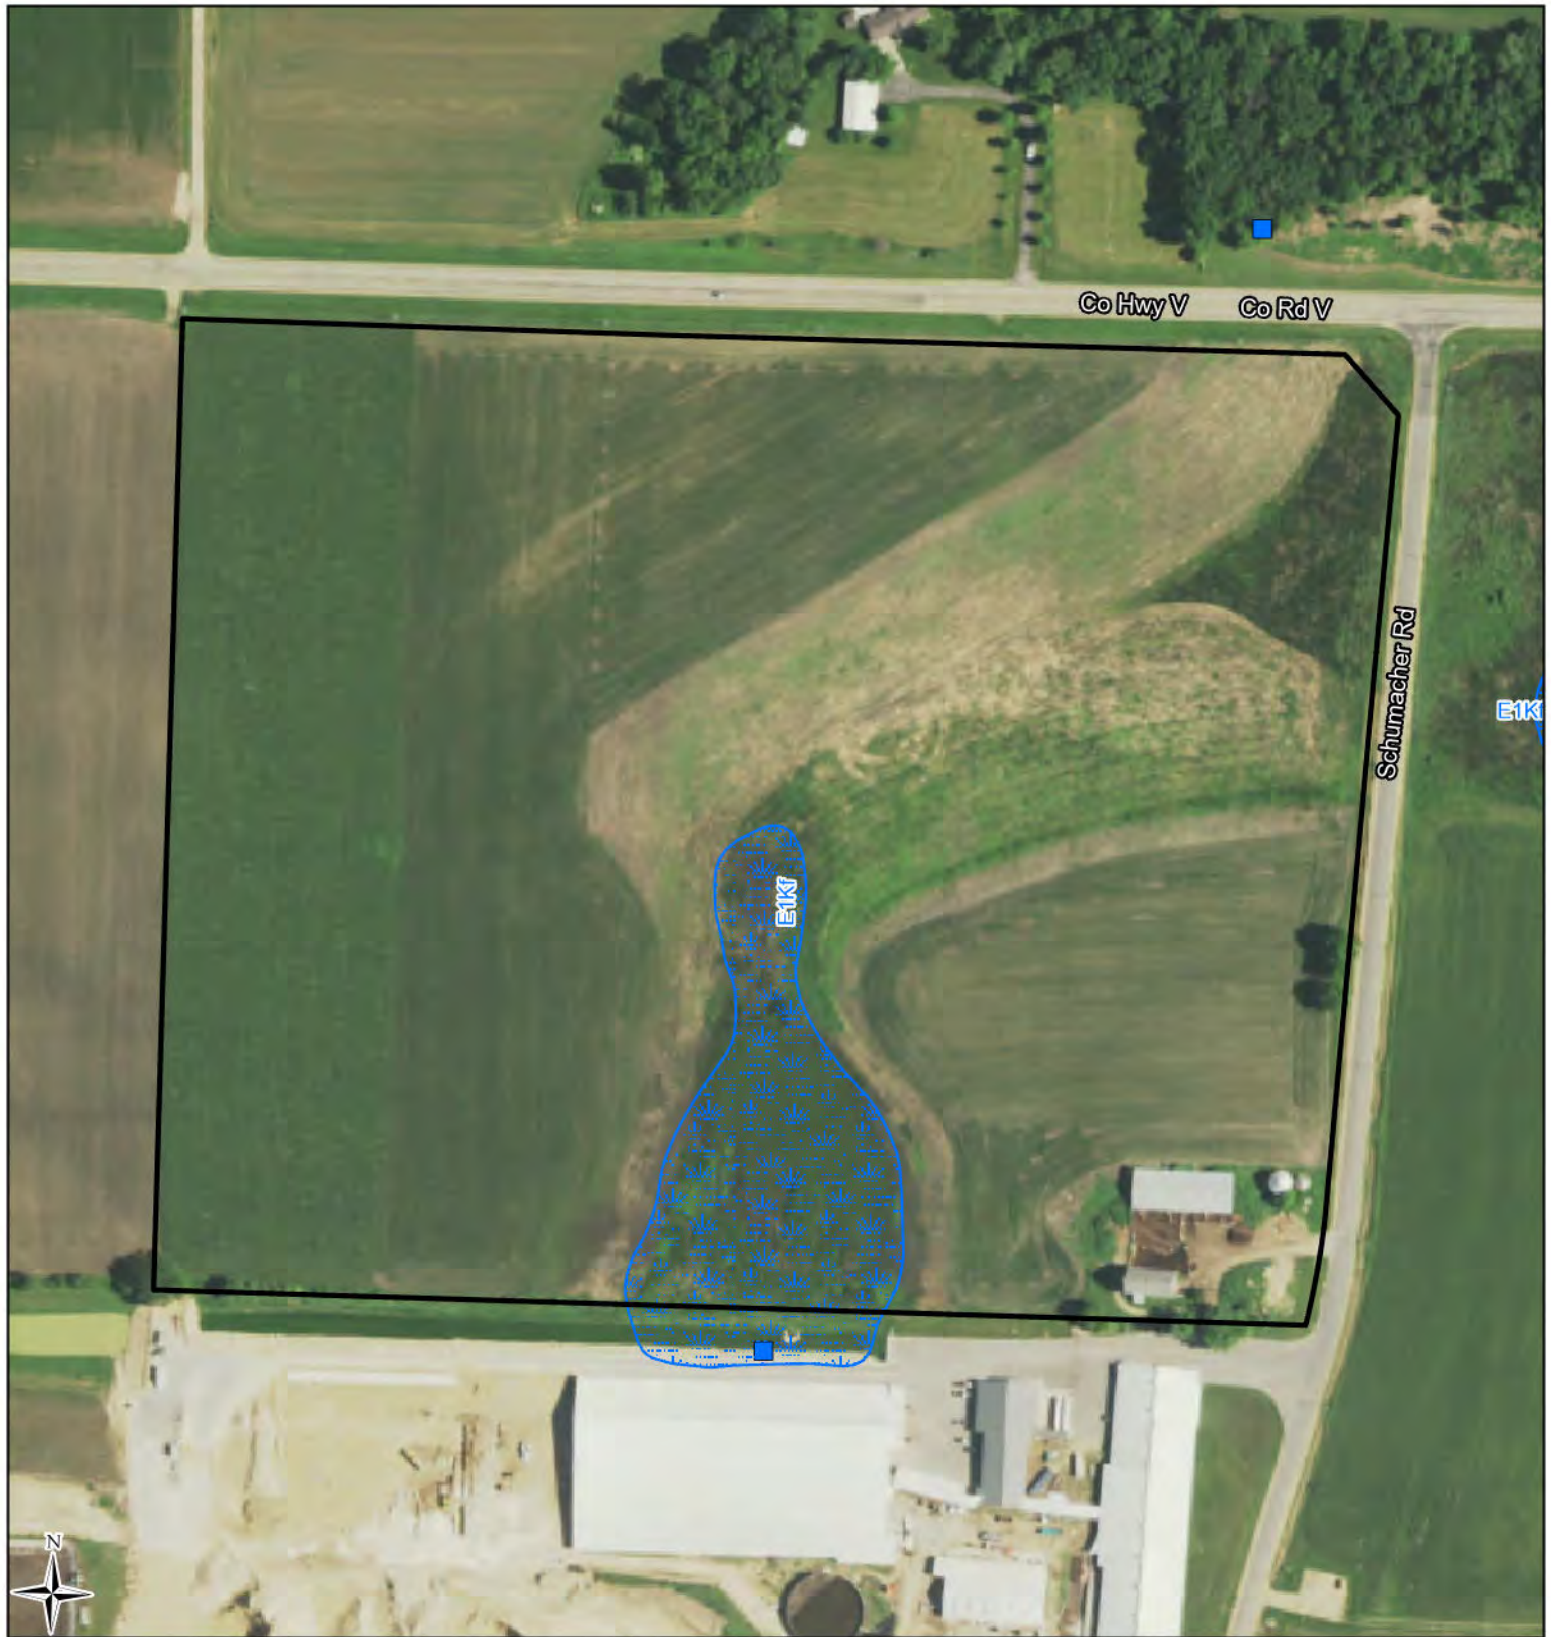
Figure 5. Wisconsin Wetland Inventory

- Study Area (44.95 ac)
- WWI Polygons
- WWI Points
- Perennial Streams (None in Map Extent)
- Intermittent Streams (None in Map Extent)
- Waterbodies (None in Map Extent)
